## FIELD INSPECTION

| <b>Project Name:</b> | Mountain Valley Pipeline | <b>Inspector:</b> | Matthew Grant |
| <b>Inspection Date:</b> | Wednesday, August 21, 2019 | <b>Project Contact:</b> | Brian Clauto |

## FIELD INSPECTION PHOTO LOG

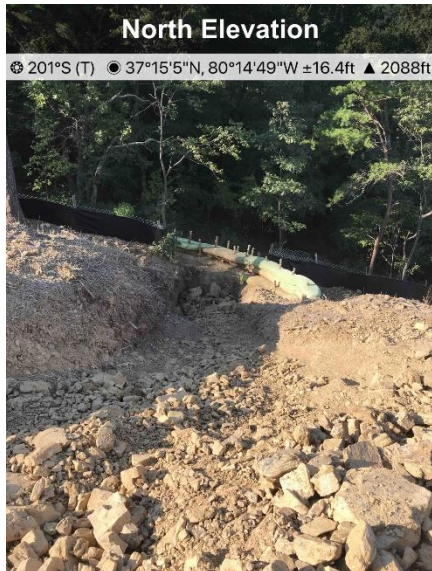
- Fig. 1 St12232+20 sump lacks adequate storage

**Recommend Corrective Action:** Maintain and install all controls per the approved plan and specs

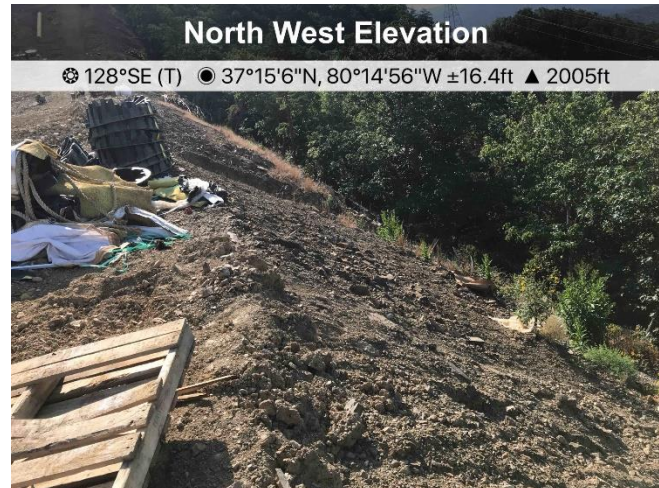
- Fig. 2 St12232+00 uncontained trash

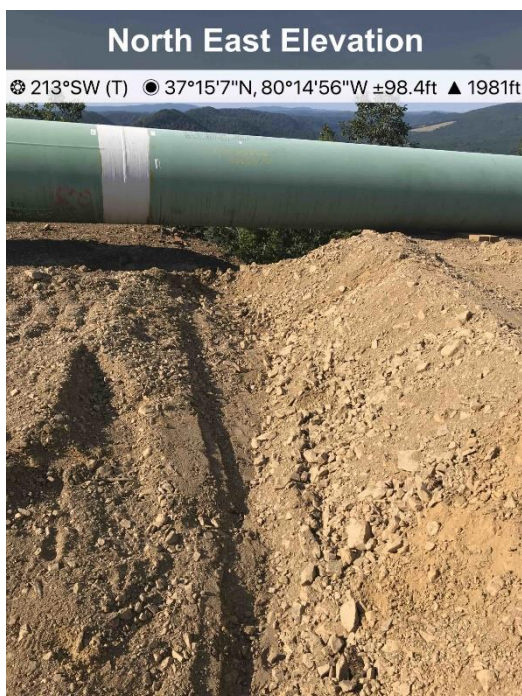
- Fig. 3. St12225+00 waterbar flow path requires maintenance.

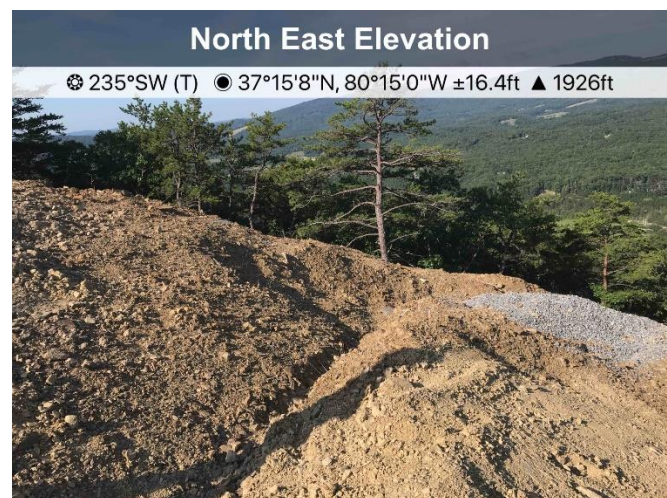
- Fig. 4 St12222+10 waterbar lacks end treatment

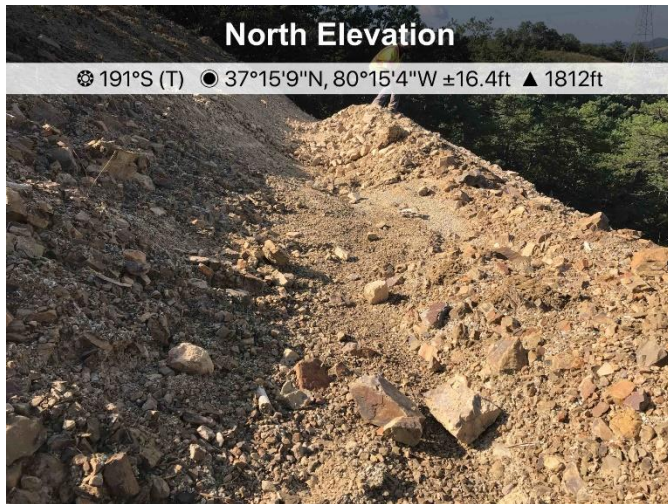
- Fig. 5 St12218+40 waterbar not built to spec

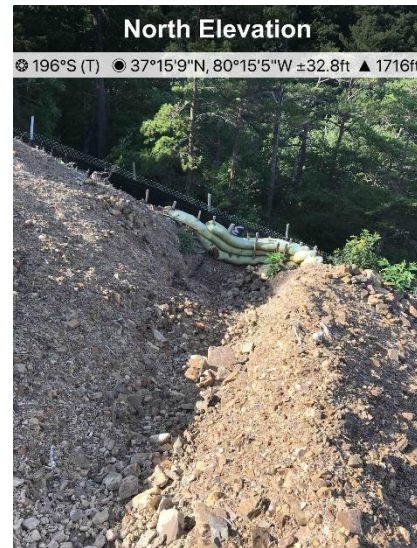
- Fig. 6 St12217+50 waterbar requires maintenance of end treatment and sump

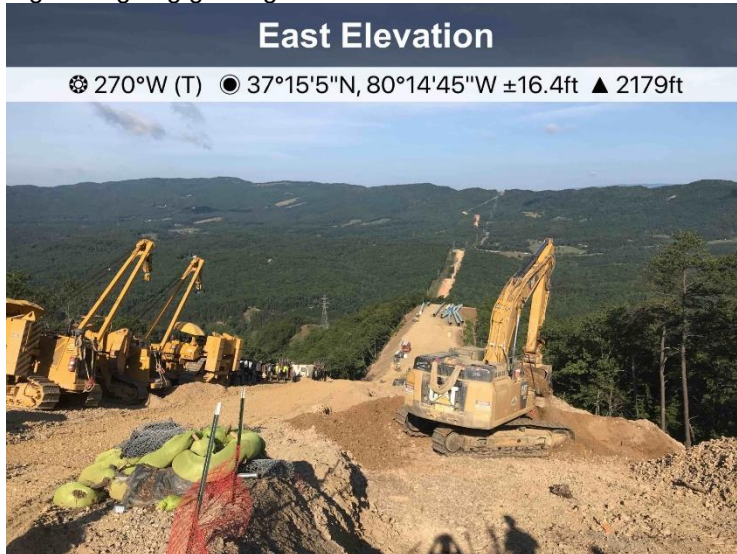
- Fig. 7 Ongoing grading activities near St12235+00

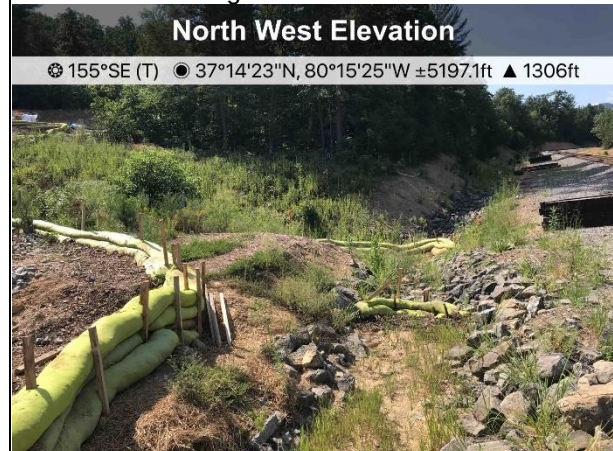
- Fig. 8 Designated stream S-0011, ECD's are in place and functioning.
