## FIELD INSPECTION

| <b>Project Name:</b> | Mountain Valley Pipeline | <b>Inspector:</b> | Matthew Grant |
| <b>Inspection Date:</b> | Tuesday, August 20, 2019 | <b>Project Contact:</b> | Brian Clauto |
| <b>Spread:</b> Franklin Co.<br>MP247<br>St13063+23-13061+44<br>AR290 | Spread H | <b>Weather (Wet/Dry/Rain):</b> | Dry |

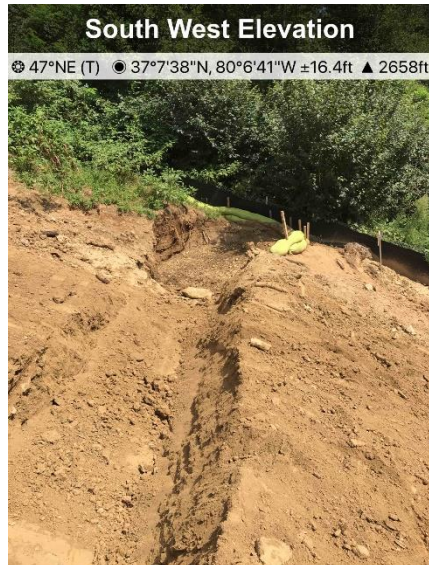
- Inspected designated streams included: SG-26, SG-27,
- St13061+44 sump lacks adequate storage and SSF has been undermined

- Fig. 1 St13061+44 sump lacks adequate storage

**Recommend Corrective Action:** Maintain and install all controls per the approved plan and specs

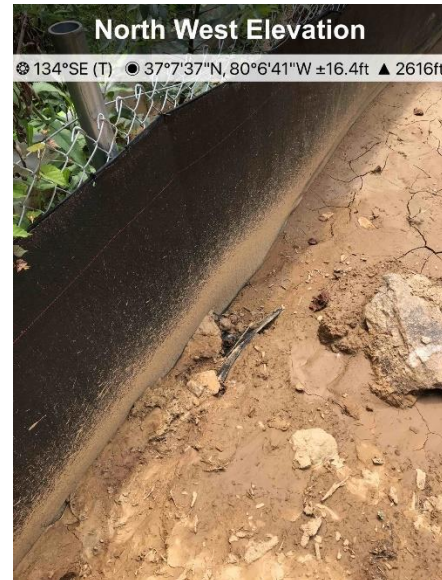
- Fig. 2 St13061+44 SSF has been undermined

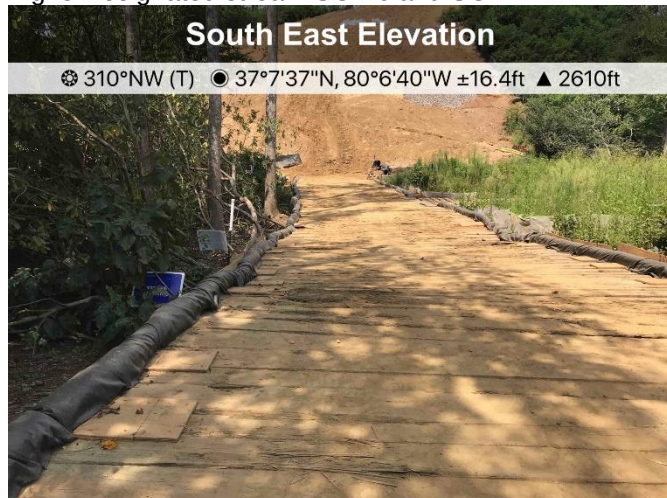
- Fig. 3 Designated stream SG-26 and SG-27

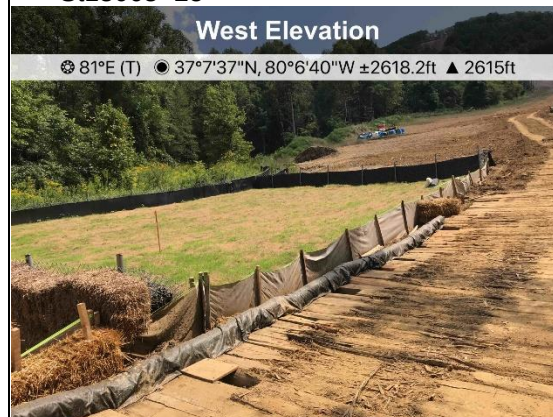
- Fig. 4 Bore pit has been backfilled and stabilized near St13063+25
