## FIELD INSPECTION

| Project Name: | Mountain Valley Pipeline | Inspector: | Matthew Grant |
| Inspection Date: | Wednesday, December 19, 2018 | Project Contact: | Brian Clauto |
| Spread: Montgomery County MP 227-228 | Spread H | Weather (Wet/Dry/Rain): | Wet |

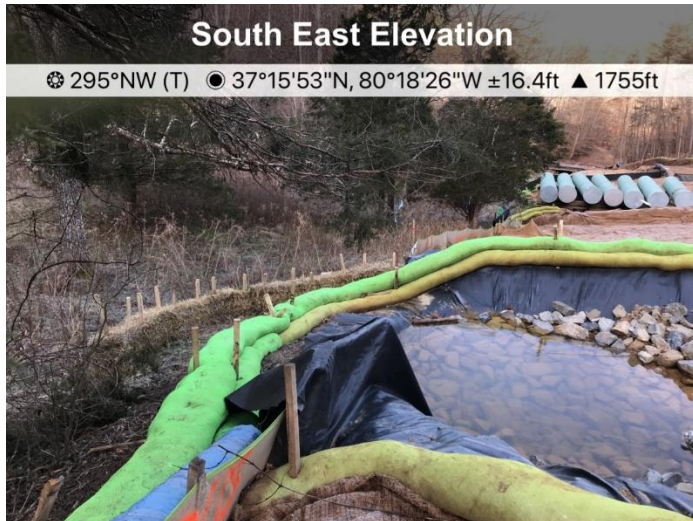
- Fig. 1 St#12038+00 plunge pool installed and functioning.

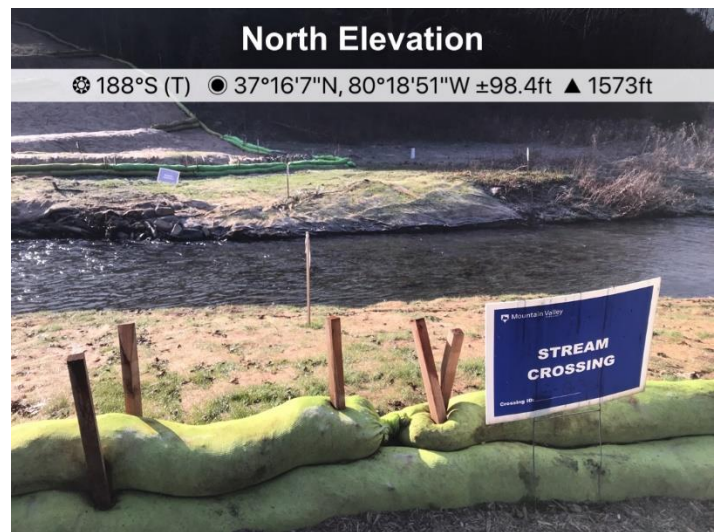
- Fig. 2 designated stream crossing S-G36 controls in place and functioning.

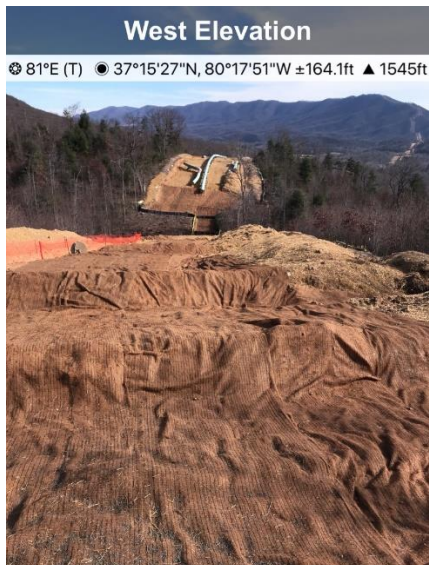
- Fig. 3 St#10273+65 matting has been installed and is functioning.

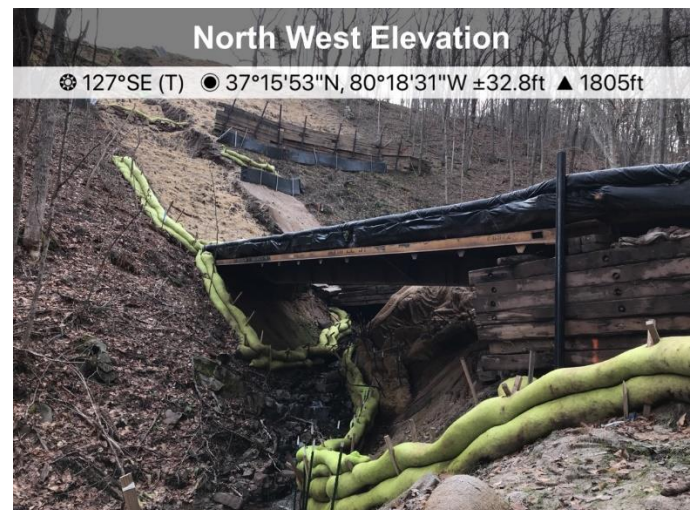
- Fig. 4 St#12031+56 at designated stream S-G 39 controls in place and functioning.
