## FIELD INSPECTION

| <b>Project Name:</b> | Mountain Valley Pipeline | <b>Inspector:</b> | Matthew Grant |
| <b>Inspection Date:</b> | Wednesday, November 28, 2018 | <b>Project Contact:</b> | Brian Clauto |
| <b>Spread: Franklin County MP 261 St#13814-13808</b> | Spread I | <b>Weather (Wet/Dry/Rain):</b> | Wet |

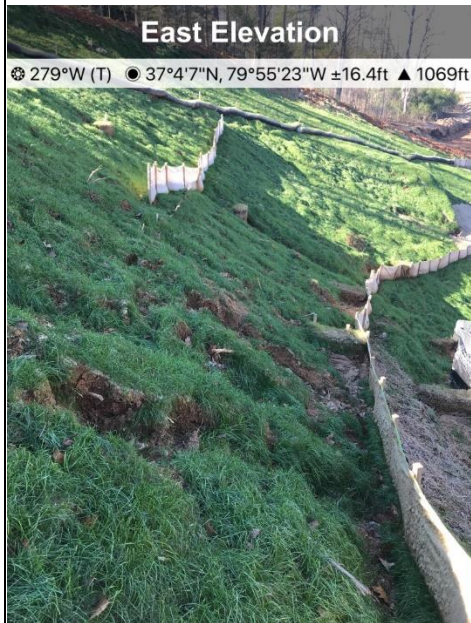
- Fig. 1 St#13819+01 slope is showing signs of erosion

**Recommended Corrective Action:** repair and maintain all controls per the approved plan.

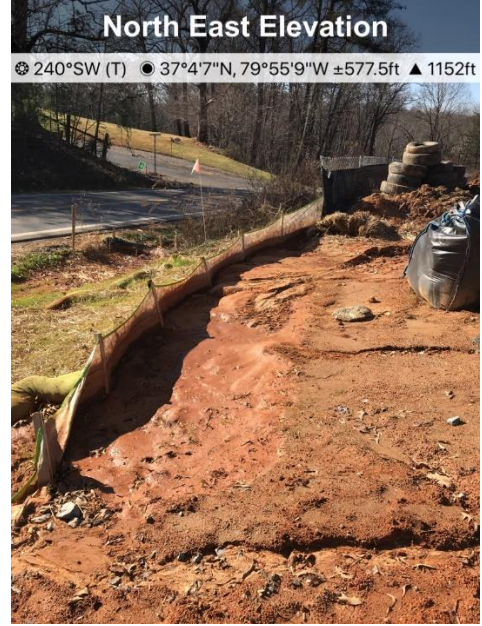
- Fig. 2 St#13811 Silt fence is filled with sediment

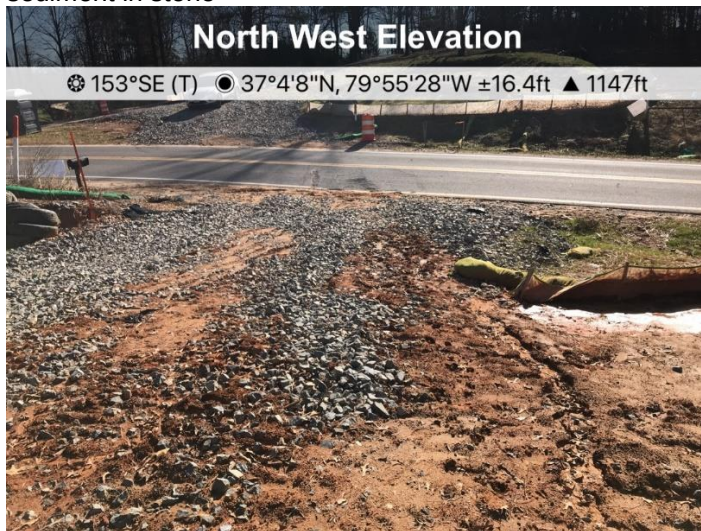
- Fig. 3 Brick Church Rd construction entrance has signs of sediment in stone

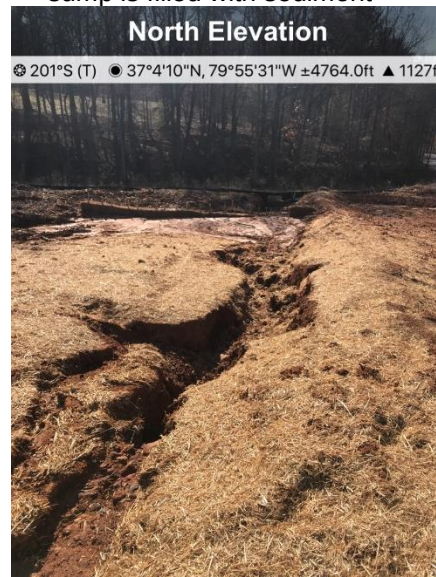
- Fig. 4 St#13808+74 waterbar flow path has eroded and sump is filled with sediment
