## FIELD INSPECTION

| <b>Project Name:</b> | Mountain Valley Pipeline | <b>Inspector:</b> | Matthew Grant |
| <b>Inspection Date:</b> | Monday, November 26, 2018 | <b>Project Contact:</b> | Brian Clauto |
| <b>Spread: Roanoke County MP243 St#12867-12865</b> | Spread H | <b>Weather (Wet/Dry/Rain):</b> | Wet |

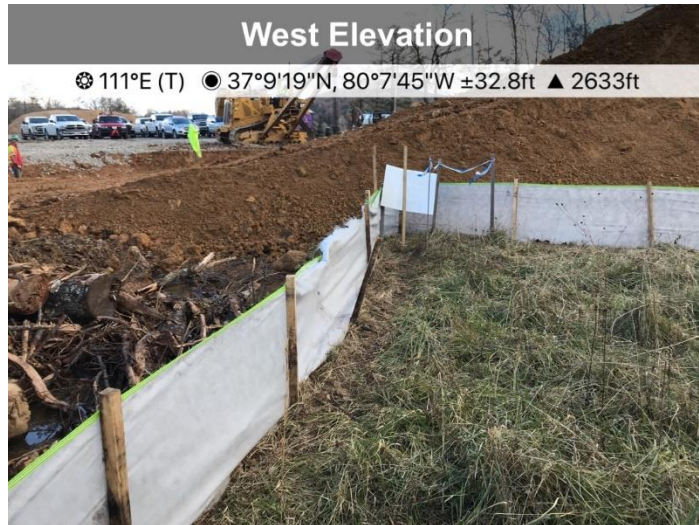
- St#12867+08 – St#12865+11 all work being conducted was within the LOD, no construction was being conducted within the designated wetlands. Torn silt fence was observed at St#12865+11

Fig. 1  
Torn silt fence at St#12865+11

**Recommended Corrective Action:** replace and maintain all controls per the annual standard and specs.

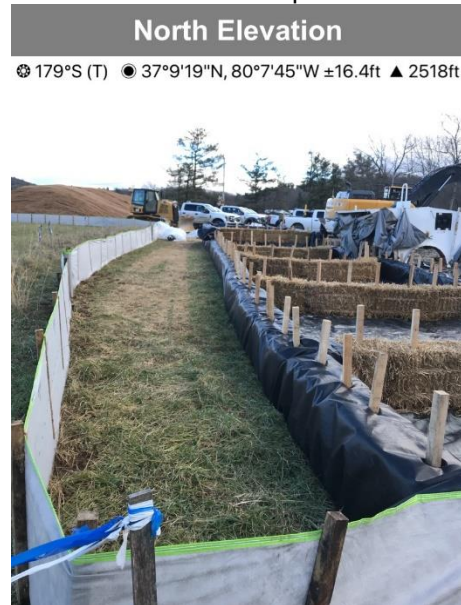
Fig. 2 Dewatering structure in place and functioning at the Bottoms Creek bore pit.

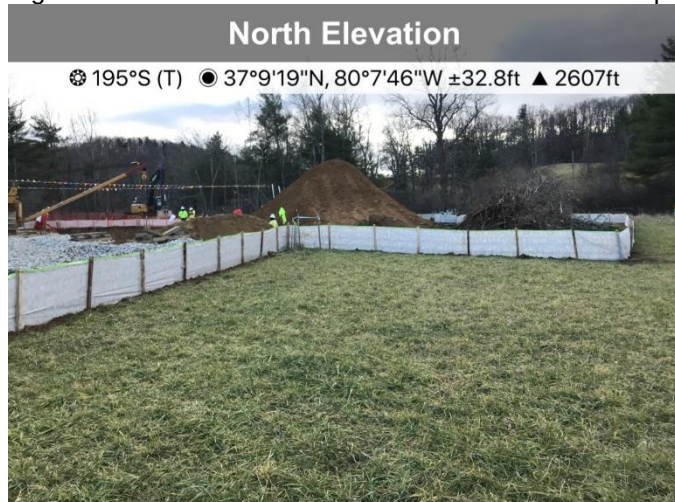
Fig. 3 Work within the LOD of the Bottoms Creek bore pit.

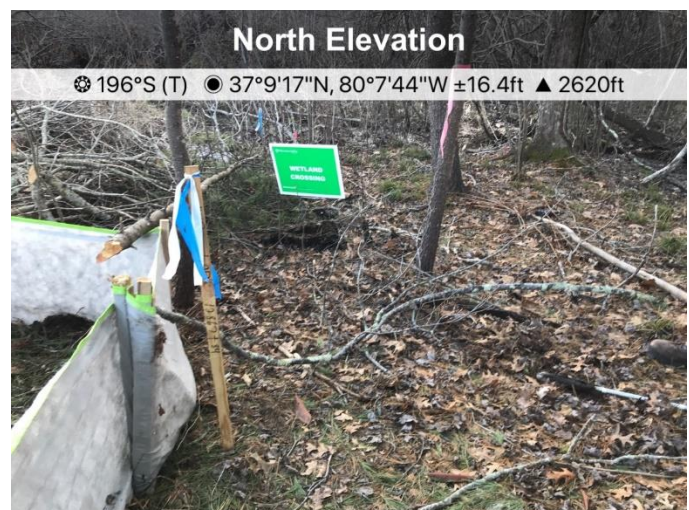
Fig. 4 Wetland perimeter at St#12867+64
