## FIELD INSPECTION

| Project Name: | Mountain Valley Pipeline | Inspector: | Matthew Grant |
| Spread: Franklin County MP 261 St#13813-13837 | Spread I | Weather (Wet/Dry/Rain): | Dry |

## FIELD INSPECTION PHOTO LOG

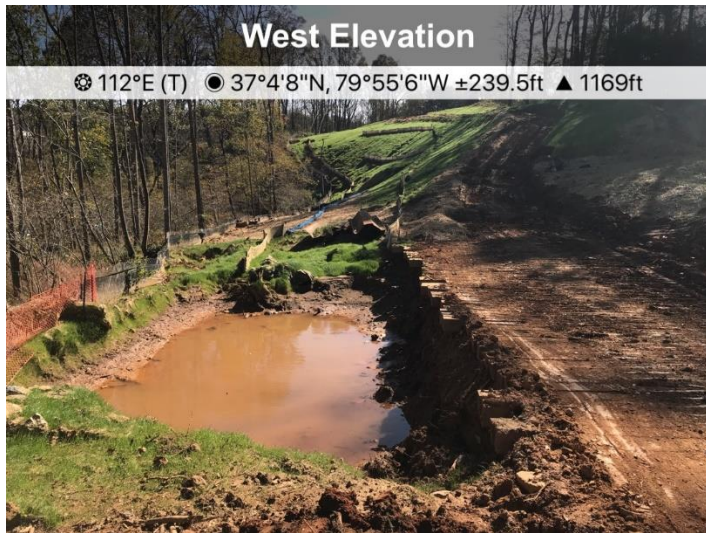
Fig. 1  
At St#13817+00, sump is not completed

- **Area 1** –MP 261 through MP 262
  - 13834+00 to 13837+40, sediment off right of way
  - 13820+00 to 13834+00, sediment off right of way
  - 13818+62, Undermined silt fence / check dam
  - 13820+00, Sumps not complete
  - 13824+00, Stabilization and rill repair required
  - 13824+50, Stabilization and rill repair required
  - 13837+40, designated stream S-C 14 buffers is not adequately stabilized
- **Recommend Corrective Action:** Remove sediment per DEQ approval and install / maintain controls per the annual standards and spec.

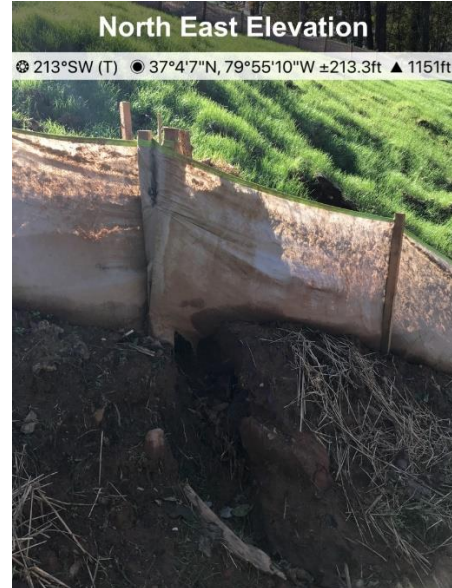
Fig. 2  
At 13818+62, undermined silt fence

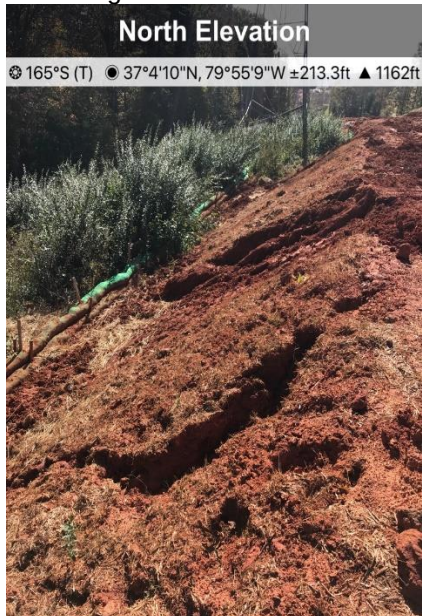
Fig. 3 At 13824+50 slope is not adequately stabilized and is eroding

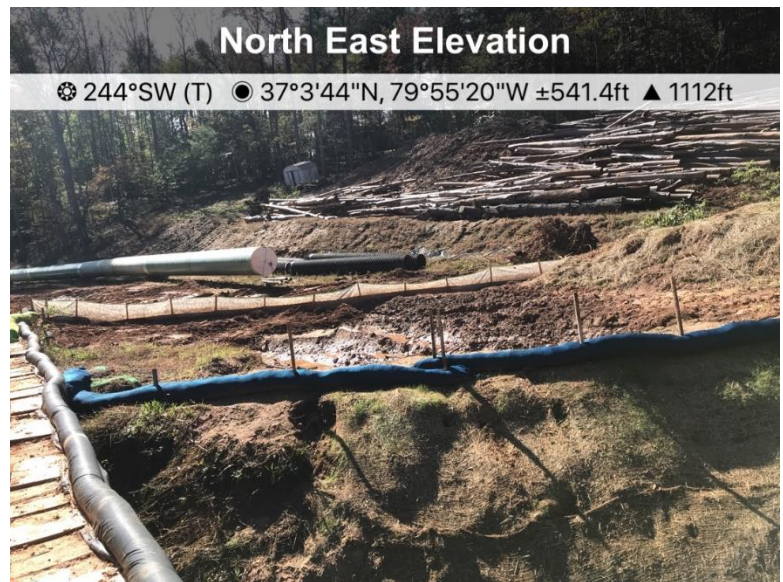
Fig. 4 At designated stream S-C14 stream buffers not adequately stabilized.
