## FIELD INSPECTION

| <b>Project Name:</b> | Mountain Valley Pipeline | <b>Inspector:</b> | Matthew Grant |
| <b>Spread: Franklin County MP 263 St#130903-13938</b> | Spread I | <b>Weather (Wet/Dry/Rain):</b> | Wet |

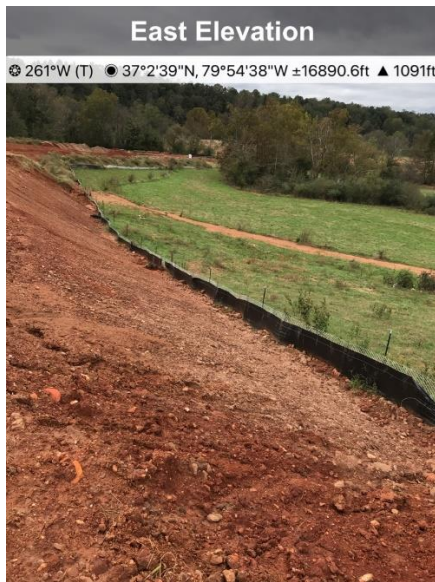
- **Area 1** –MP 263 St#13903-13938 Observations: no work was being conducted in the wetlands or streams within this area per the Nationwide Permit 12 Verification Suspension letter dated 10/5/18. The area between St#13903 and St#13926 lacks stabilization, at St#13903+00 sediment has left the ROW. At St#13916+23 debris is outside of ROW, which had been noted in the SWPPP by MVP.

Fig. 1  
The area between 13903 and St#13926 lacks stabilization.

**Recommended Corrective Action:** Stabilized slope between stations 13903 and 13926 and remove sediment per DEQ approval.

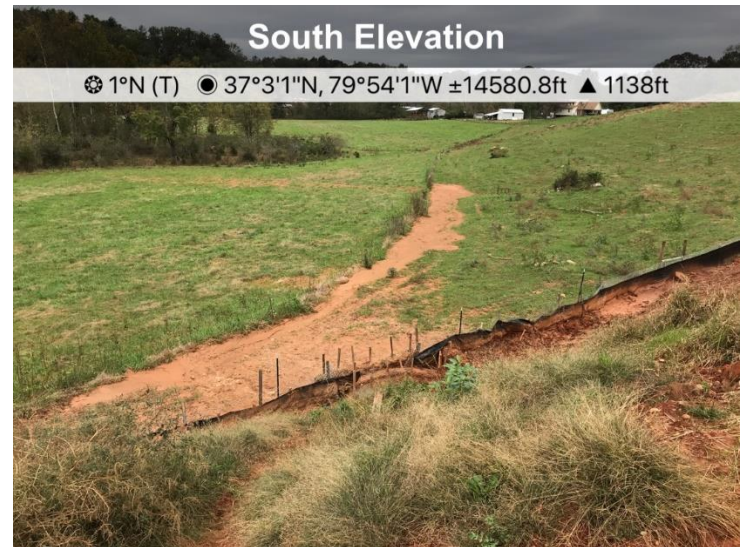
Fig. 2  
At St#13903+00 sediment has left the ROW.

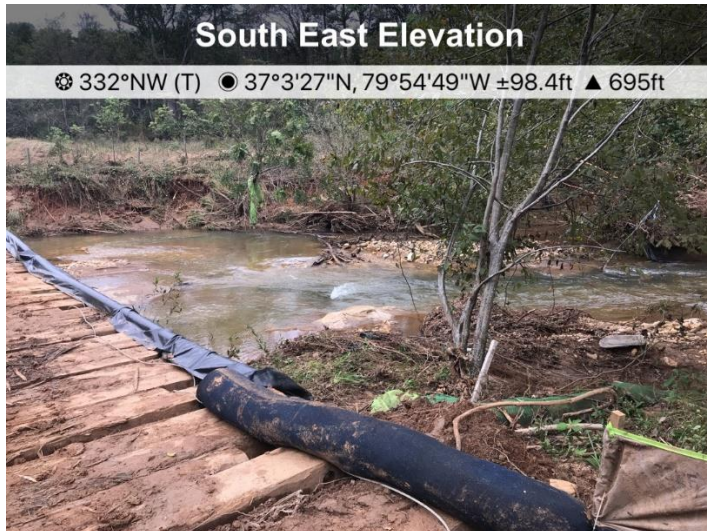
Fig. 3.  
At St#13916+23 debris is outside of ROW.
