## FIELD INSPECTION

| <b>Project Name:</b> | Mountain Valley Pipeline | <b>Inspector:</b> | Matthew Grant |
| <b>Inspection Date:</b> | Tuesday, October 9, 2018 | <b>Project Contact:</b> | Brian Clauto |
| <b>Spread: Franklin County MP 265 St#13998</b> | Spread G | <b>Weather (Wet/Dry/Rain):</b> | Wet |

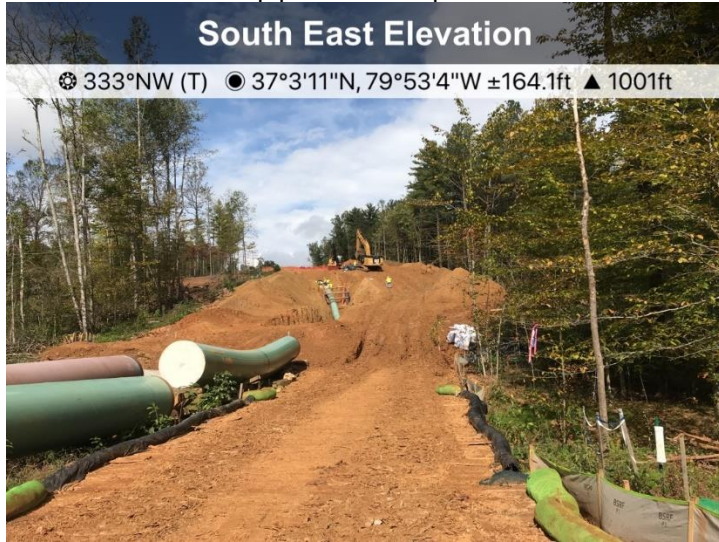
- **Area 1** –MP265 St#13998 ECD's are in place, pipe has been placed in trench. Escaped sediment has been removed off ROW below St#13998+10.

Fig. 1  
At St# 13998+10 the pipe has been placed in trench.

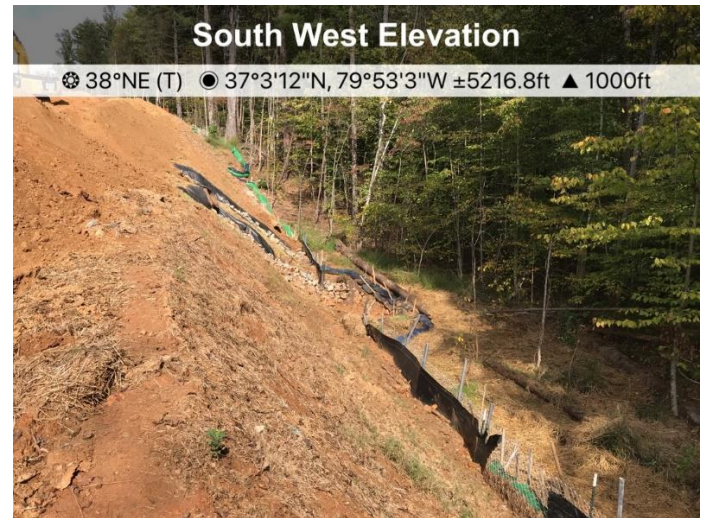
Fig. 2  
At St#13998+10 ECD's are in place below slope

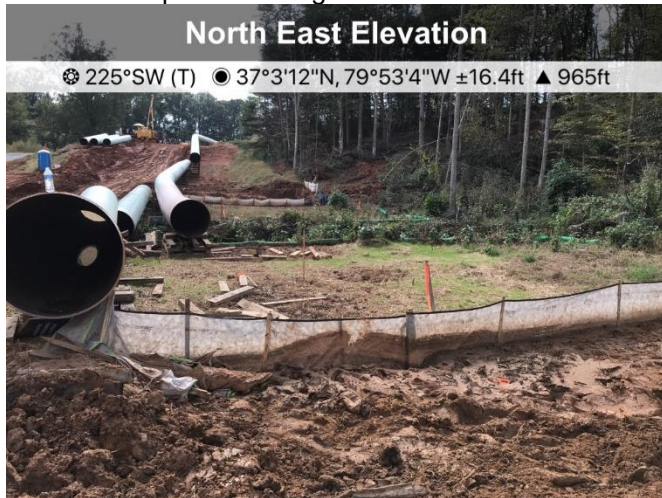
Fig. 3  
EVD's are in place at designated stream SKL 36
