## FIELD INSPECTION

| Project Name: | Mountain Valley Pipeline | Inspector: | Matthew Grant |
| Spread: Franklin County MP 254 | Spread G | Weather (Wet/Dry/Rain): | Dry |

## FIELD INSPECTION PHOTO LOG

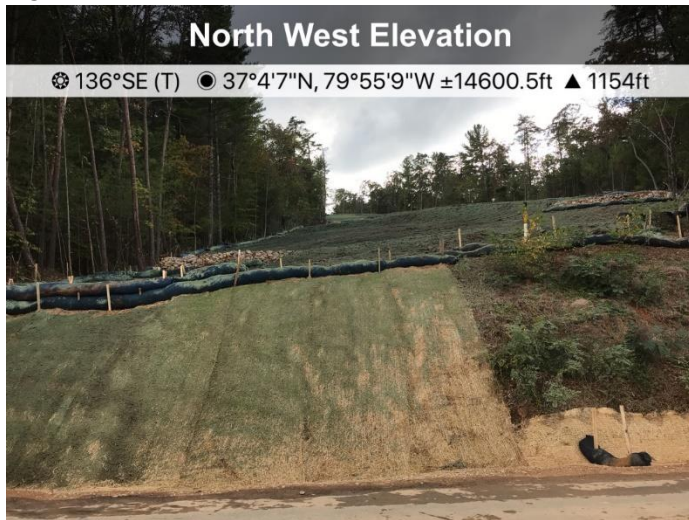
Fig. 1  
At Cahas Rd intersection, matting has been installed with ECD's.

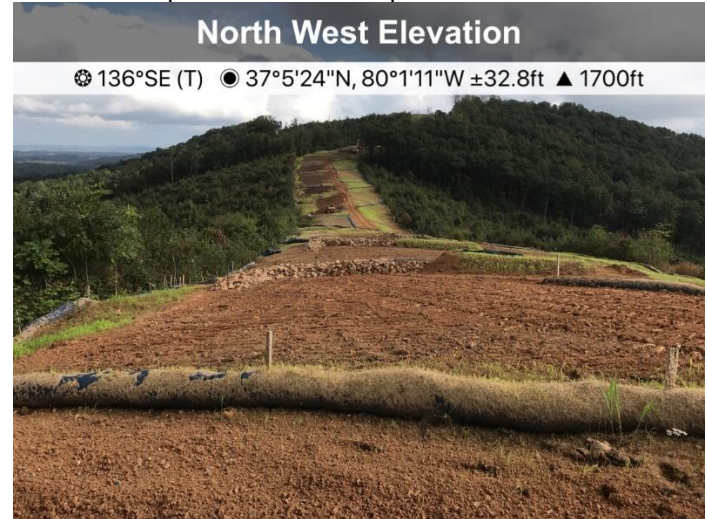
- **Area 1** –MP254 St#13438+31- 13431+86 permanent water bars have been installed.

Fig. 2  
At St#13438 permanent bars in place.

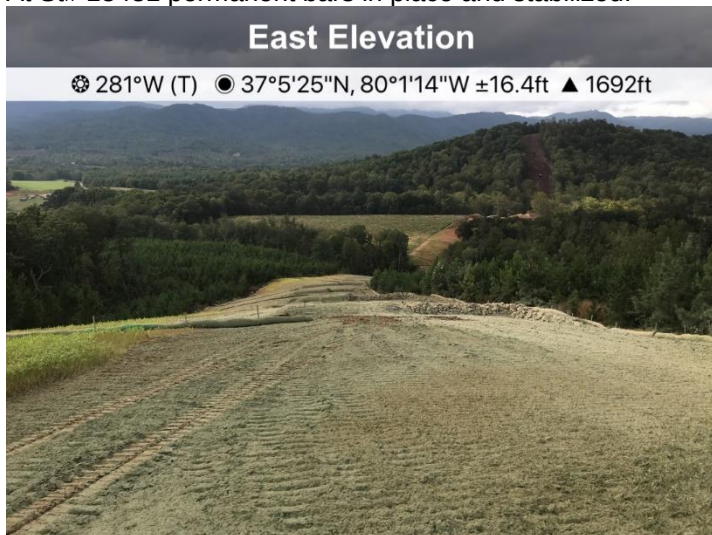
Fig. 3  
At St# 13431 permanent bars in place and stabilized.
