## FIELD INSPECTION

| Project Name: | Mountain Valley Pipeline | Inspector: | Matthew Grant |
| Inspection Date: | Wednesday, September 26, 2018 | Project Contact: | Brian Clauto |

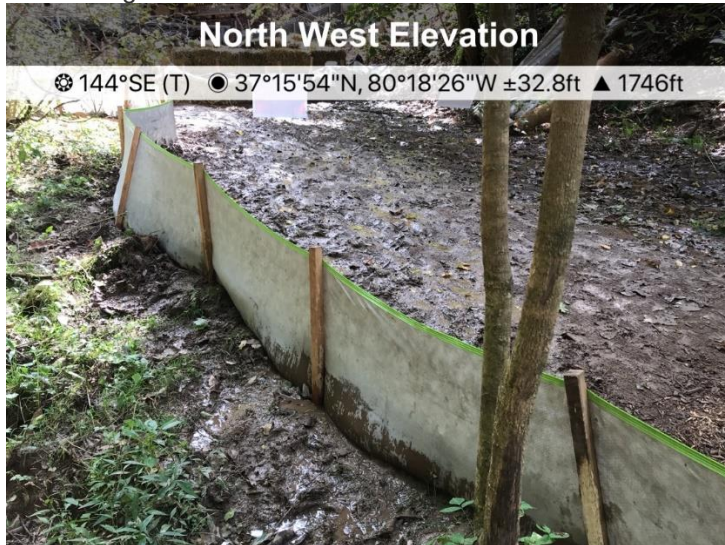
- **Area 1** – Follow up to inspection on 9/25/18, MP 227.9 station#12035+19 designated stream SG-40 additional controls below dewatering structure were installed, pump around rock outfall energy dissipater was installed. Remove sediment per DEQ approval.

Fig. 1  
MP 227.9 St#12035+19 designated stream SG-40  
dewatering structure outfall area

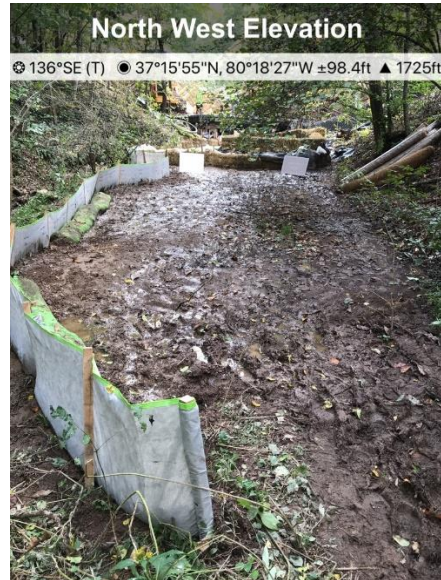
Fig. 2  
MP 227.9 St#12035+19 designated stream SG-40 dewatering  
structure outfall area

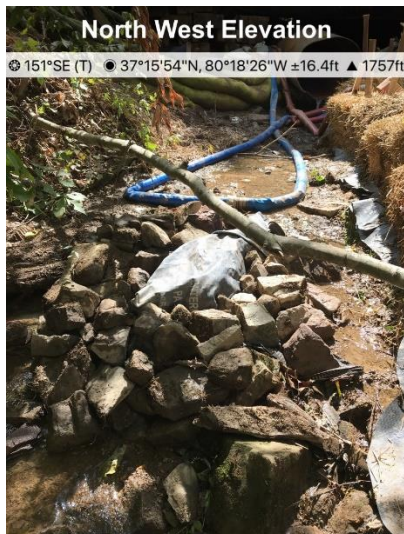
Fig. 3  
Designated stream SG-40 pump around energy dissipater

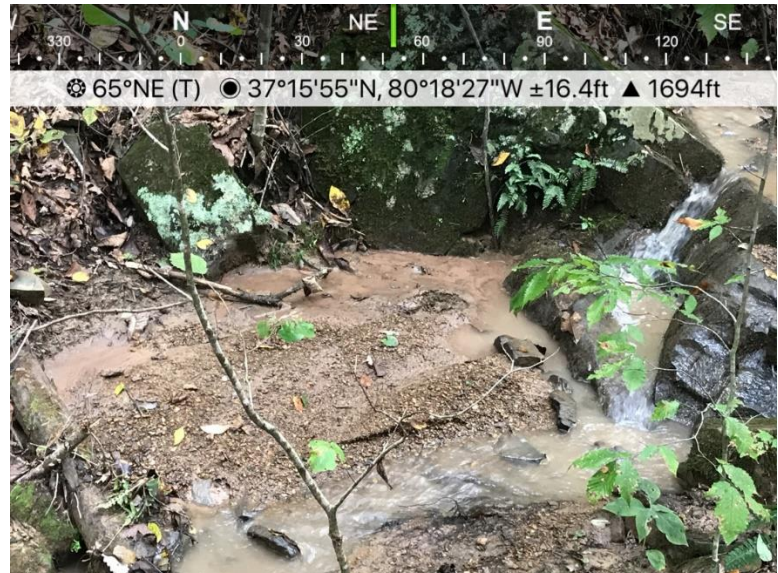
Fig.4  
Sediment in stream

**Deadline:** within 24hr notification
