## FIELD INSPECTION

| <b>Project Name:</b> | Mountain Valley Pipeline | <b>Inspector:</b> | Matthew Grant |
| <b>Inspection Date:</b> | Thursday, August 30, 2018 | <b>Project Contact:</b> | Brian Clauto |

## FIELD INSPECTION PHOTO LOG

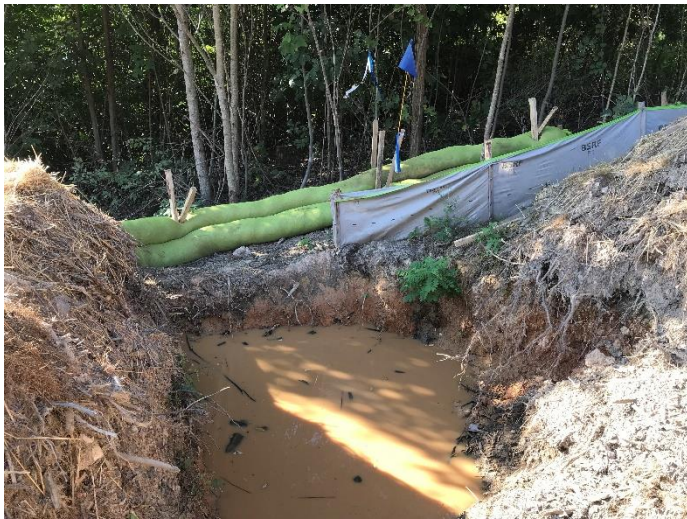
Fig. 1

At approximately St# 12083 maintenance had been conducted on end treatments.

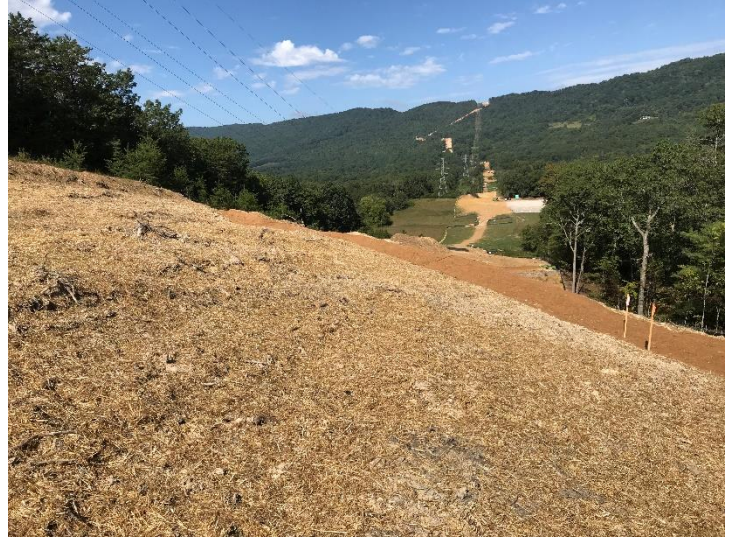
Fig. 2

MP 230.15 station # 12152+00 area had been stabilized

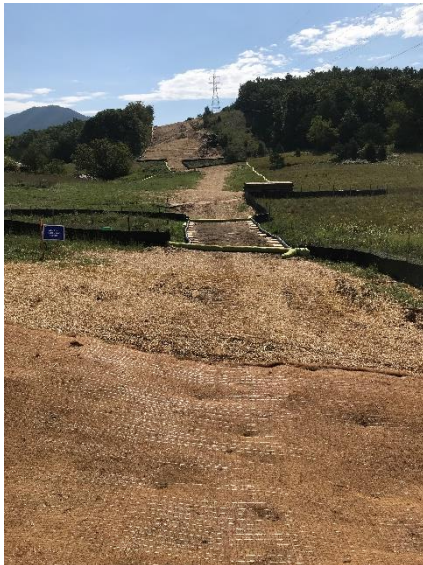
Fig. 3

MP 229.88 station #12138 area had been stabilized.
