## VWP FIELD INSPECTION CHECKLIST

| <b>Project Name</b> | Mountain Valley Pipeline Spread I, Franklin County | <b>VWP Permit #</b> | N/A | <b>Inspection Date</b> | 10/16/2018 |
| <b>Address or lat/long (if no permit no.)</b> | Stream Crossing E-48 (BonBrook #2) | <b>Others Present During Inspection</b> | N/A | | |

Site Name: Mountain Valley Pipeline\_Spread I; Stream E-48

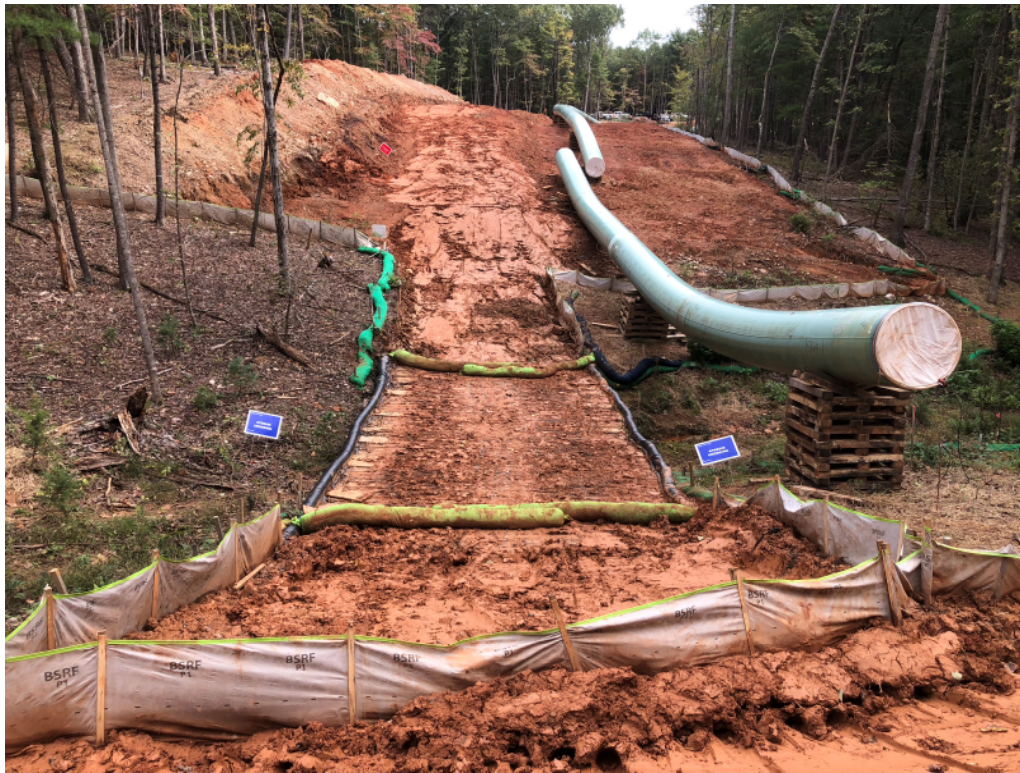
**Photo 1:** Overview of Stream Crossing E-48

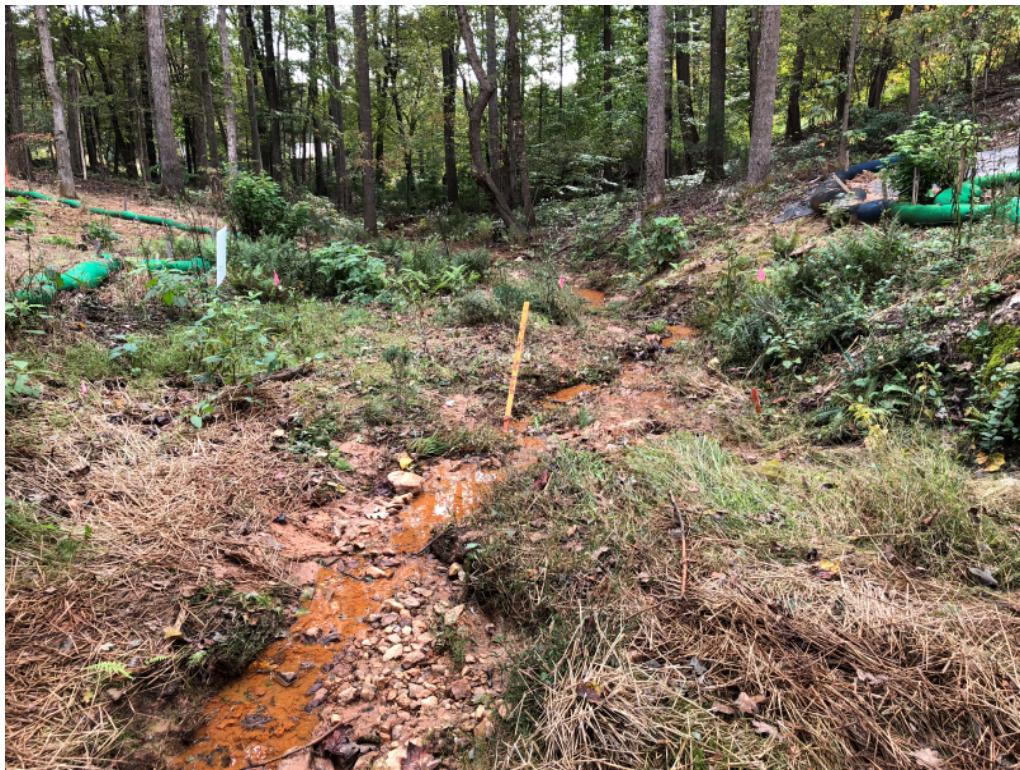
**Photo 2:** View downstream from bridge in Photo 1

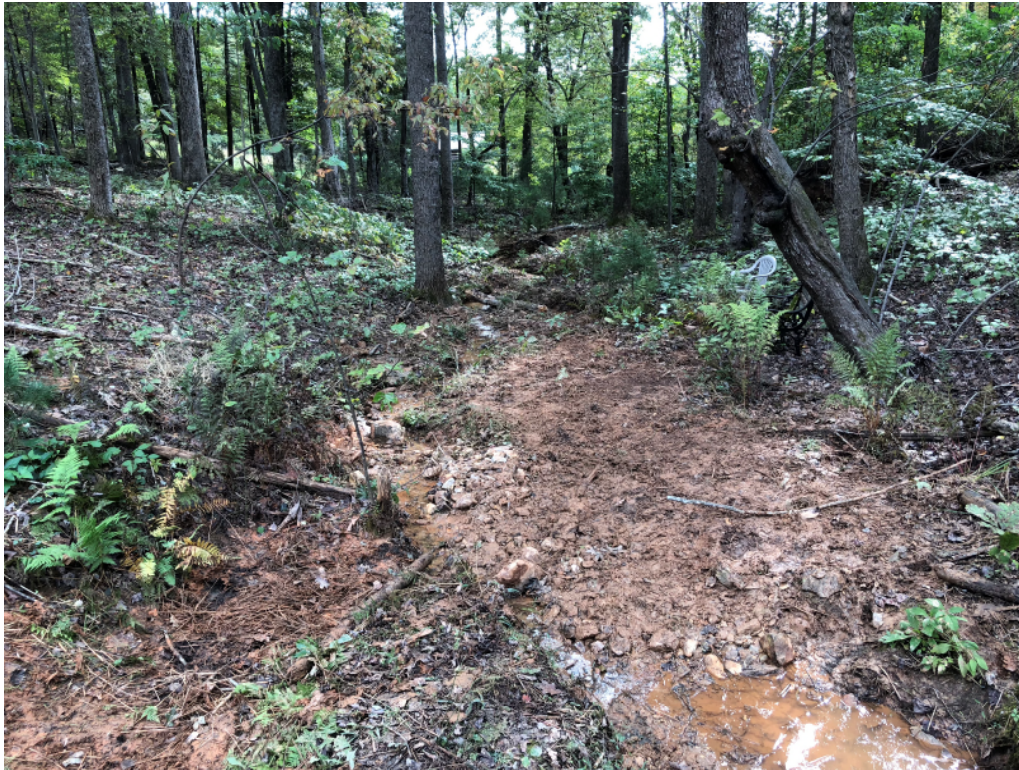
Sediment ranging from <0.5-inch to a maximum depth of 2-inches was observed. Sediment was also observed within forested buffer. Flow was present in the 1-3' wide channel at time of inspection. Sediment within the stream's thalweg was generally <1-inch in depth; sediment bars and pool deposition was generally 1 to 2-inches in depth. Landowner permission was not granted for adjacent property downstream.

**Photo 3:** Sediment in stream and on banks at edge of RoW; Depth = 0.5-2"  
**Orientation:** Downstream

1. Repair erosion and sediment controls in areas where needed;
2. Stabilize all slopes above and below perimeter controls;
3. Remove sediment from impacted stream channel using hand removal methods (buckets and shovels) and stabilize with appropriate seed mix where applicable.

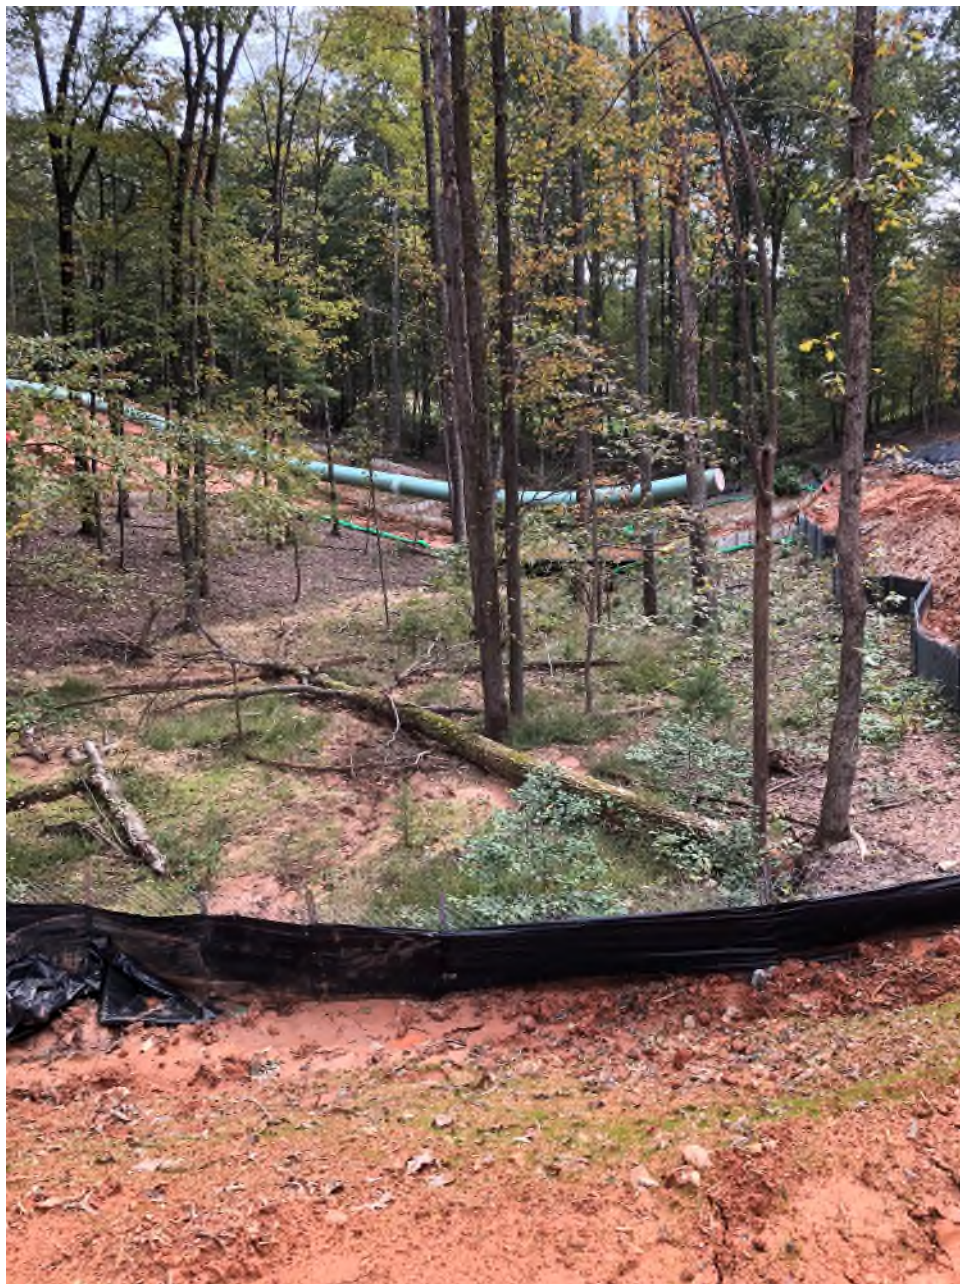
**Photo 4:** Overview of stream crossing and sediment within forested buffer  
**Orientation:** SE
