## COMPLAINT INSPECTION REPORT

| <b>Project Name:</b> | Mountain Valley Pipeline | <b>Inspector:</b> | Marshall Willis |
| <b>Inspection Date:</b> | Monday, July 8, 2019 | <b>Project Contact:</b> | Brian Clauto |
| <b>Spread H:<br/>Montgomery County</b> | STA 12180+00 – 12200+00<br>ATWS 703, ATWS 704A,<br>ATWS 1446 & ATWS 1375<br>MVP-MN-275 | <b>Weather (Wet/Dry/Rain):</b> | Dry |

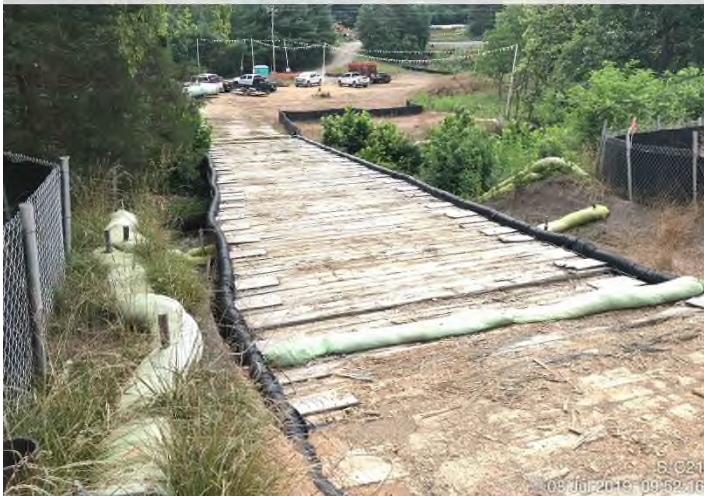
Fig. 1: **Stream S-C21** – Bradshaw Creek Crossing at approx. STA 12192+36. CFS and bridge waddles in place and in good condition. SSF installed correctly and functioning properly. Timber mat bridge clean and sideboards in appear in good condition.

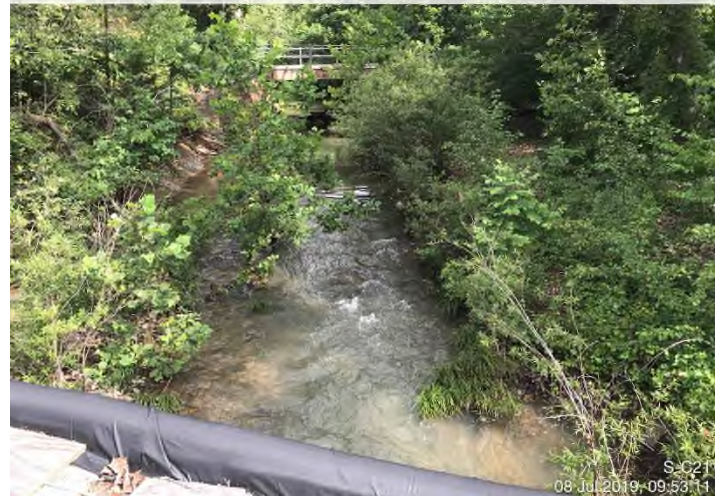
Fig. 2: **Stream S-C21** – Bradshaw Creek Crossing at approx. STA 12192+36. Looking upstream towards Bradshaw Road bridge.

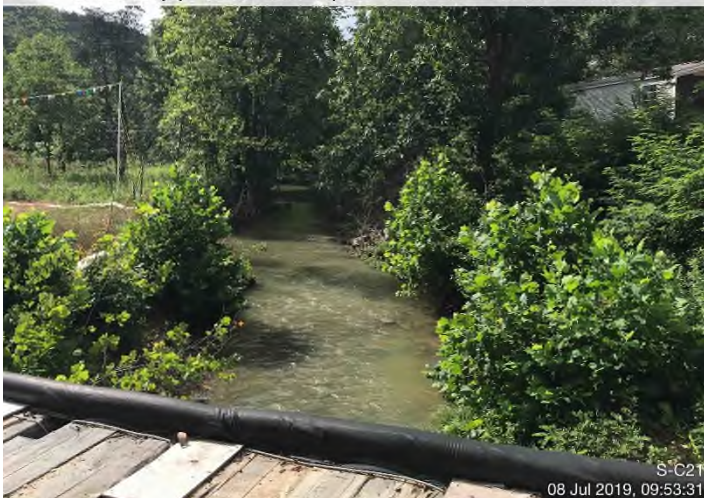
Fig. 3: **Stream S-C21** – Bradshaw Creek Crossing at approx. STA 12192+36. Looking downstream.

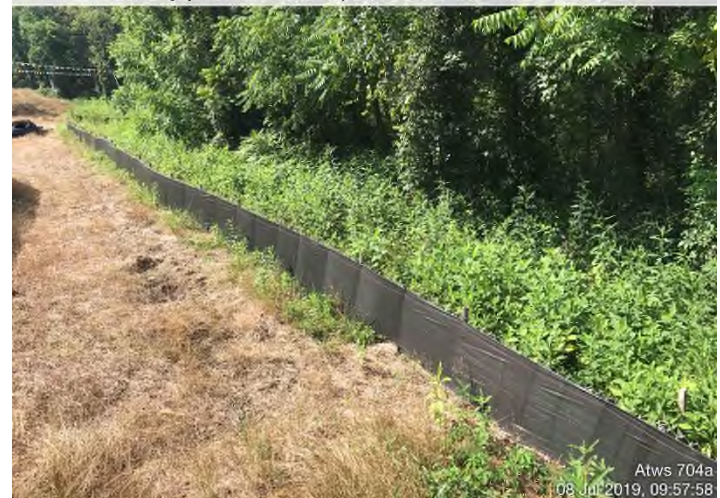
Fig. 4: **ATWS 704A** – Perimeter controls adjacent to S-C21 (Bradshaw Creek). SSF installed correctly and functioning properly. Dormant storage area within LOD stabilized with seed and straw.

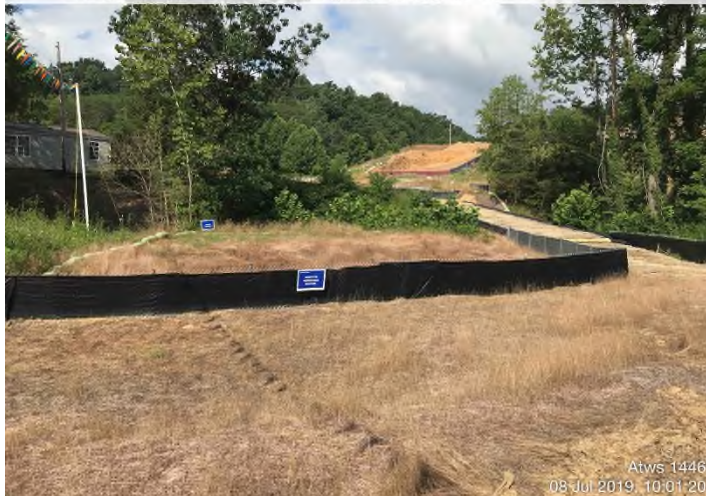
Fig. 5: **STA 12194+23** – East side of S-C21 looking west at stream buffer area. SSF is installed correctly and in good condition. Stream buffer area protected and dormant construction areas stabilized with seed, straw and Earth-Guard.

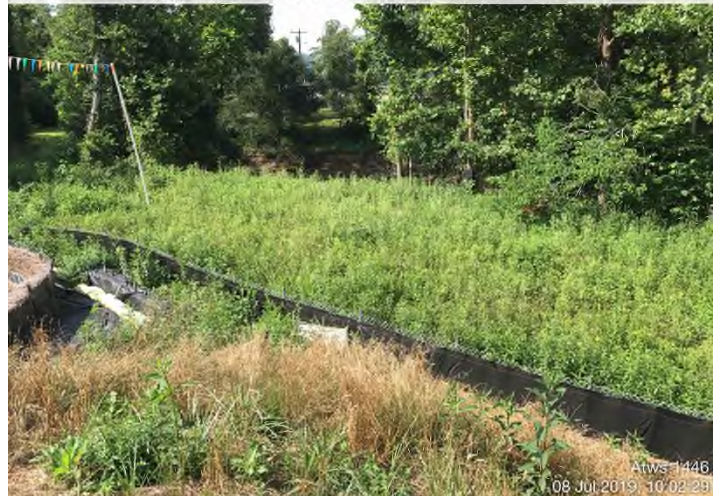
Fig. 6: **ATWS 1446** – Looking west at perimeter controls adjacent to S-C21 (Bradshaw Creek). SSF installed correctly and functioning properly. Dormant storage area within LOD stabilized with seed and straw.

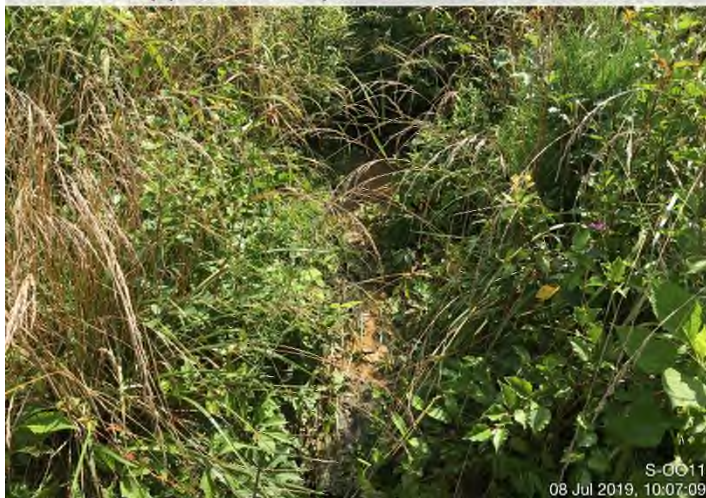
During the inspection, Stream S-OO11 (UNT to Bradshaw Creek) was found to be impacted from denuded banks from within the Norfolk Western ROW. These impacts were discovered and documented during a previous investigation by DEQ inspectors on July 02, 2019. See Photo Log Figures 7, 9 and 10 below.

Fig. 7: **Stream S-0011** – Sediment impacting S-0011 (UNT to Bradshaw Creek) at approx. STA 12196+24.

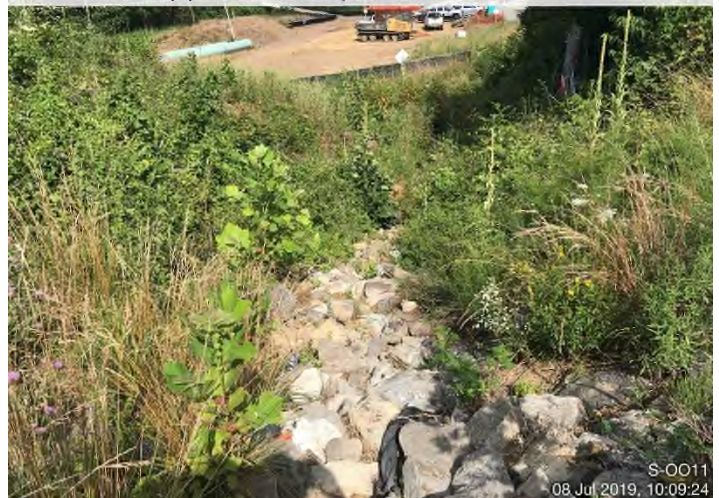
Fig. 8: **Stream S-0011** – Riprap outfall channel of S-0011 culvert on west side of Norfolk Western railroad tracks. Riprap appeared to be clean and free of sediment found impacting resource further downstream.

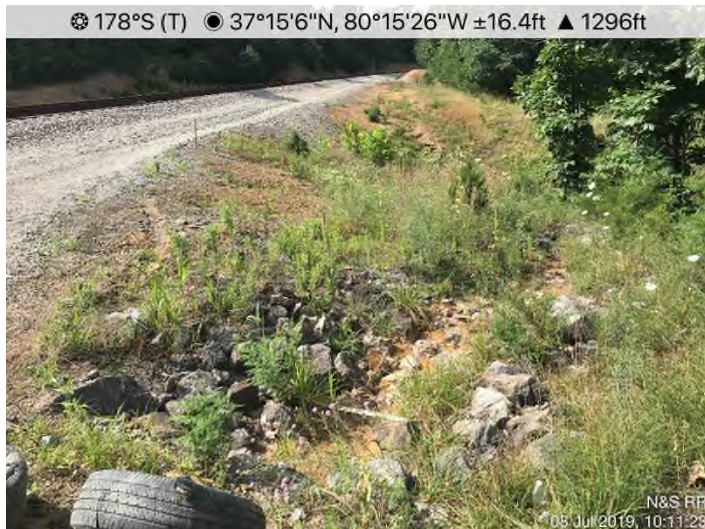
Fig. 9: **Access Road MVP-MN-275** – Looking south from MVP-MN-275. Sediment laden riprap outfall from road culvert flowing towards stream S-OO11.

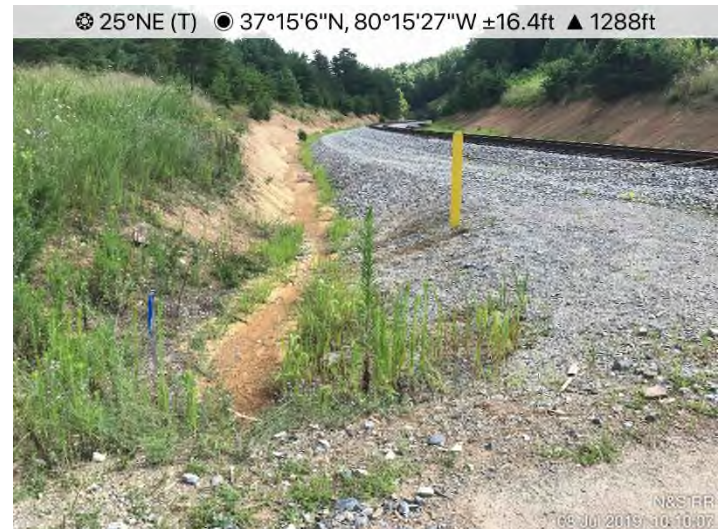
Fig. 10: **Access Road MVP-MN-275** – Source of sediment impacting stream S-OO11 off MVP ROW on north side of MVP-MN-275.

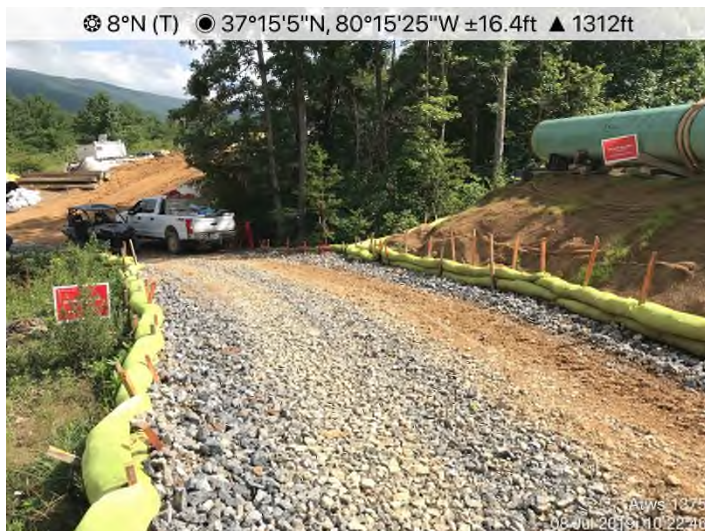
Fig. 11: **ATWS 1375** – Looking north from ATWS 1375 towards stream S-OO11. CFS is in good condition. Dormant areas stabilized with seed, straw and fabric.

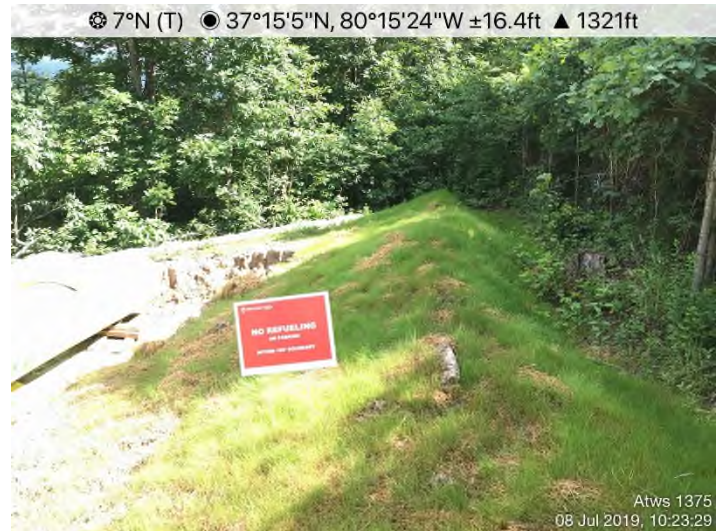
Fig. 12: **ATWS 1375** – Looking north from ATWS 1375 towards stream S-OO11. Perimeter diversions berm stabilized with seed and straw.
