## COMPLAINT INSPECTION REPORT

| Project Name: | Mountain Valley Pipeline | Inspector: | Marshall Willis |
| Inspection Date: | Tuesday, July 2, 2019 | Project Contact: | Brian Clauto |
| Spread I:<br>Franklin County | STA 13840+00 – 13892+45 | Weather (Wet/Dry/Rain): | Dry |

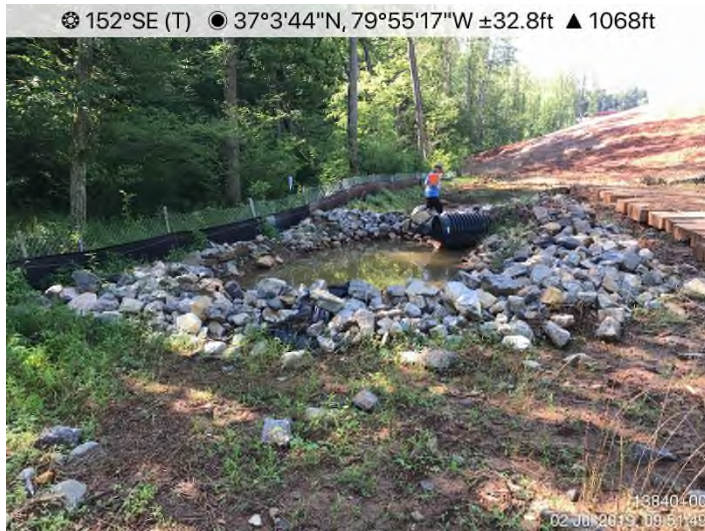
Fig. 1: **STA 13840+00** – Install and stabilize berm around CWD plunge pool.

**Recommended Corrective Action:** Maintain and install all controls per the approved plan and PSS&S.

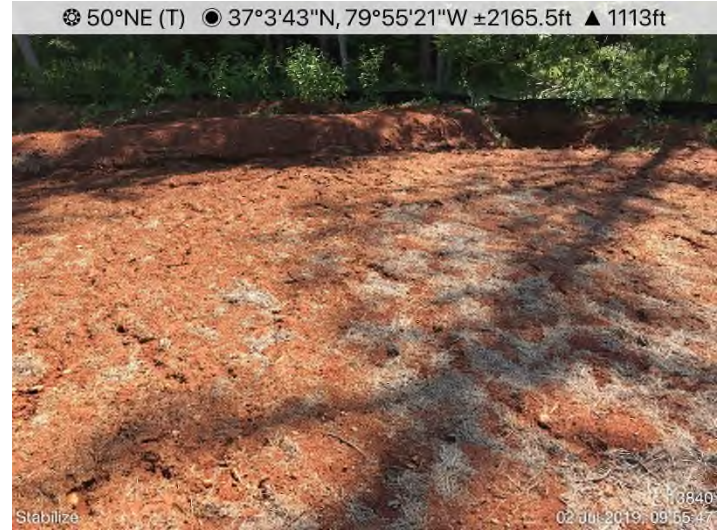
Fig. 2: **STA 13844+07 to 13846+78** – Repair rill erosion and adequately stabilize.

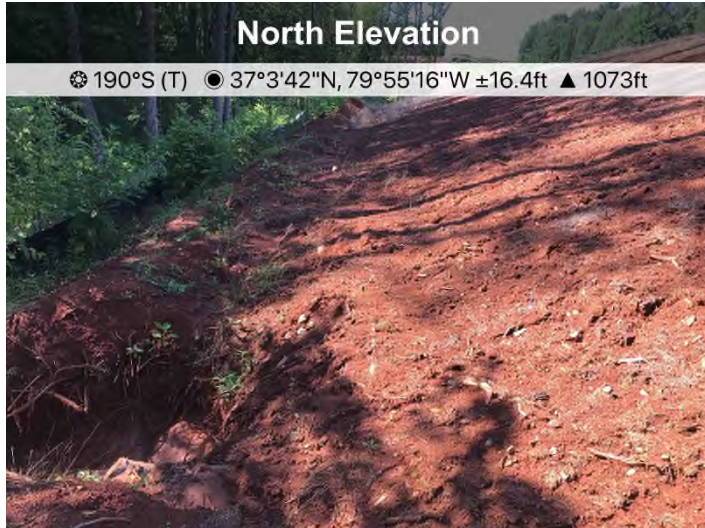
Fig. 3: **STA 13844+07 to 13846+78** – Repair and stabilize perimeter berms.

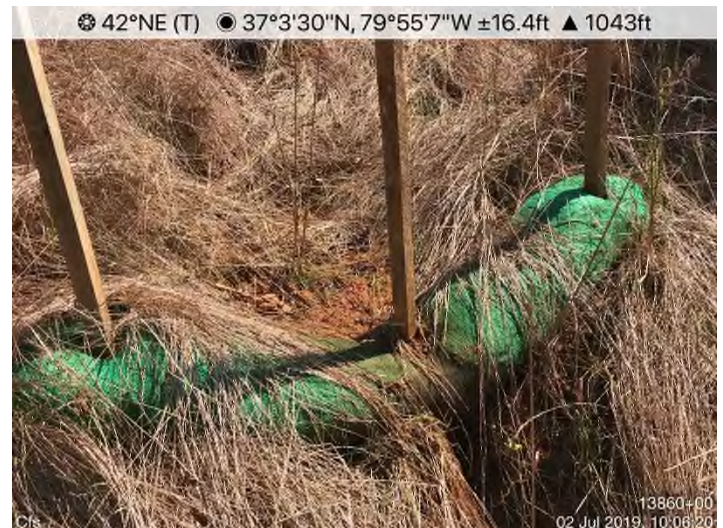
Fig. 4: **STA 13860+00** – CFS maintenance needed.

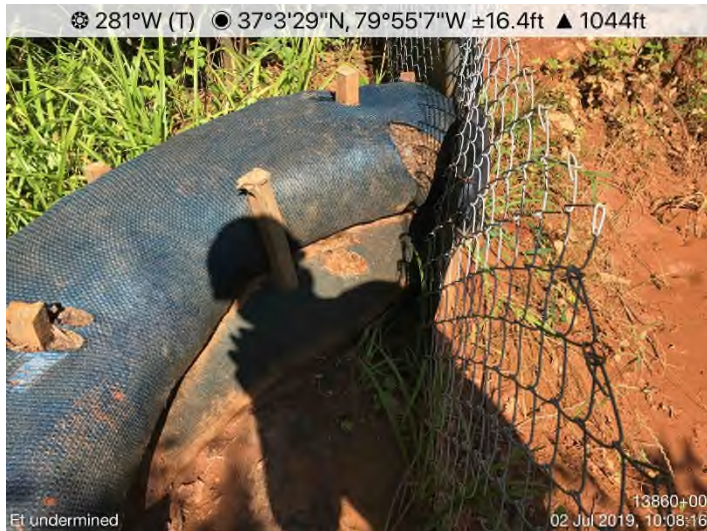
Fig. 5: **STA 13860+00** – CFS end treatment undermined.

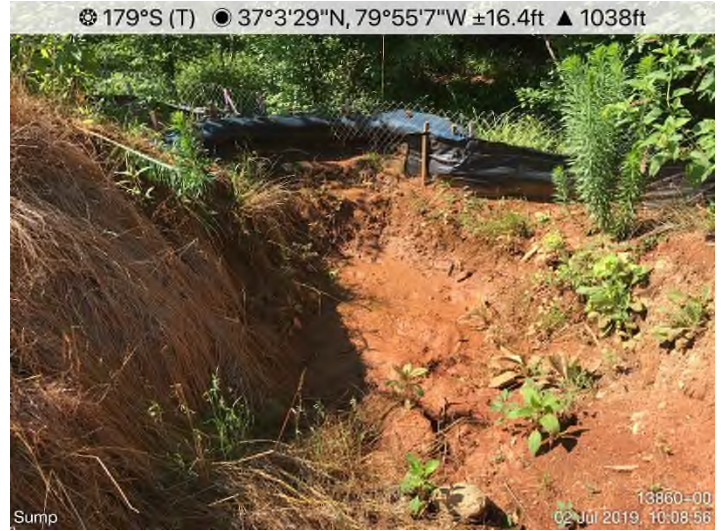
Fig. 6: **STA 13860+00** – Sump maintenance needed.

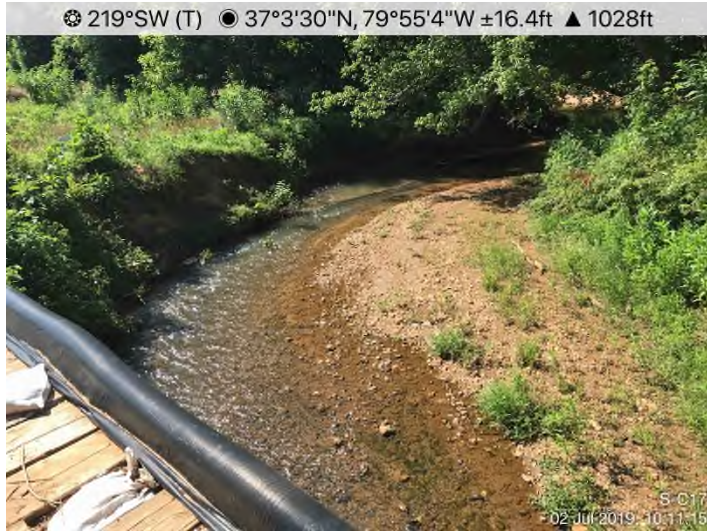
Fig. 7: **Stream S-C17** – Teels Creek. Controls in place.

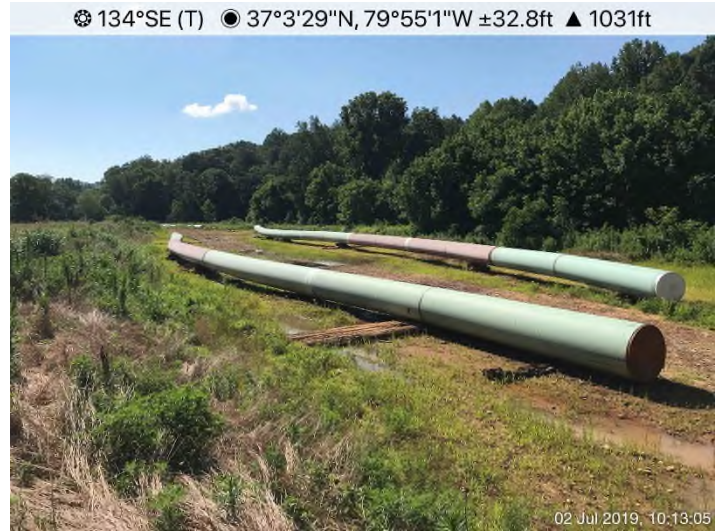
Fig. 8: **STA 13864+47** – Area stabilized. Controls in place.

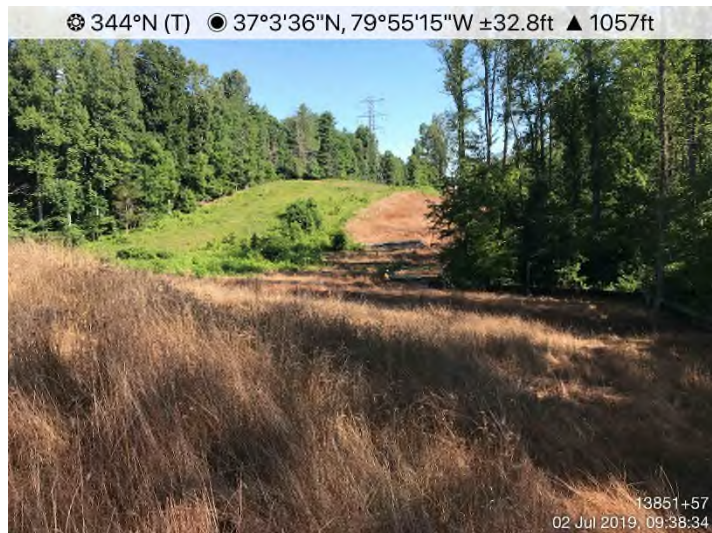
Fig. 9: **STA 13851+57** – Area stabilized. Controls in place.

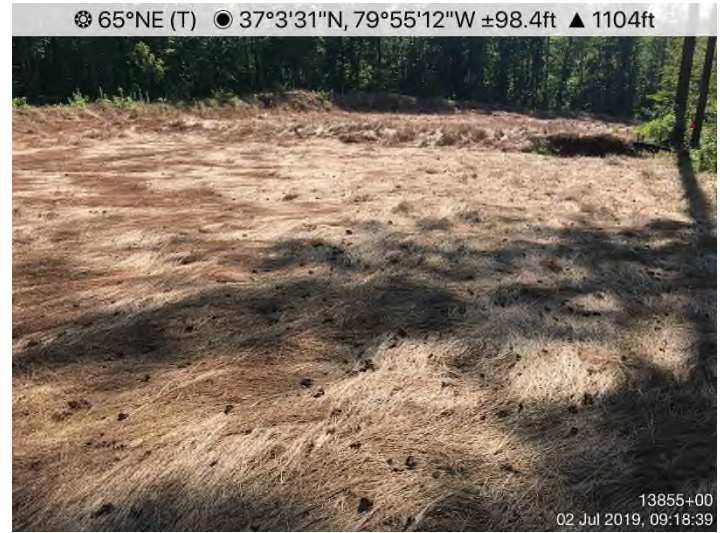
Fig. 10: **STA 13855+00** – Area stabilized. Controls in place.

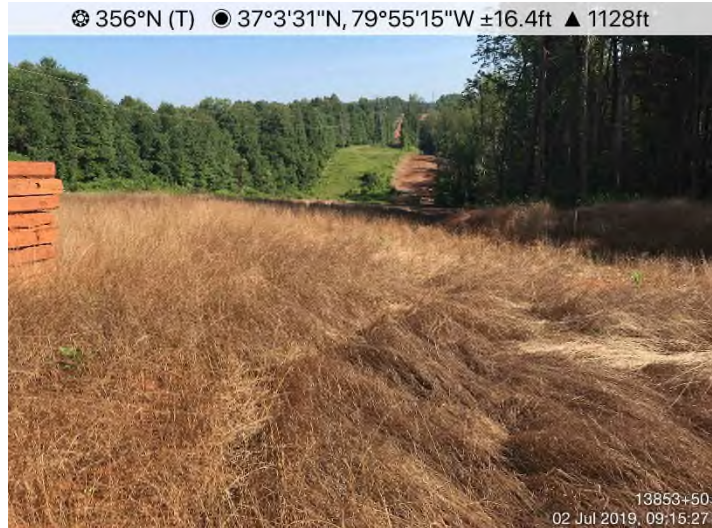
Fig. 11: **STA 13853+50** – Area stabilized. Controls in place.

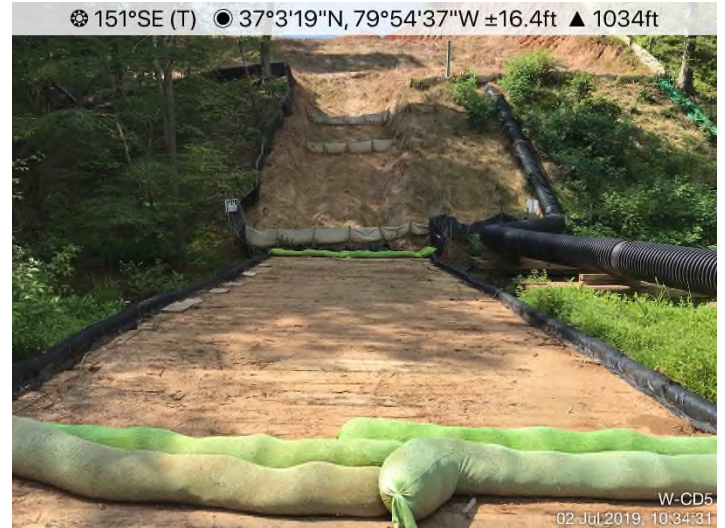
Fig. 12: **Wetland W-CD5** – Controls in place.
