## COMPLAINT INSPECTION REPORT

| Project Name: | Mountain Valley Pipeline | Inspector: | Marshall Willis |
| Spread H:<br>Montgomery County | STA 12190+85 – 12200+00<br>ATWS 1446 & 1375 | Weather (Wet/Dry/Rain): | Dry |

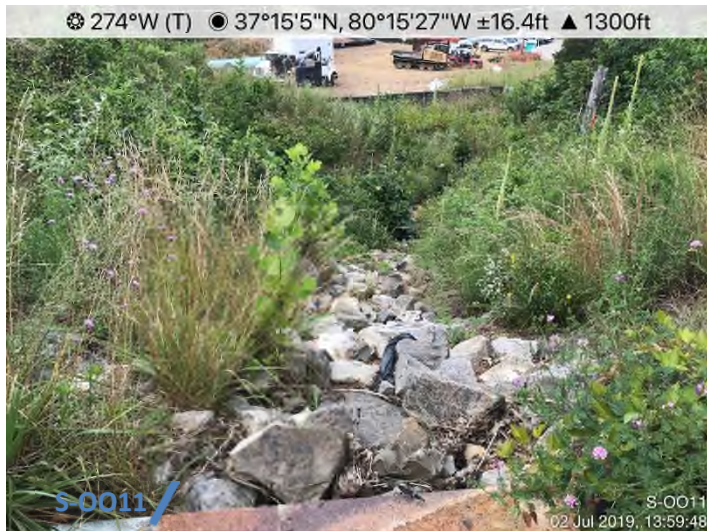
Fig. 1: **Photo Location "A"** – Stream S-0011 on the west side of Norfolk Southern ROW.

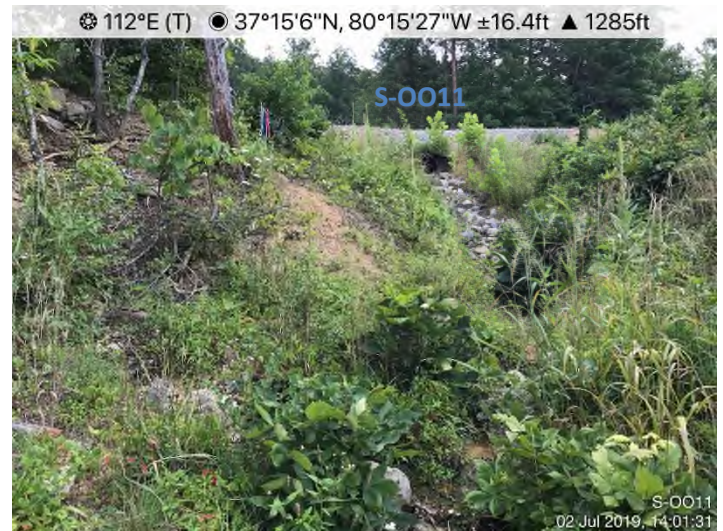
Fig. 2: **Photo Location "B"** – Sediment discharge from west side of Norfolk Southern ROW towards Stream S-0011.

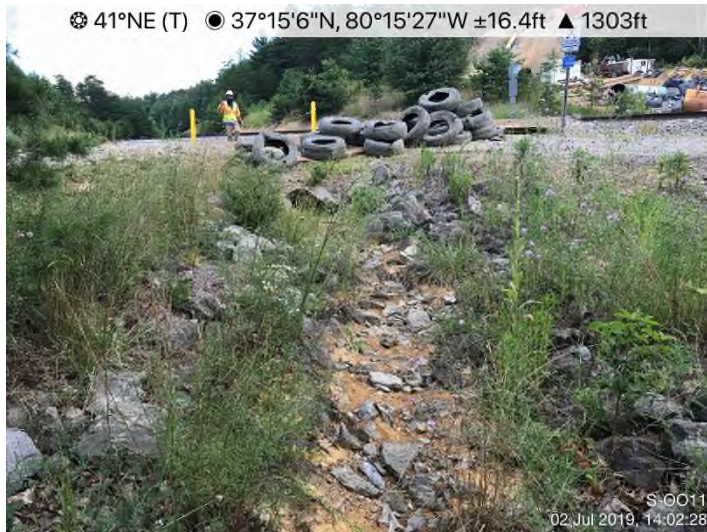
Fig. 3: **Photo Location "C"** – Sediment discharge from west side of Norfolk Southern ROW towards Stream S-0011.

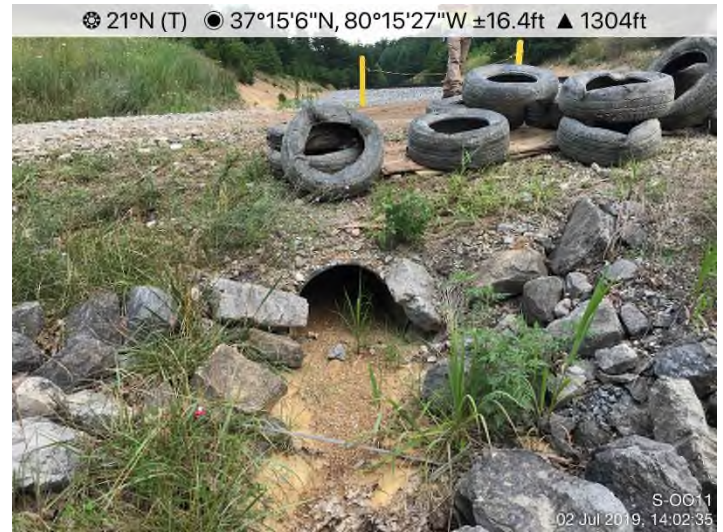
Fig. 4: **Photo Location "D"** – Sediment discharge from west side of Norfolk Southern ROW towards Stream S-0011.

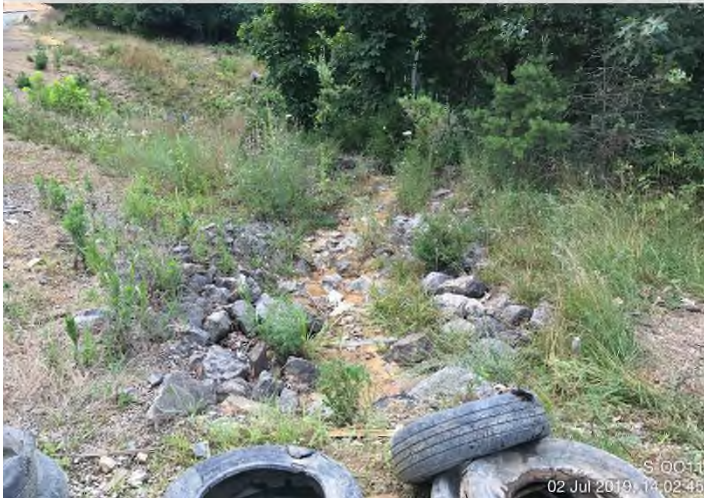
Fig. 5: **Photo Location "E"** – Sediment discharge from west side of Norfolk Southern ROW towards Stream S-OO11.

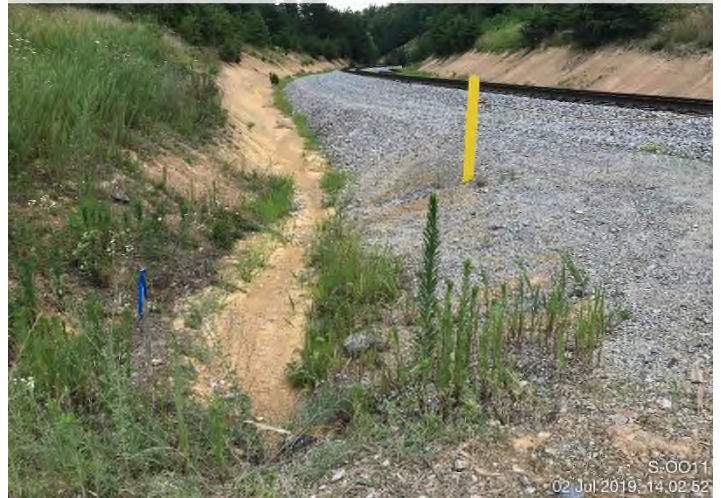
Fig. 6: **Photo Location "F"** – Sediment discharge from west side of Norfolk Southern ROW towards Stream S-OO11.

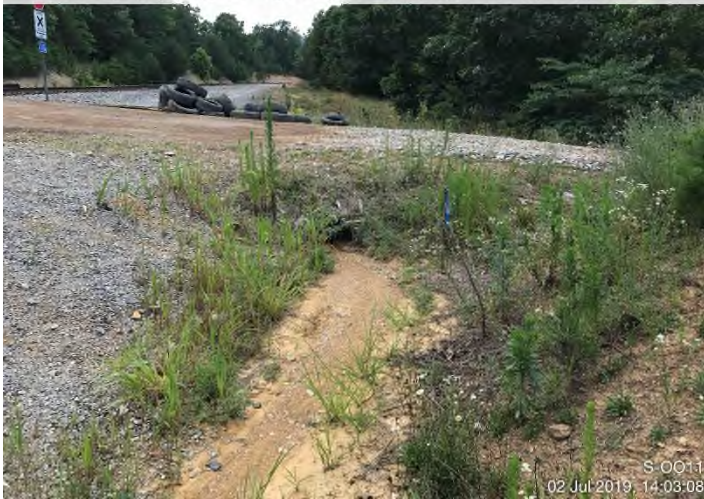
Fig. 7: **Photo Location "G"** – Sediment discharge from west side of Norfolk Southern ROW towards Stream S-OO11.

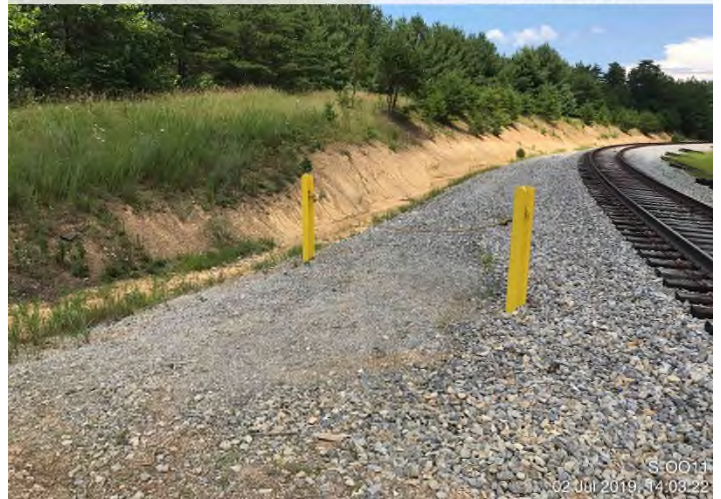
Fig. 8: **Photo Location "H"** – Denuded area on west side of Norfolk Southern ROW. Sediment is being discharged towards stream S-OO11.

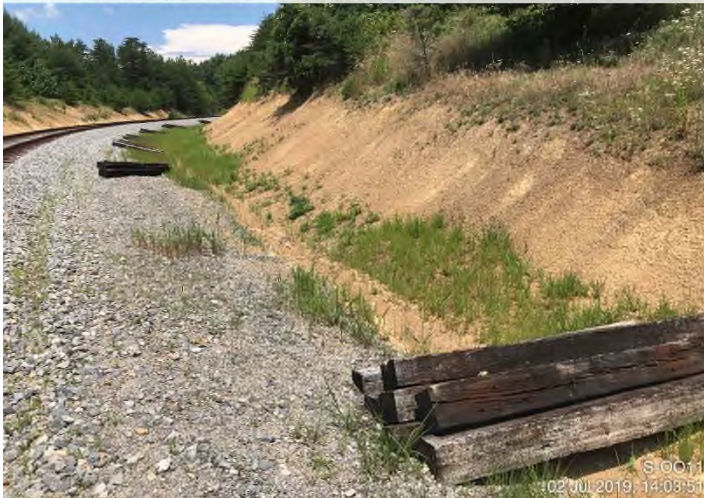
Fig. 9: **Photo Location "I"** – Denuded area on east side of Norfolk Southern ROW. Sediment is being discharged towards MVPs ECDS and stream S-OO11.

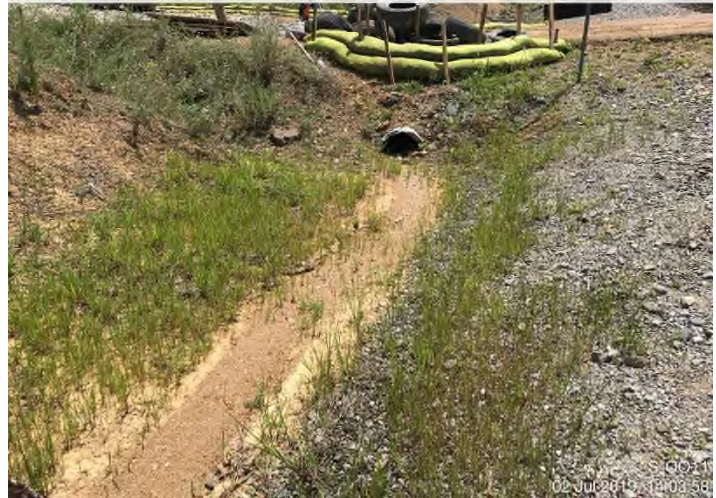
Fig. 10: **Photo Location "J"** – Sediment discharge from east side of Norfolk Southern ROW towards Stream S-OO11.

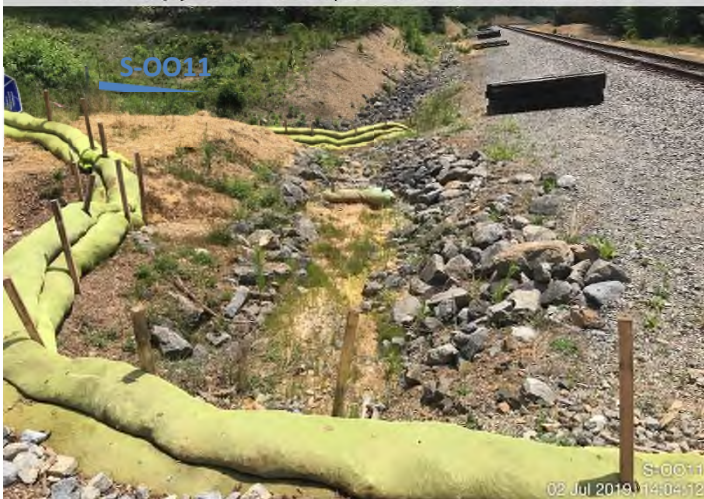
Fig. 11: **Photo Location "K"** – Sediment discharge from east side of Norfolk Southern ROW into Stream S-OO11.

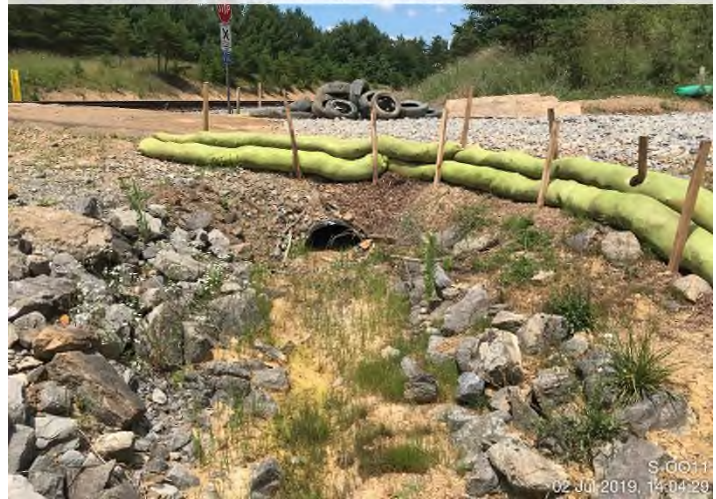
Fig. 12: **Photo Location "L"** – Sediment discharge from east side of Norfolk Southern ROW towards Stream S-OO11.

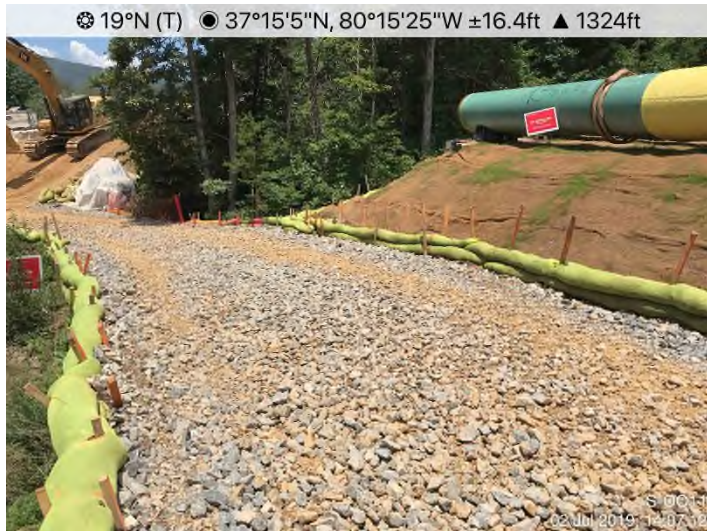
Fig. 13: **ATWS 1375** – Controls in place above Stream S-OO11 (UNT to Bradshaw Creek).

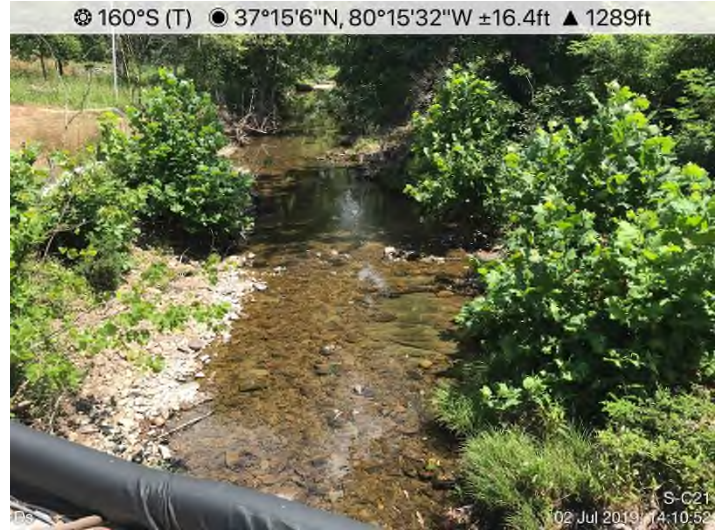
Fig. 14: **Stream S-C21** – Downstream view of Bradshaw Creek. Controls in place. (STA 12192+50)

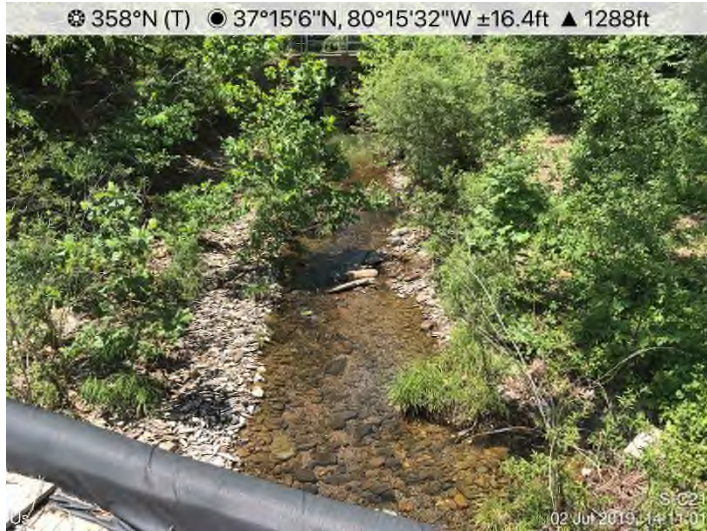
Fig. 15: **Stream S-C21** – Upstream view of Bradshaw Creek. Controls in place. (STA 12192+50)
