## COMPLAINT INSPECTION REPORT

| Project Name: | Mountain Valley Pipeline | Inspector: | Marshall Willis |
| Inspection Date: | Tuesday, April 23, 2019 | Project Contact: | Brian Clauto |
| Spread G:<br>Montgomery County | STA 11929+47 – 11988+96 | Weather (Wet/Dry/Rain): | Dry |

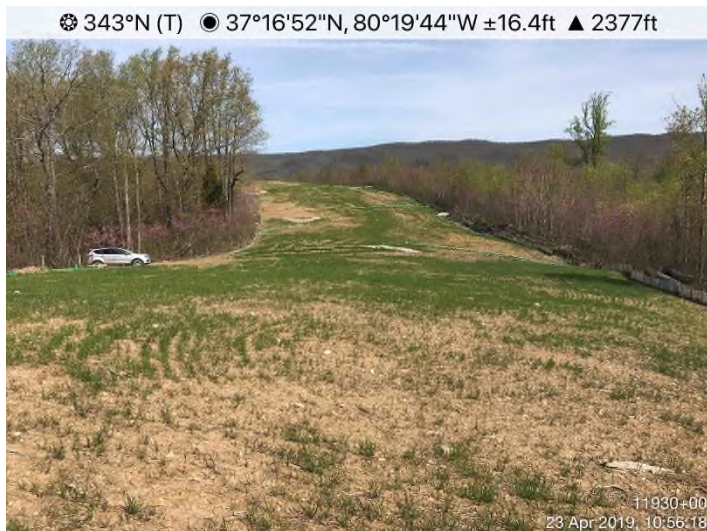
Fig. 1: **STA 11930+00** – Area stabilized. Controls in place.

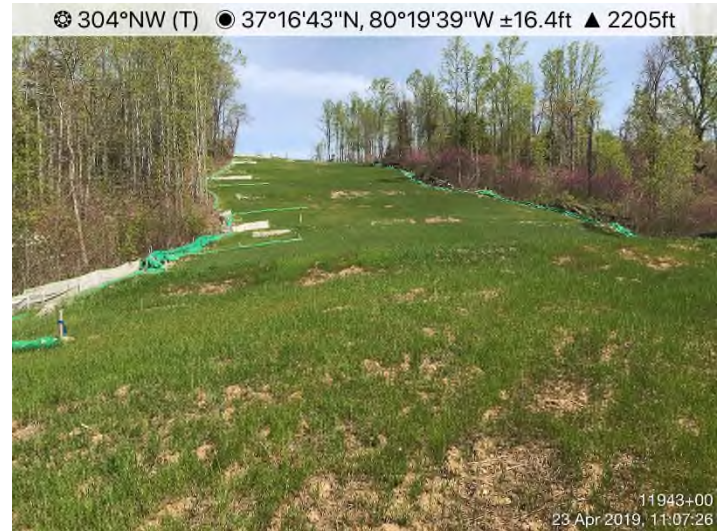
Fig. 2: **STA 11943+00** – Area stabilized. Controls in place.

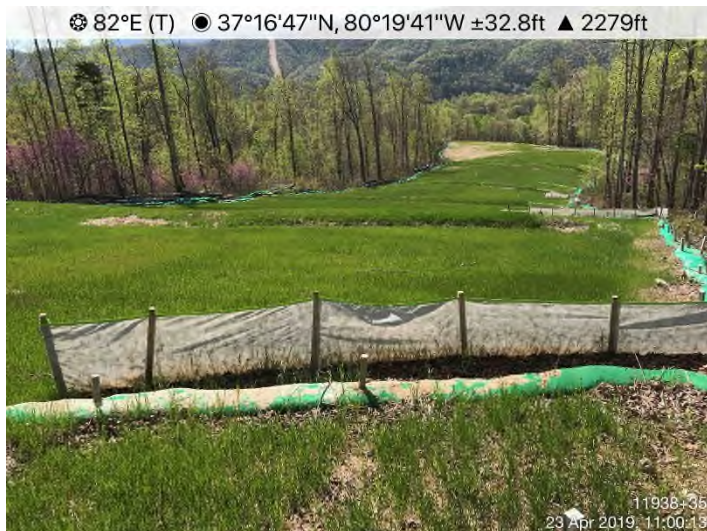
Fig. 3: **STA 11938+35** – Area stabilized. Controls in place.

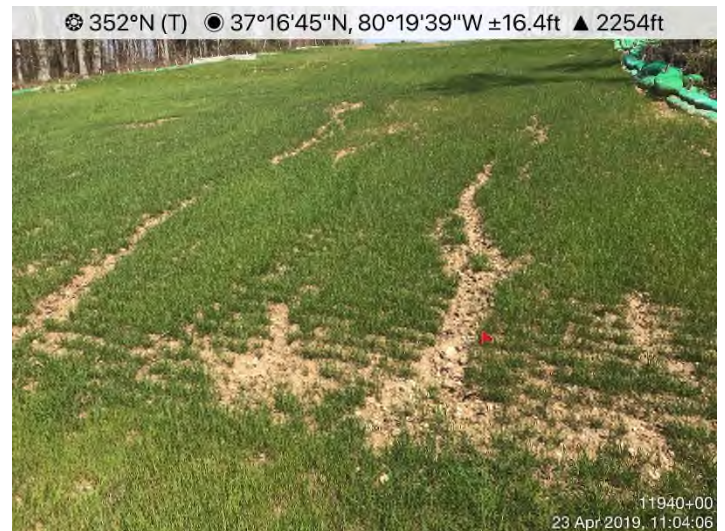
Fig. 4: **STA 11940+00** – Rill erosion occurring.

STA 11940+00: Repair rill erosion, stabilize slope.

**Recommended Corrective Action:** Stabilize areas exhibiting erosion.

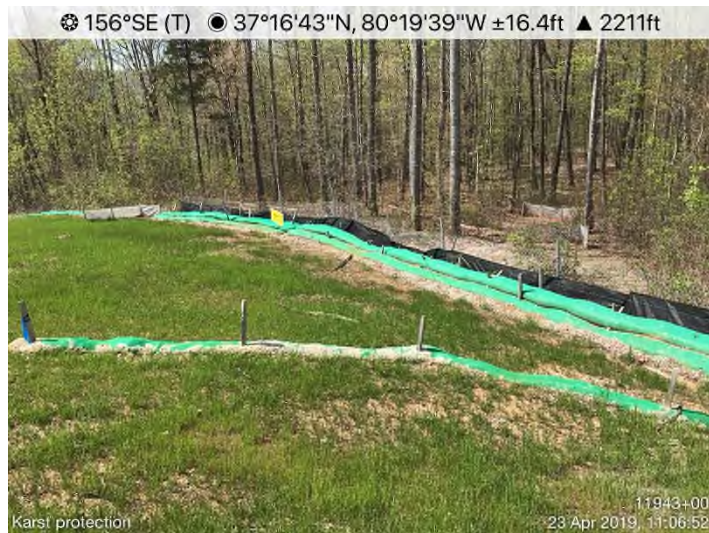
Fig. 5: **STA 11943+00** – Area stabilized. Controls in place above karst feature.

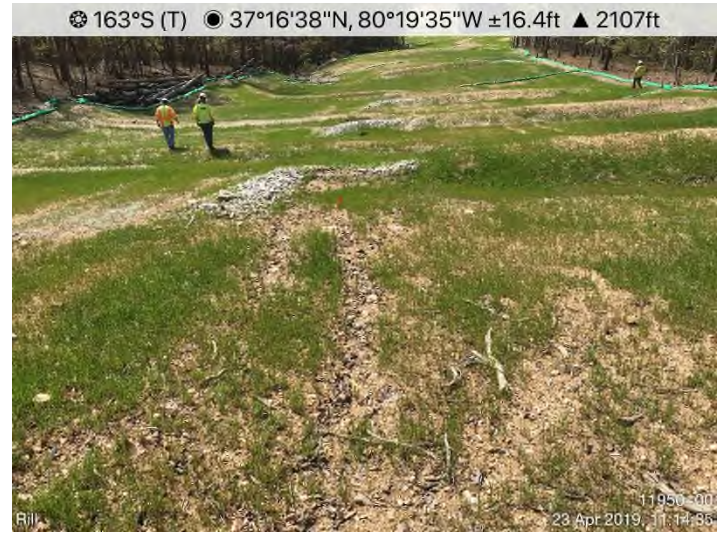
Fig. 6: **STA 11948+00** – Rill erosion occurring.

STA 11948+00: Repair rill erosion, stabilize slope.

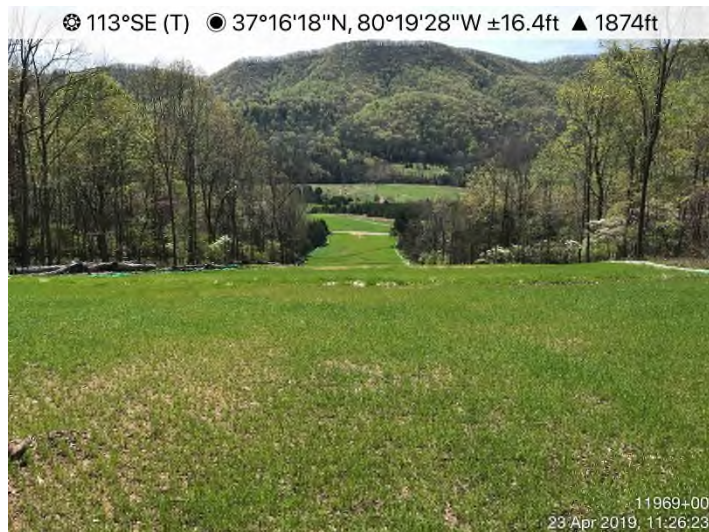
Fig. 7: **STA 11969+00** – Area stabilized. Controls in place.

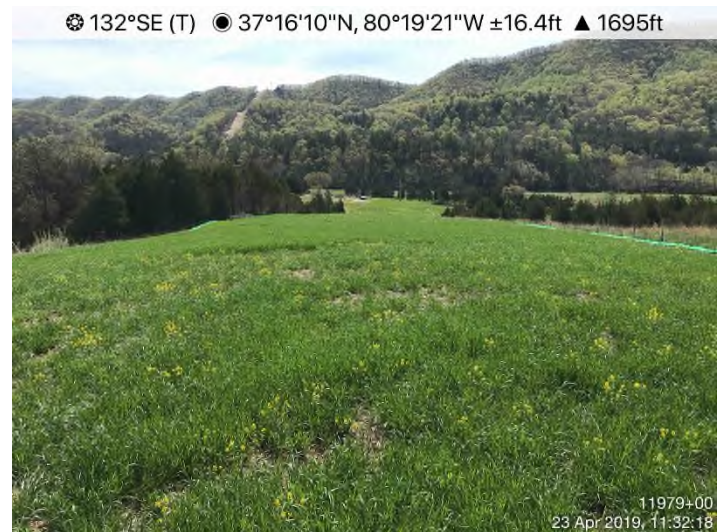
Fig. 8: **STA 11979+00** – Area stabilized. Controls in place.
