## FIELD INSPECTION

| Project Name: | Mountain Valley Pipeline | Inspector: | Marshall Willis |
| Inspection Date: | Monday, August 19, 2019 | Project Contact: | Brian Clauto, Cory Chalmers |
| Spread I:<br>Franklin County | STA 14018+47- 14042+25<br>MVP-MLV-31 | Weather (Wet/Dry/Rain): | Dry |

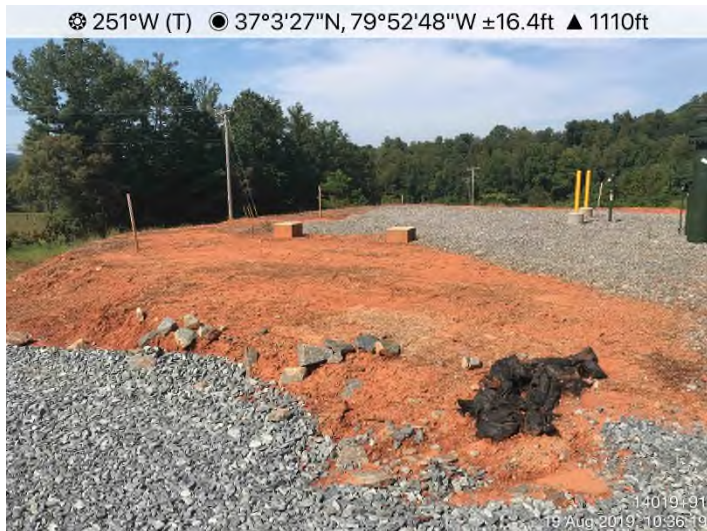
Fig. 1: **STA 14019+91** – Stabilize slopes and area adjacent to MLV-31.

**Recommended Corrective Action:** Maintain and install all controls per the approved plan and PSS&S.

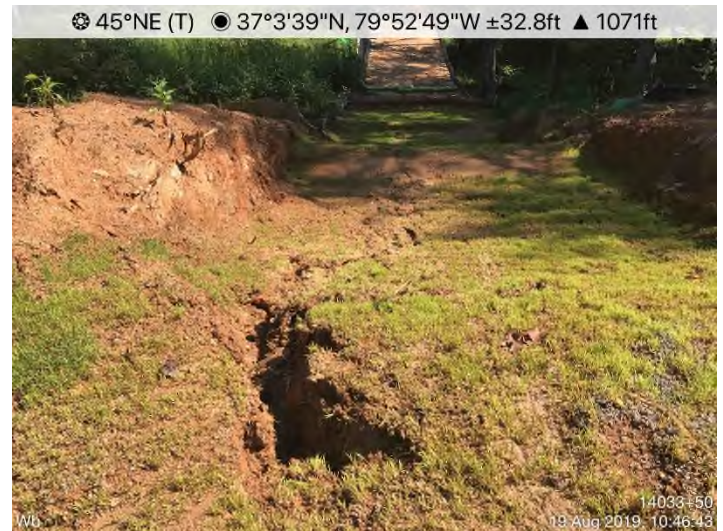
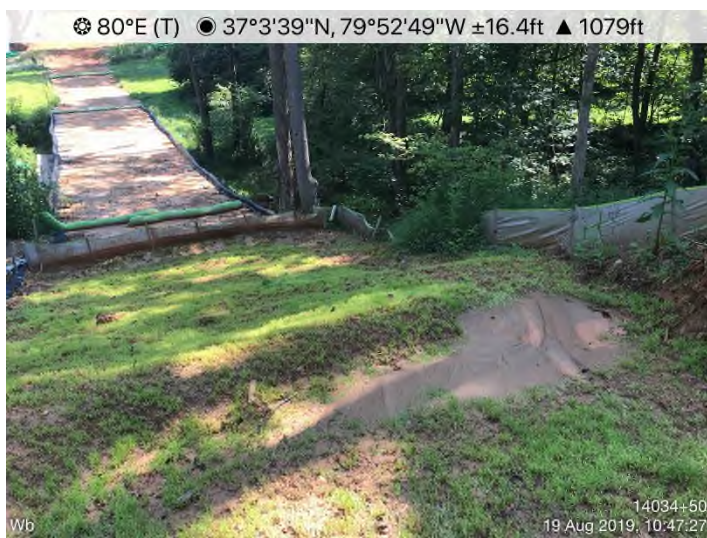
Fig. 2: **STA 14033+50 to 14034+50** – Maintain waterbars.

Fig. 3: **STA 14033+50 to 14034+50** – Maintain waterbars.

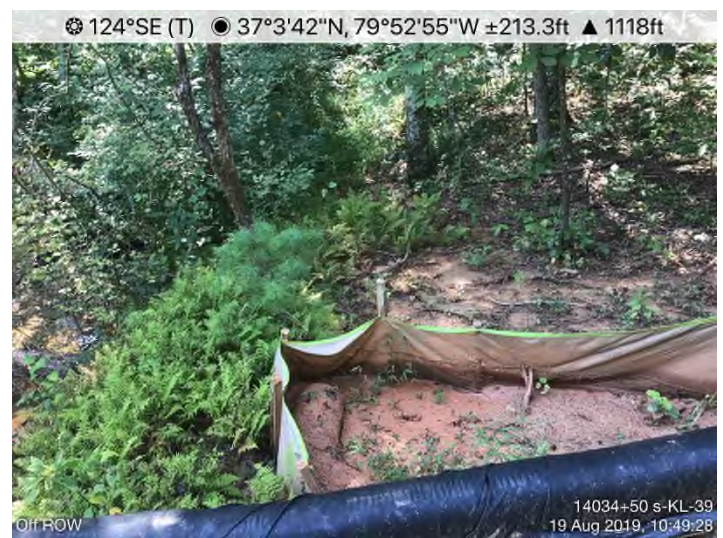
Fig. 4: **STA 14034+50** – Sediment off ROW.
