## FIELD INSPECTION

| Project Name: | Mountain Valley Pipeline | Inspector: | Marshall Willis |
| Inspection Date: | Thursday, August 15, 2019 | Project Contact: | Brian Clauto, Cory Chalmers |
| Spread H:<br>Montgomery County | STA 12482+67– 12544+06 | Weather (Wet/Dry/Rain): | Dry |

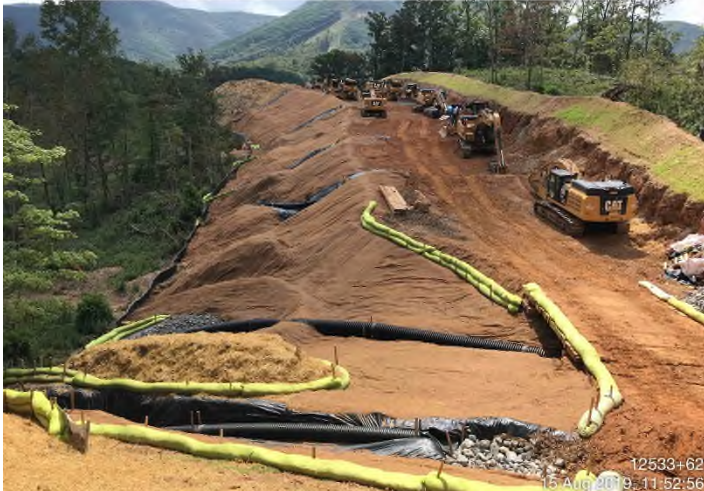
Fig. 1: **STA 12533+62** – Controls in place. Slope drains used to convey discharge down fill slopes. Stockpiles stabilized with straw and seed. Fill slopes stabilized with erosion blanket.

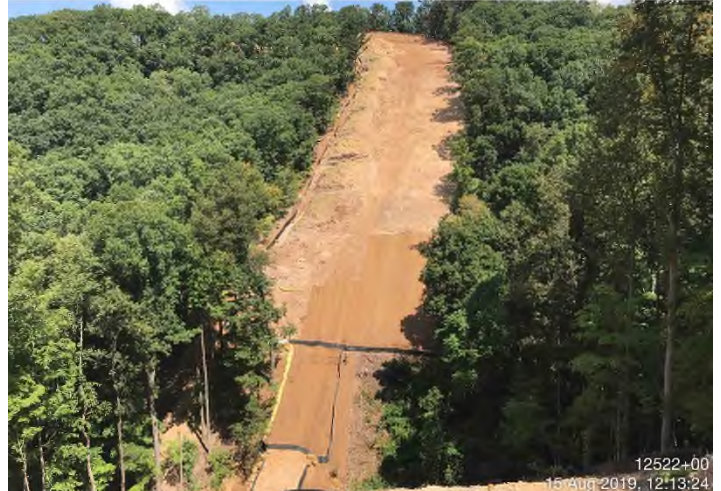
Fig. 2: **STA 12522+800** – Controls in place. Waterbars extend full length of ROW and connected to end-treatment CFS and sumps. Stockpiles stabilized with straw and millet.

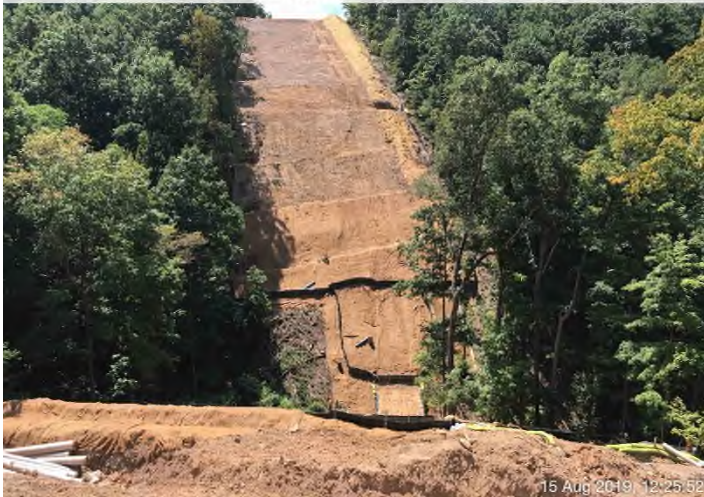
Fig. 3: **STA 12515+30** – Controls in place. Berms stabilized with straw and millet. Waterbars installed full length of ROW and connected to sumps and end-treatments.

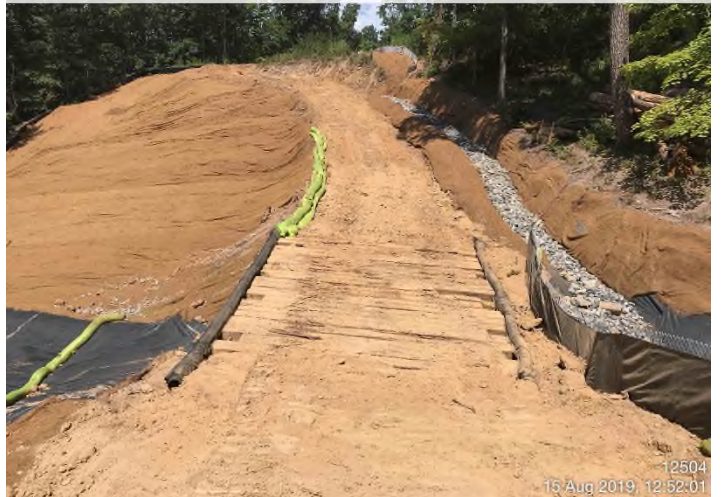
Fig. 4: **STA 12504+00** – Controls in place. Sideboards for CWD crossing installed. Area stabilized with erosion matting and millet.
