## FIELD INSPECTION

| Project Name: | Mountain Valley Pipeline | Inspector: | Marshall Willis |
| Inspection Date: | Wednesday, August 14, 2019 | Project Contact: | Brian Clauto, Cory Chalmers |
| Spread H:<br>Montgomery County | STA 12482+67– 12544+06 | Weather (Wet/Dry/Rain): | Dry |

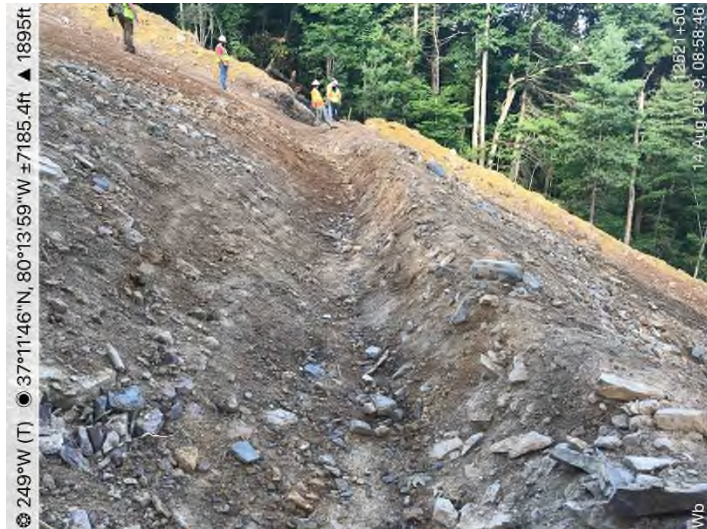
STA 12521+50: Waterbar does not have positive drainage to end-treatment.  
 STA 12507+86: Waterbars do not extend to edge of ROW.  
 STA 12504+00: Sideboards needed on CWD crossing.

Fig. 1: **STA 12521+50** – Waterbar does not have positive drainage to end-treatment.

**Recommended Corrective Action:** Maintain and install all controls per the approved plan and PSS&S.

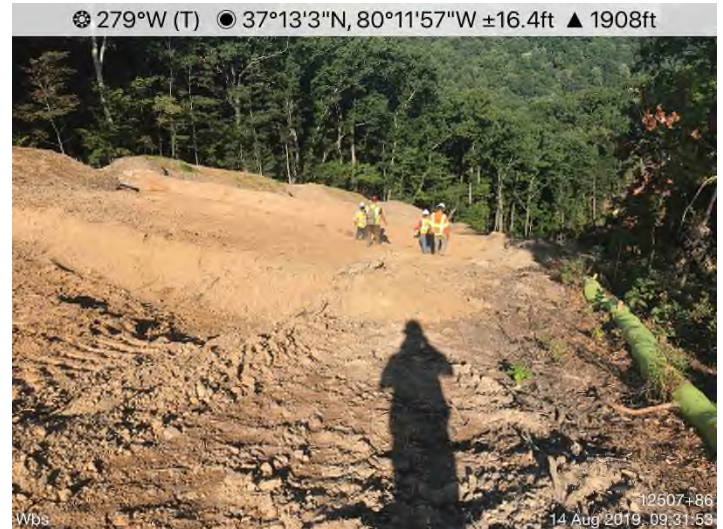
Fig. 2: **STA 12507+86** – Waterbars do not extend full length of ROW.

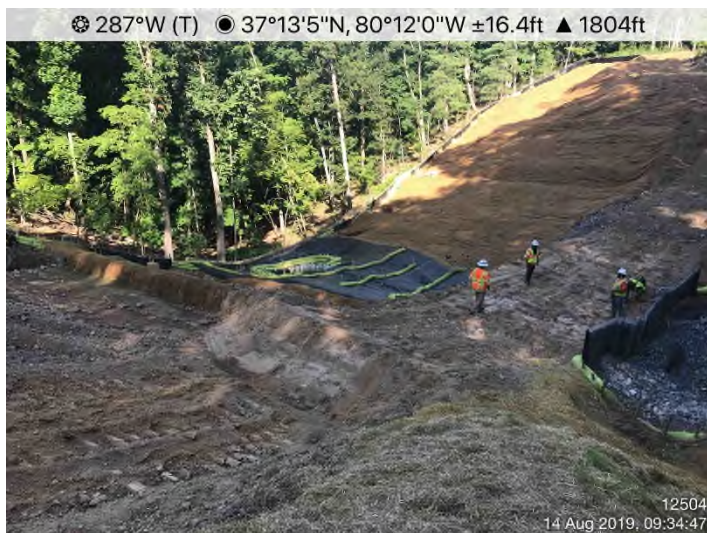
Fig. 3: **STA 12504+00** – Bridge sideboards needed along CWD crossing.

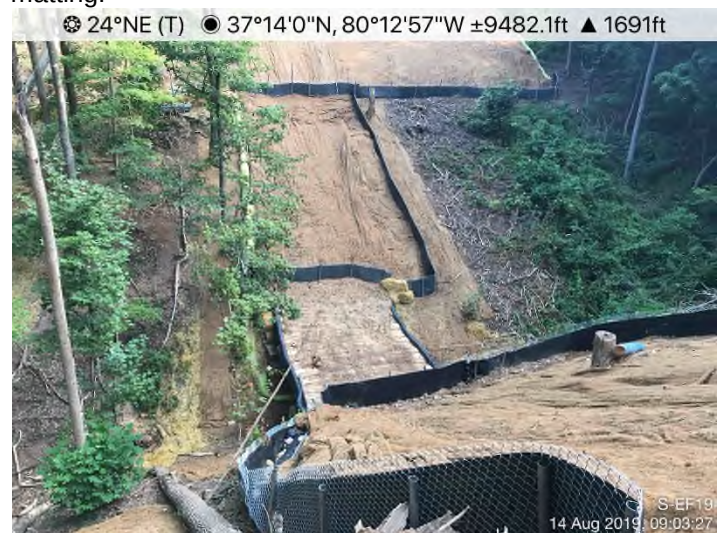
Fig. 4: **Stream S-EF19** – Controls in place along stream S-EF19. SSF entrenched properly and stabilized with erosion matting.
