FIELD INSPECTION

Project Name:	Mountain Valley Pipeline	Inspector:	Marshall Willis
Inspection Date:	Monday, August 12, 2019	Project Contact:	Brian Clauto, Cory Chalmers
Spread I: Franklin County	STA 14230+00 – 14250+00 MVP-MLV-AR-32 ATWS 351 + 351A ATWS 693 + 693A	Weather (Wet/Dry/Rain):	Dry

FIELD INSPECTION PHOTO LOG

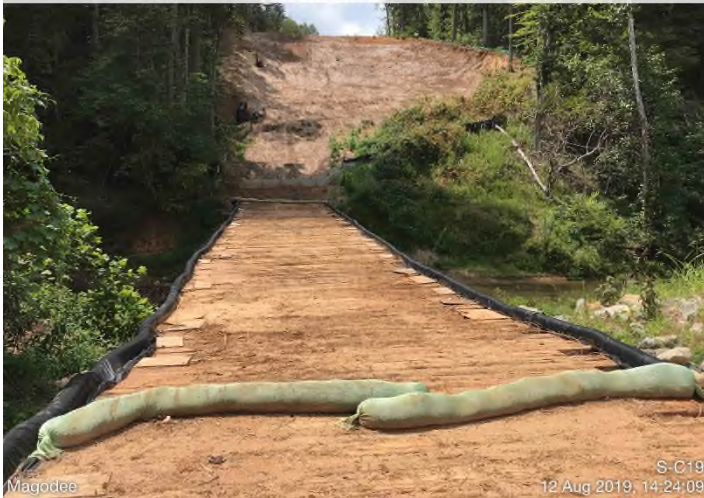
Fig. 1: **STA 14233+57** –Maggodee Creek (S-C19) MVP ROW crossing. Controls are in place and functioning. Area stabilized with straw and Earth-Guard.

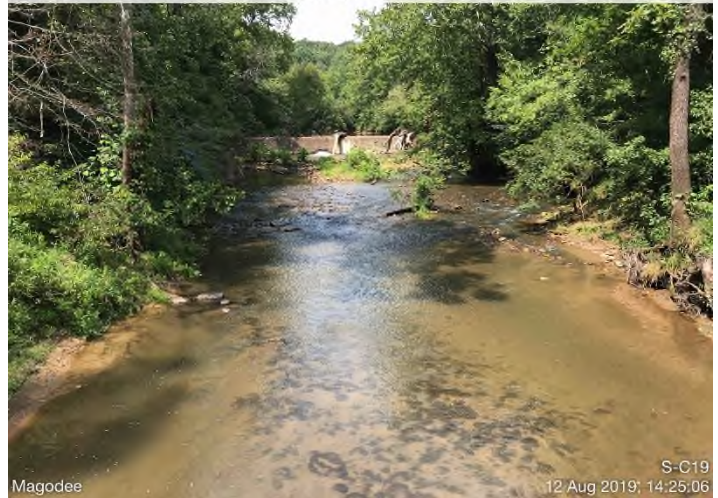
Note: Discharge from Maggodee Creek is no longer going over dam upstream of MVP ROW. Documentation from inspection on 7/26/2019 shows water flowing over dam, however inspection on 8/12 shows low flow orifice active only. Change in discharge from this control device may cause temporary elevated turbidity levels downstream in Maggodee Creek and Blackwater River. USGS MVP "upstream" monitoring station is located just below confluence of Maggodee Creek and Blackwater River.

Fig. 2: **STA 14233+57** – Upstream view Maggodee Creek (S-C19) from MVP ROW crossing. Note: Discharge not overtopping dam structure.

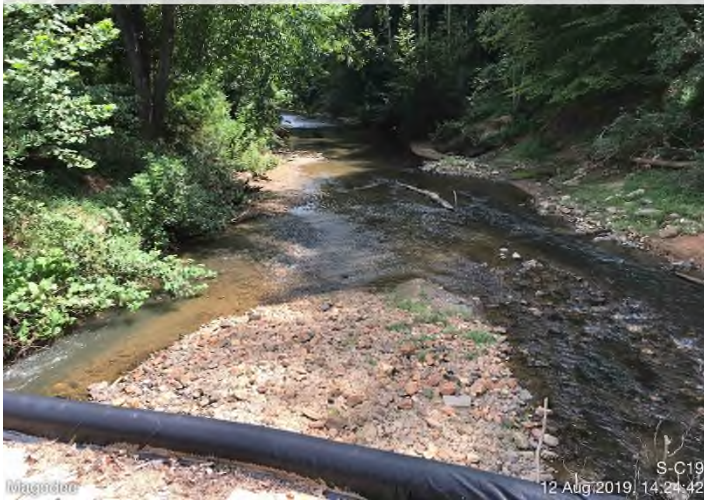
Fig. 3: **STA 14233+57** – Downstream view Maggodee Creek (S-C19) from MVP ROW crossing looking towards confluence of Blackwater River.

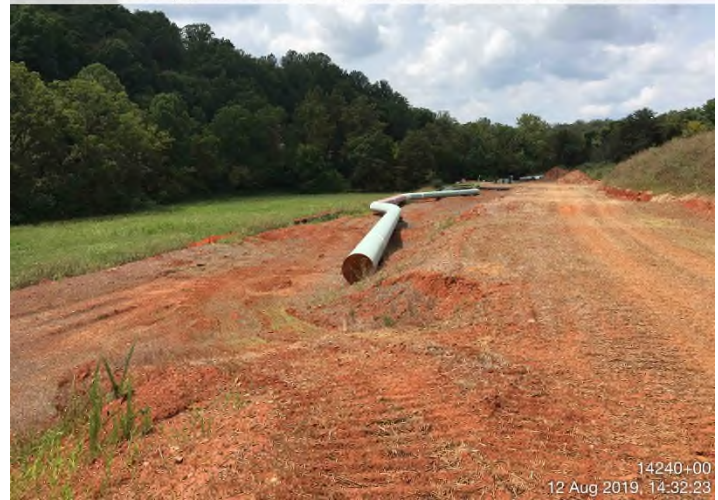
Fig. 4: **STA 14240+00** – Area stabilized with Earth-Guard, millet and straw. Controls in place and functioning. No observed sediment off ROW.

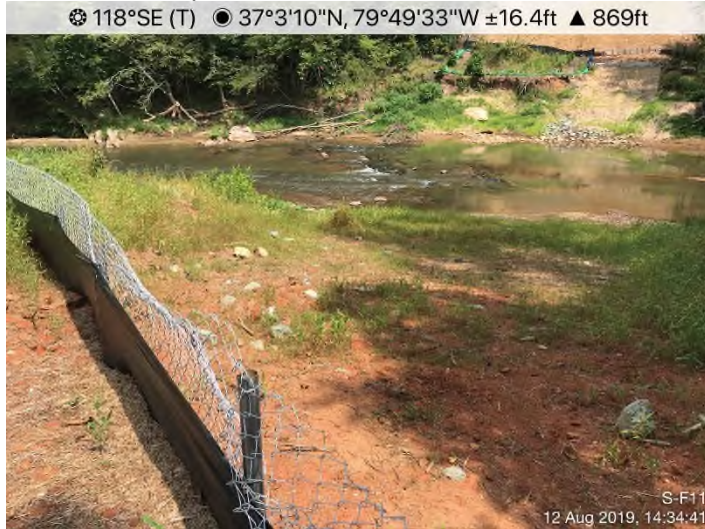
Fig. 5: **STA 14249+19** – Blackwater River (S-F11) from MVP ROW crossing. Area stabilized and controls in place. No observed impacts or sediment off ROW.

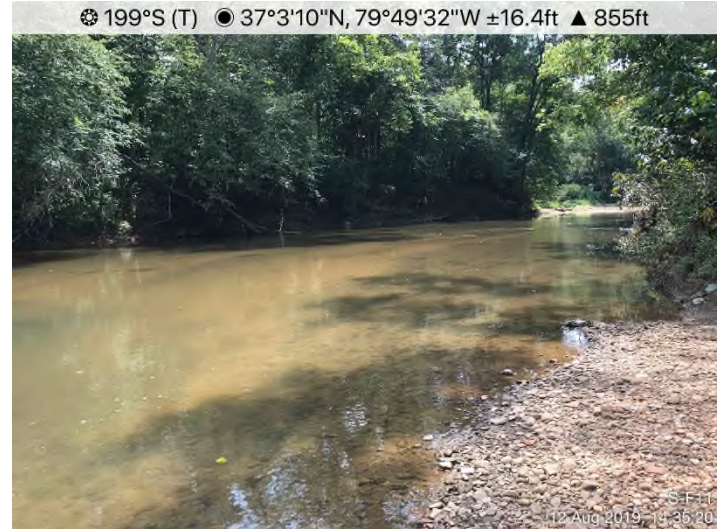
Fig. 6: **STA 14249+19** – Upstream view Blackwater River (S-F11) from MVP ROW.

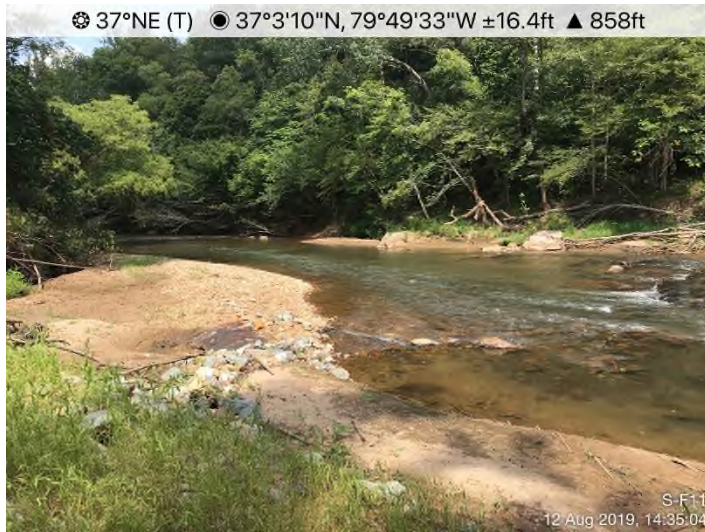
Fig. 7: **STA 14249+19** – Downstream view Blackwater River (S-F11) from MVP ROW.
