## FIELD INSPECTION

| Project Name: | Mountain Valley Pipeline | Inspector: | Marshall Willis |
| Inspection Date: | Thursday, August 8, 2019 | Project Contact: | Brian Clauto, Cory Chalmers |

## FIELD INSPECTION PHOTO LOG

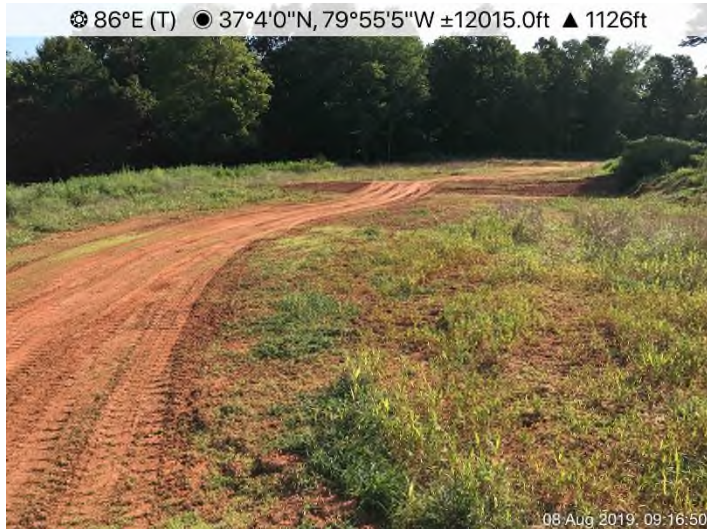
Fig. 1: **STA 13978+00** – Controls in place. Area stabilized with Earth-Guard and millet.

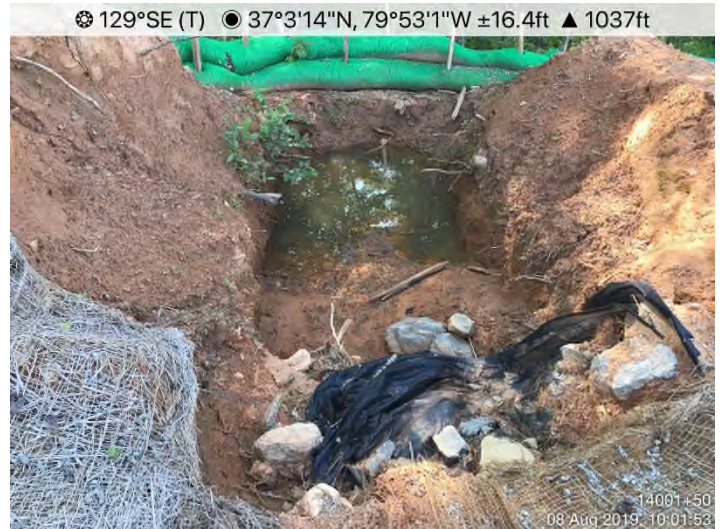
STA 14001+50: Sump maintenance needed.

Fig. 2: **STA 14001+50** – Sump maintenance needed.

**Recommended Corrective Action:** Maintain and install all controls per the approved plans and PSS&S.

**Deadline:** Within 24-hr notification

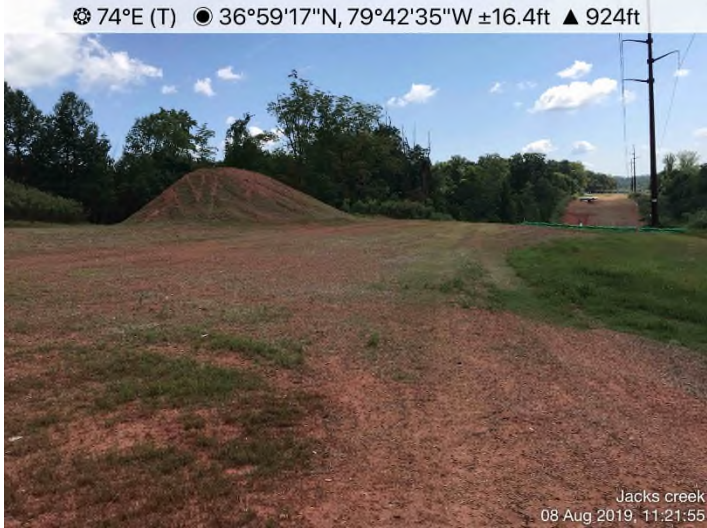
Fig. 3: **STA 14695+00** – Controls in place. Area stabilized with Earth-Guard and millet.

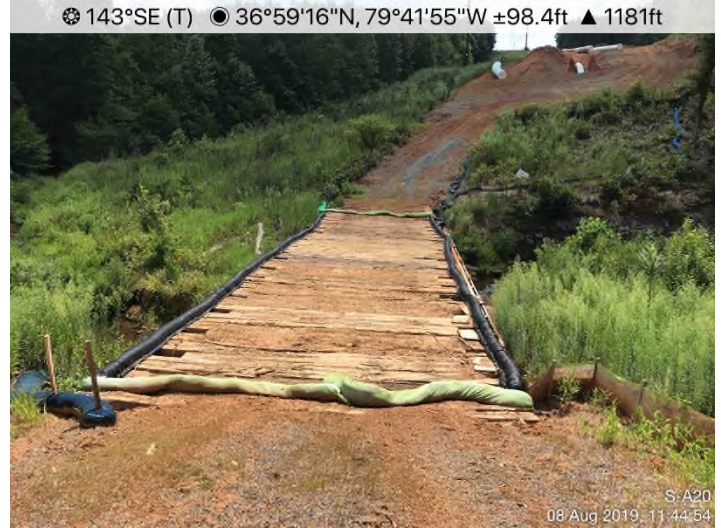
Fig. 4: **Stream S-A20** – Controls in place. Sideboards and perimeter controls appear to be functioning. Area stabilized with Earth-Guard and millet.
