## FIELD INSPECTION

| <b>Project Name:</b> | Mountain Valley Pipeline | <b>Inspector:</b> | Marshall Willis |
| <b>Spread H:</b><br>Roanoke County<br>Montgomery County | STA 12445+19 – 12544+06<br>STA 12071+80 – 12102+69 | <b>Weather (Wet/Dry/Rain):</b> | Dry |

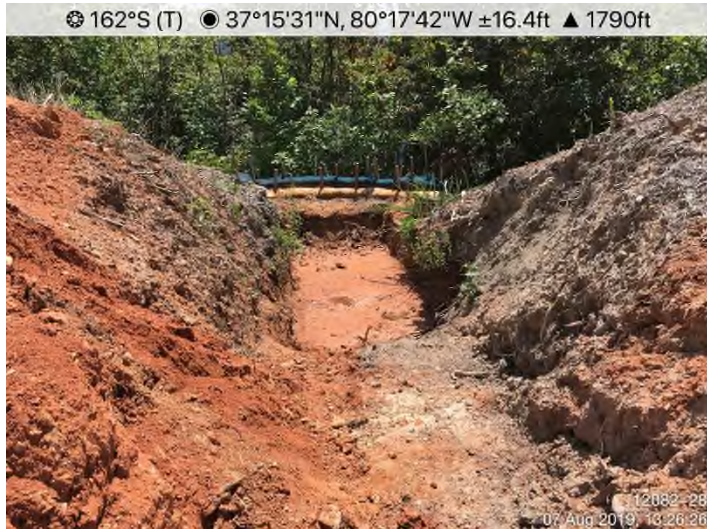
STA 12082+28: Maintain sump.  
 STA 12083+00: Maintain sump.  
 STA 12093+28: Maintain sump.

Fig. 1: **STA 12082+28** – Sump maintenance needed.

**Recommended Corrective Action:** Install and maintain all controls per the approved plans and PSS&S.

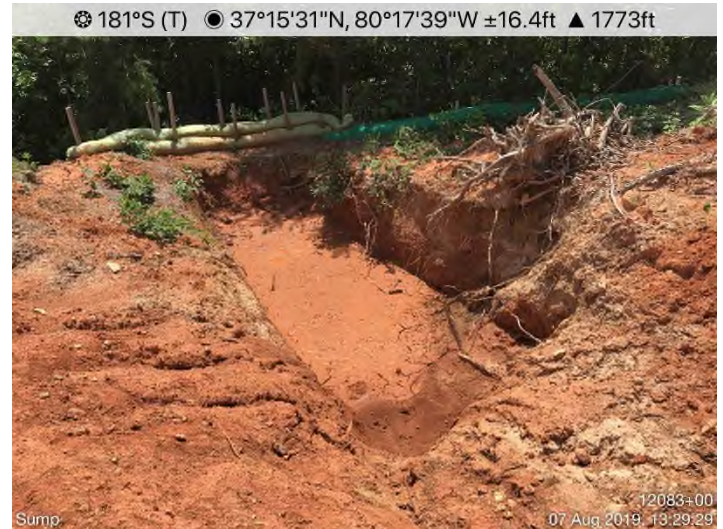
Fig. 2: **STA 12083+00** – Sump maintenance needed.

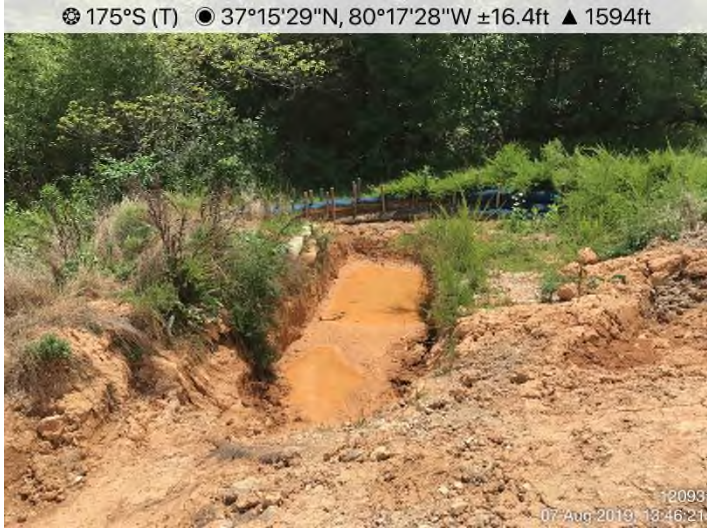
Fig. 3: **STA 12093+00** – Sump maintenance needed.

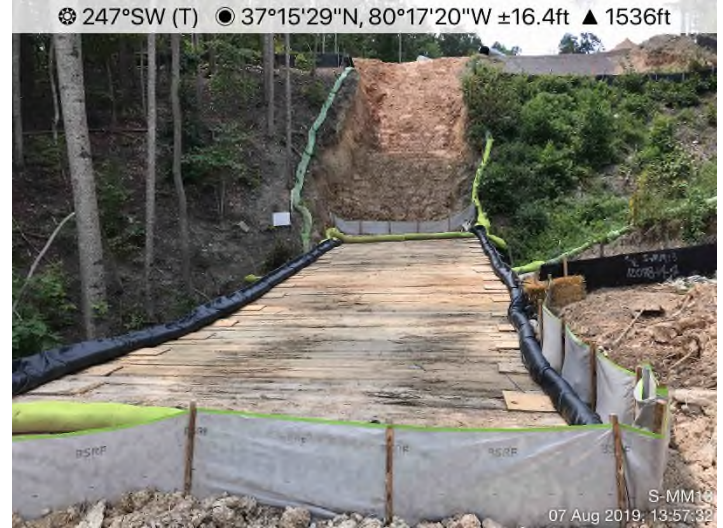
Fig. 4: **Stream S-MM13** – Perimeter controls in place. Bridge clean and sideboards in place and functioning.
