## FIELD INSPECTION

| <b>Project Name:</b> | Mountain Valley Pipeline | <b>Inspector:</b> | Marshall Willis |
| <b>Inspection Date:</b> | Tuesday, August 6, 2019 | <b>Project Contact:</b> | Brian Clauto, Cory Chalmers |

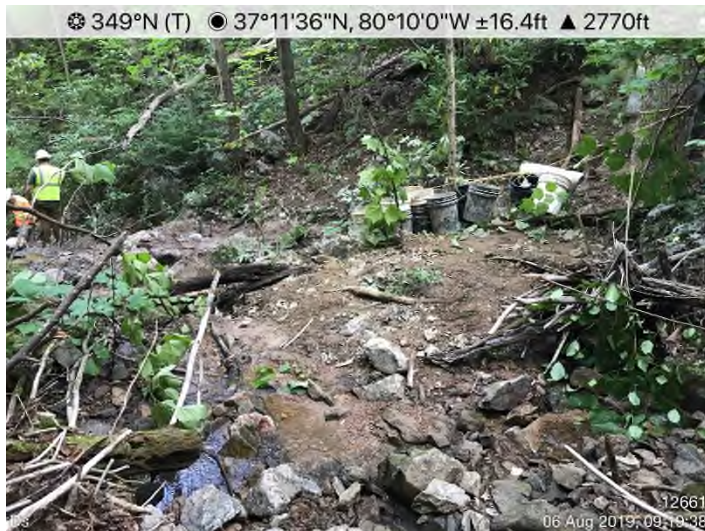
Sediment retrieval from offsite discharge ongoing at Stream S-IJ50 (STA 12656+89).  
 Conventional bore at Stream S-G26/G27 (STA 13061+89) is complete.  
 Conventional bore at Stream S-II4 (STA 13260+75) is complete but tie-in ongoing.  
 Conventional bore at Stream S-GH7 (STA 13309+09) is ongoing.

Fig. 1: **STA 12690+43** – Off ROW impacts to Stream S-IJ50. Ongoing cleanup efforts underway.

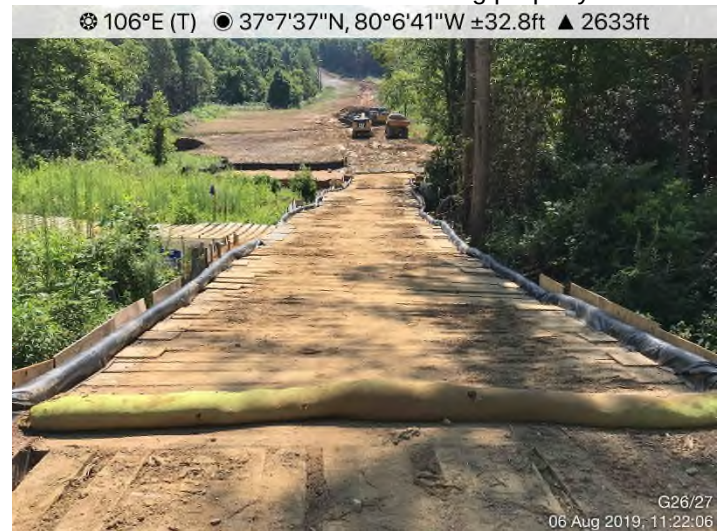
Fig. 2: **Stream S-G26/27** – Conventional bore completed. Perimeter controls in place. Buffers stabilized. Bridge clean and sideboards installed and functioning properly.

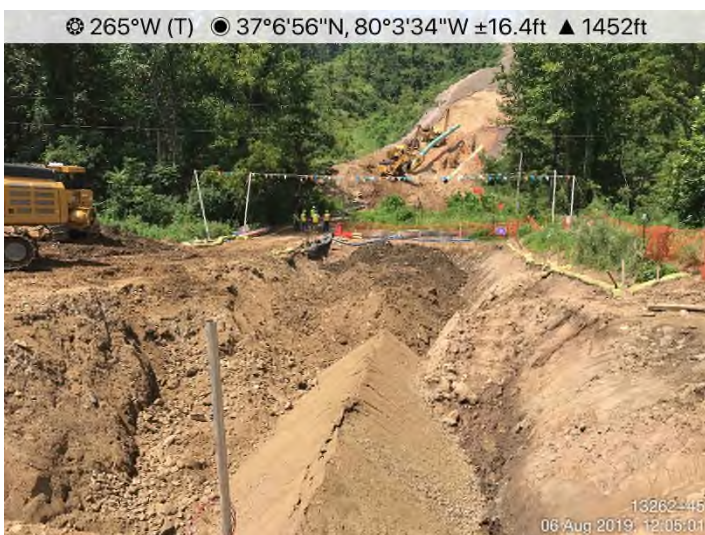
Fig. 3: **Stream S-II4** – Conventional bore completed. Tie-in ongoing. Controls in place.

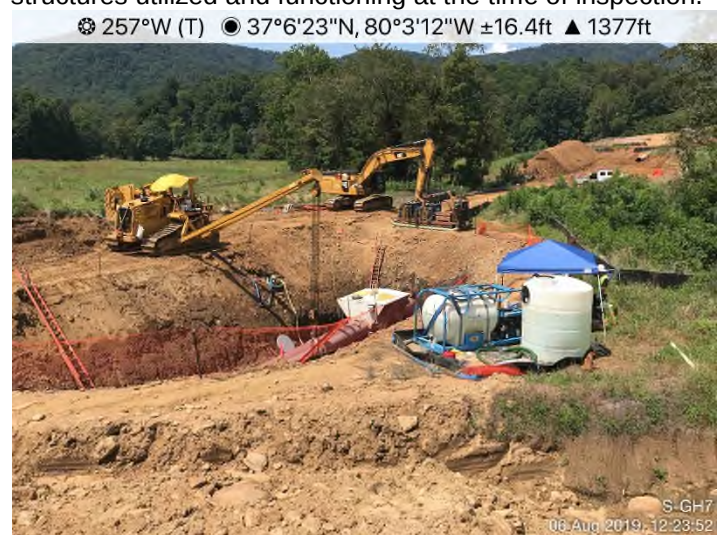
Fig. 4: **Stream S-GH7** – Conventional bore ongoing. Secondary containment and controls in place. Dewatering structures utilized and functioning at the time of inspection.
