## FIELD INSPECTION

| Project Name: | Mountain Valley Pipeline | Inspector: | Marshall Willis |
| Inspection Date: | Thursday, August 1, 2019 | Project Contact: | Brian Clauto, Cory Chalmers |
| Spread H:<br>Montgomery County | STA 12482+67- 12544+06<br>MVP-MLV-AR-28 | Weather (Wet/Dry/Rain): | Dry |

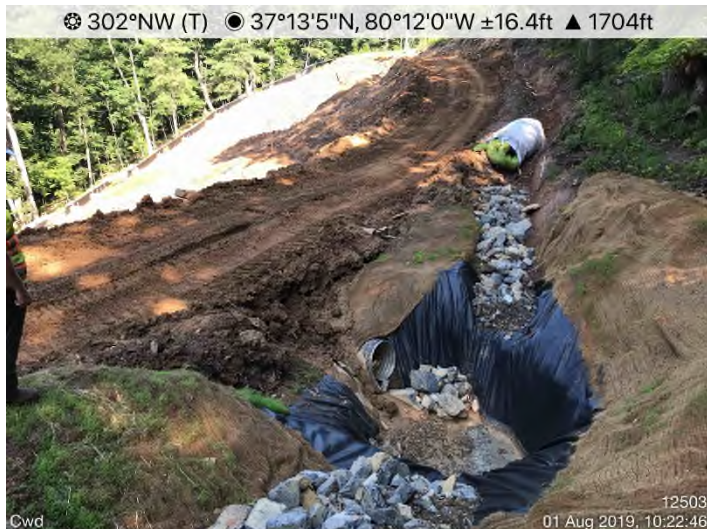
Fig. 1: **STA 12503+00** – CWD inlet not protected from onsite discharge. Diversion not stabilized. Not installed per approved PSS&S.

**Recommended Corrective Action:** Recommend stop work from STA 12482+67 to 12544+06. Maintain and install all controls per the approved PSS&S prior to additional forward progress.

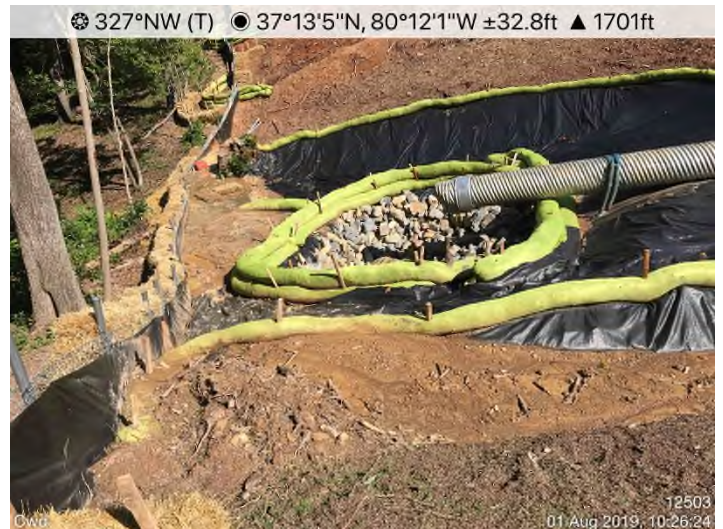
Fig. 2: **STA 12503+00** – CWD outlet/plunge pool not protected from onsite discharge. Sediment accumulation in outfall. ECDs overtopped. Not installed per approved PSS&S.

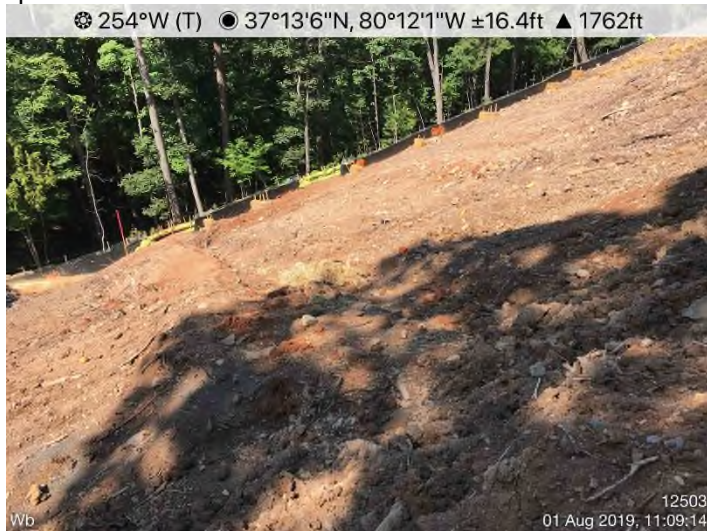
Fig. 3: **Various Locations** – Waterbars and End Treatments not in-compliance with the approved specifications. See MVP PSS&S MVP17 & ES42.

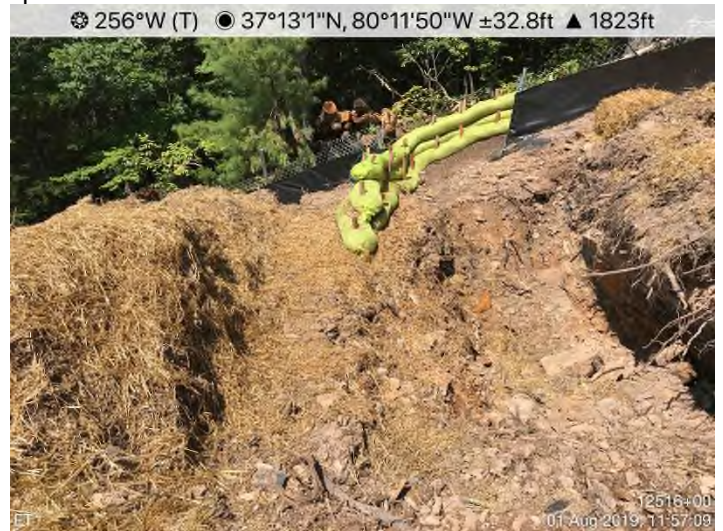
Fig. 4: **Various Locations** – Waterbars and End Treatments not in-compliance with the approved specifications. See MVP PSS&S MVP17 & ES42.

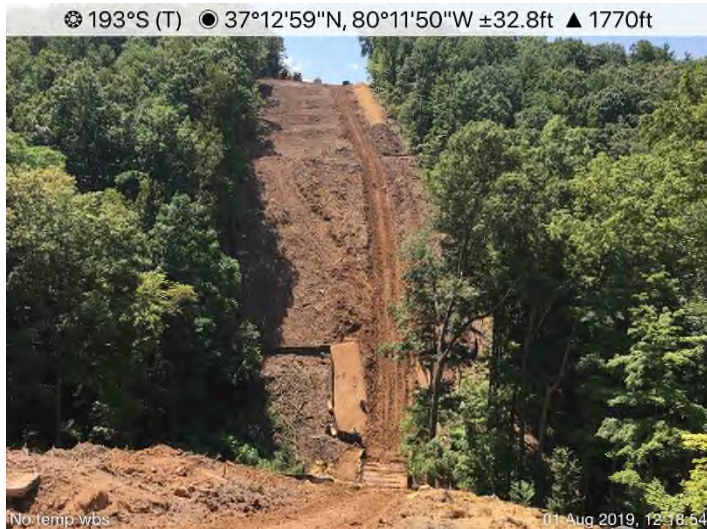
Fig. 5: **STA 12482+00** – No waterbars installed on lower half of slope above previously impacted stream S-EF19.

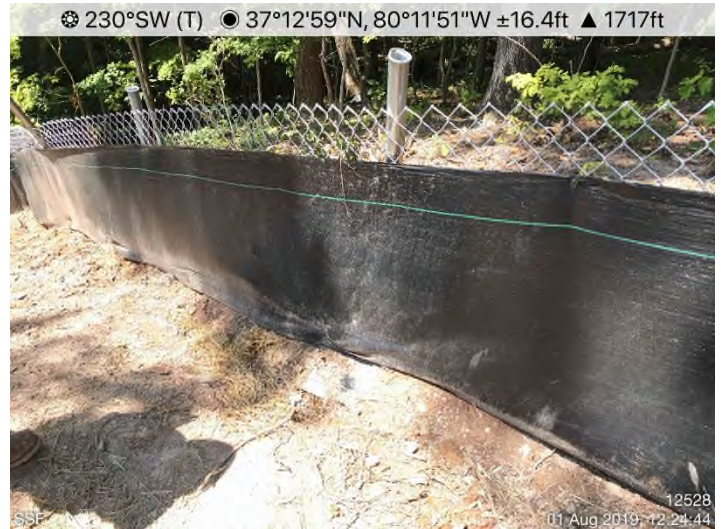
Fig. 6: **STA 12528+00** – SSF undermined.

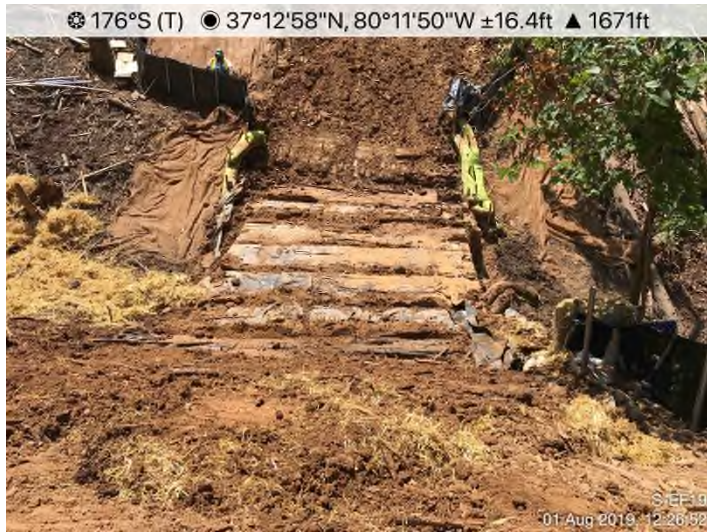
Fig. 7: **Stream S-EF19** – UNT to Indian Run impacted with sediment discharge from ROW at STA 12519+41.

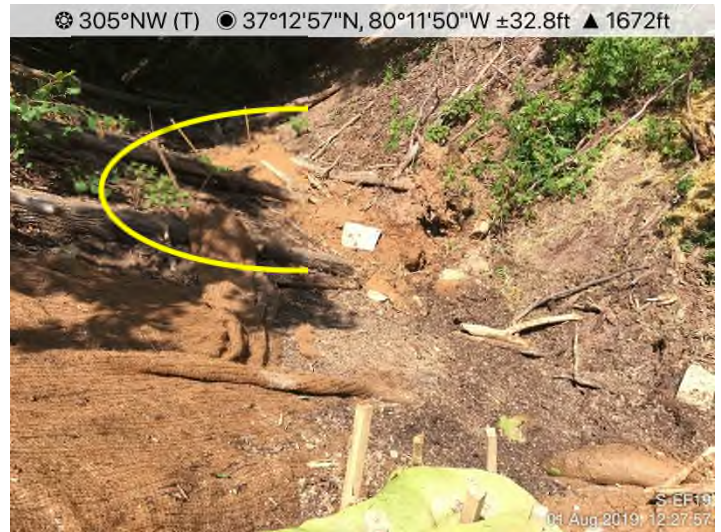
Fig. 8: **Stream S-EF19** – UNT to Indian Run impacted with sediment discharge from ROW at STA 12519+41.

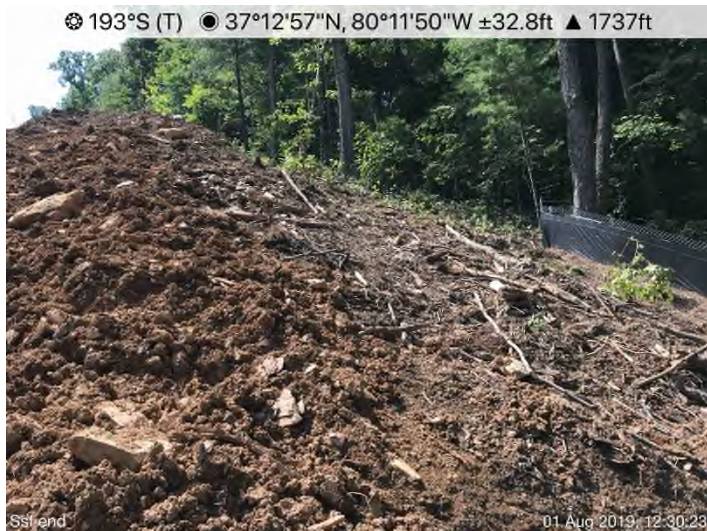
Fig. 9: **STA 12520+00** – Incomplete installation of perimeter controls.

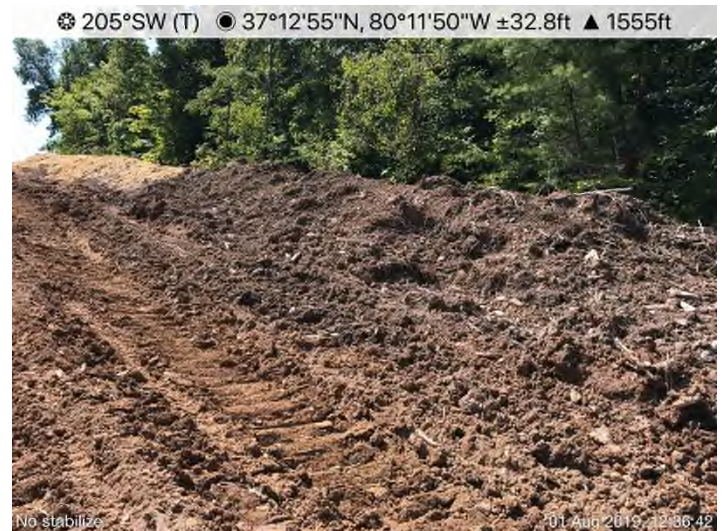
Fig. 10: **STA 12520+00** – Perimeter clean water diversions not stabilized.

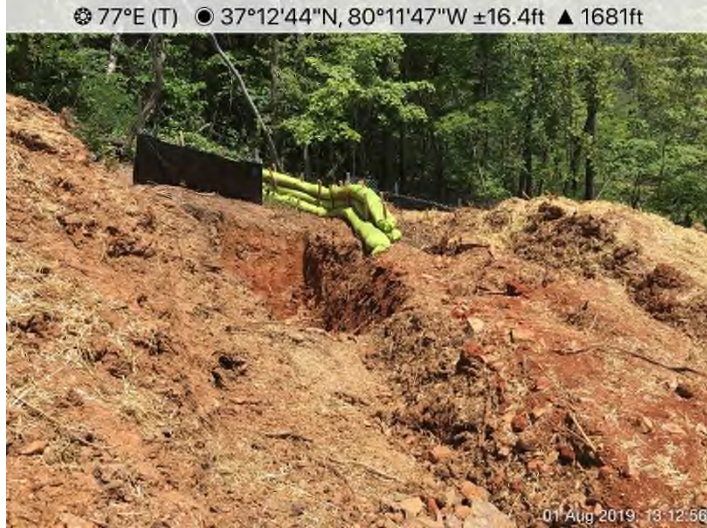
Fig. 11: **Various Locations** – Waterbars and End Treatments not in-compliance with the approved specifications. See MVP PSS&S MVP17 & ES42.

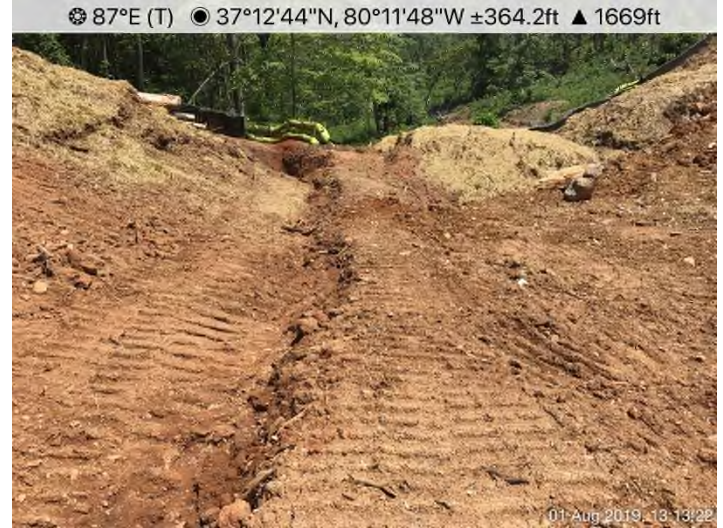
Fig. 12: **Various Locations** – Waterbars and End Treatments not in-compliance with the approved specifications. See MVP PSS&S MVP17 & ES42.

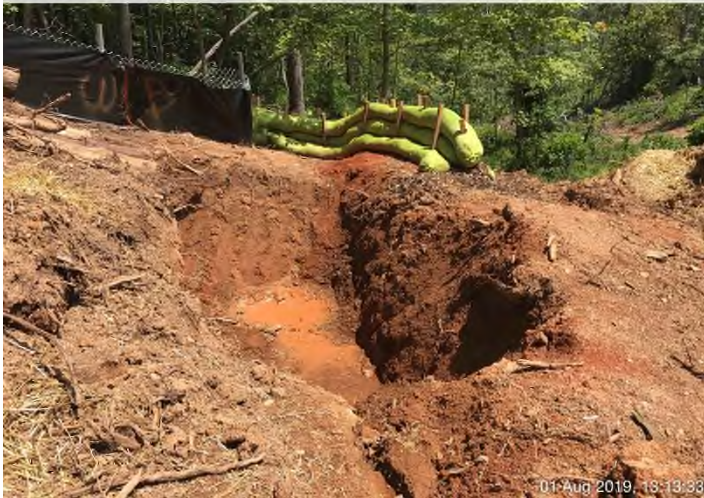
Fig. 13: **Various Locations** – Waterbars and End Treatments not in-compliance with the approved specifications. See MVP PSS&S MVP17 & ES42.

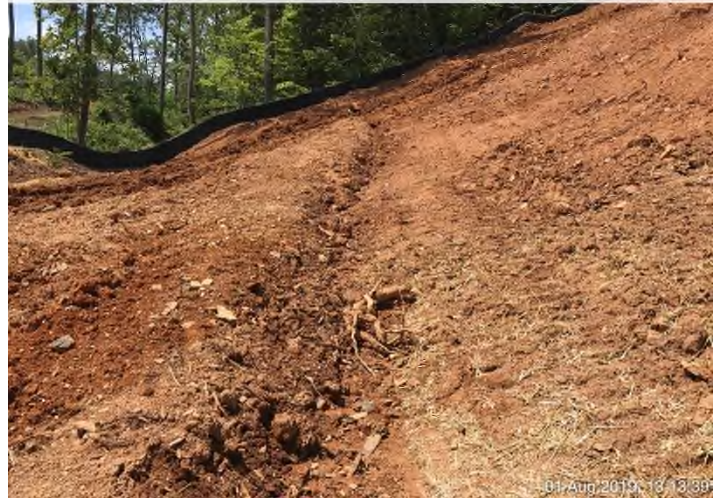
Fig. 14: **Various Locations** – Waterbars and End Treatments not in-compliance with the approved specifications. See MVP PSS&S: MVP-17 & ES42.

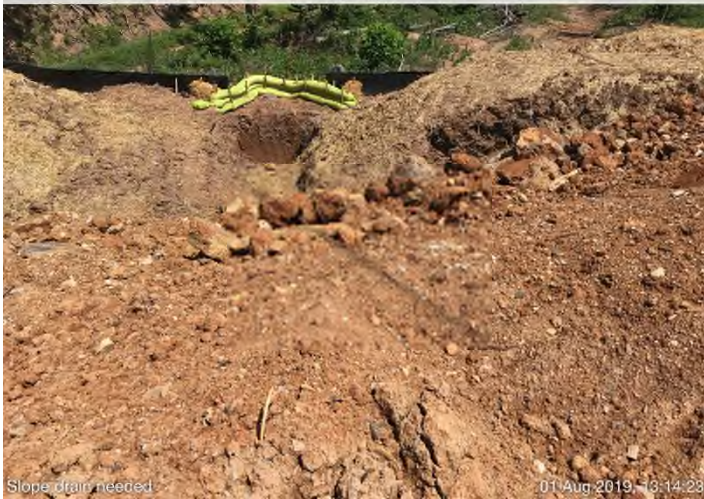
Fig. 15: **Approx. STA 12533+00 to 12537+00** – Discharge directed down unprotected fill slopes. See MVP PSS&S: ES59, ES60 & ES61.

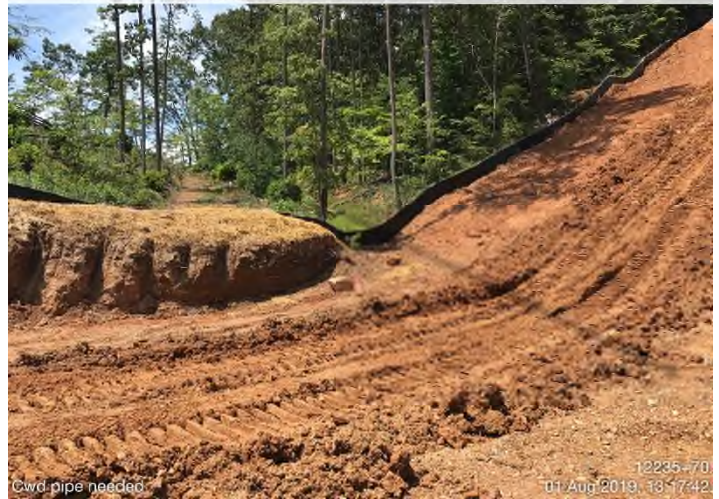
Fig. 16: **STA 12532+70** – CWD needed to divert clean water around ROW.
