## **FIELD INSPECTION**

Project Name:	Mountain Valley Pipeline	Inspector:	Marshall Willis
Inspection Date:	Wednesday, July 31, 2019	Project Contact:	Brian Clauto
Spread H: Montgomery County	STA 12445+19 - 12482+67 MVP-MLV-AR-28	Weather (Wet/Dry/Rain):	Wet

### FIELD INSPECTION PHOTO LOG

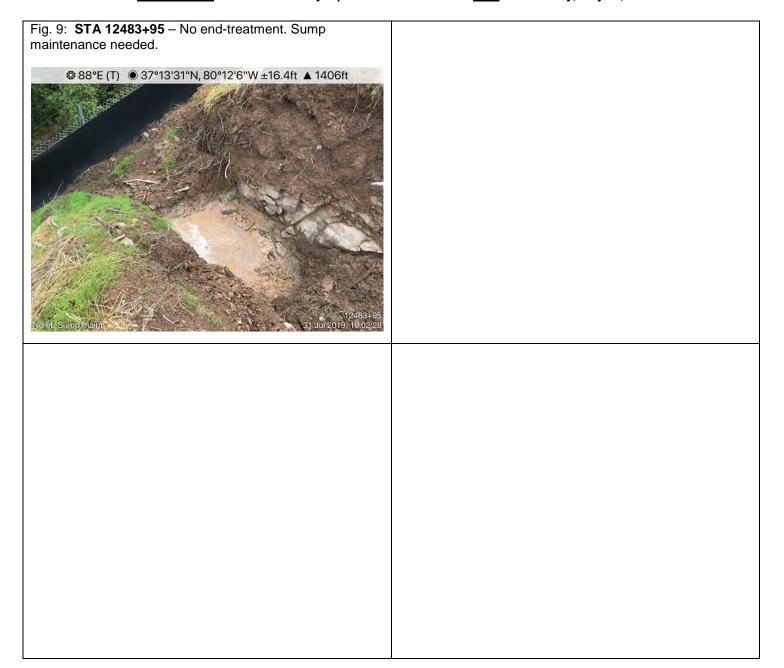
STA 12482+00: CFS maintenance required.					
STA 12483+00: Sump maintenance required. STA 12483+00: Waterbar failure.					
STA 12483+00. Waterbar failure. STA 12482+95: No end-treatment at end of waterbar, sump maintenance needed.					
on 12 102 100. No one treatment at one of waterbar, bump maintenance necess.					
Recommended Corrective Action: Maintain and install all controls per the approved plan and specs.
