## FIELD INSPECTION

| <b>Project Name:</b> | Mountain Valley Pipeline | <b>Inspector:</b> | Marshall Willis |
| <b>Spread H:<br/>Montgomery County</b> | STA 12298+39 – 12421+68<br>MVP-MN-276.03<br>ATWS 724 | <b>Weather (Wet/Dry/Rain):</b> | Dry |

## FIELD INSPECTION PHOTO LOG

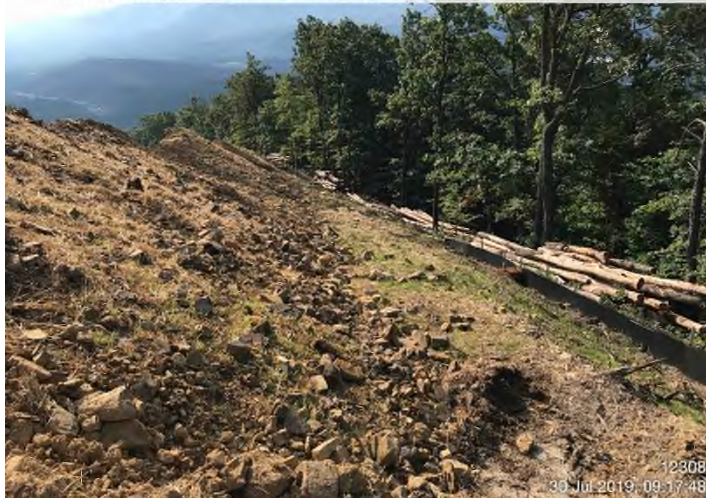
Fig. 1: **STA 12308+00** – Perimeter controls in place and functioning. Topsoil piles stabilized with straw and millet.

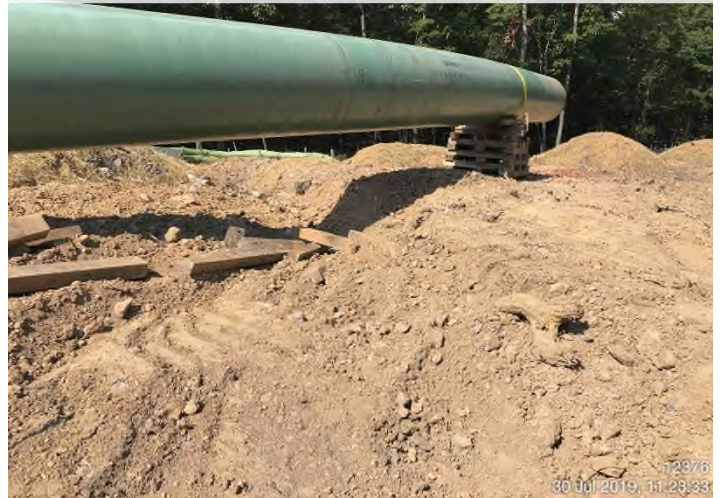
Fig. 2: **STA 12376+00** – Waterbar flow path obstructed. Maintain clear flowpath.

STA 12376+00: Repair obstructed waterbar flow path.

**Recommended Corrective Action:** Maintain and install all controls per the approved plan and specs.

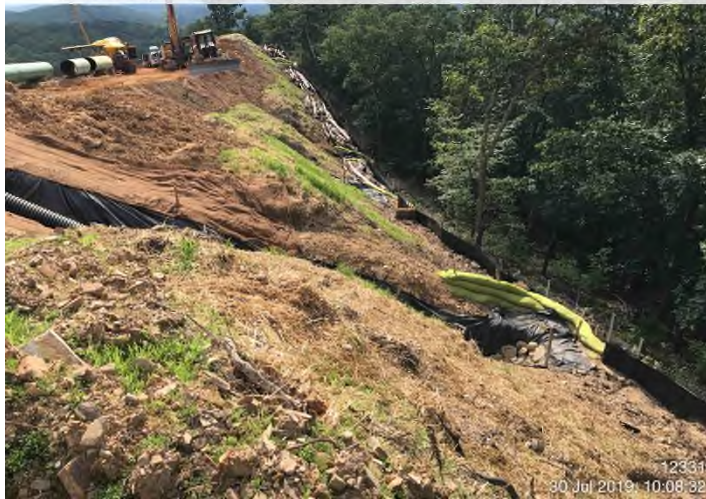
Fig. 3: **STA 12331+00** – Perimeter controls and slope drains in place and functioning. Topsoil piles stabilized with straw and millet.

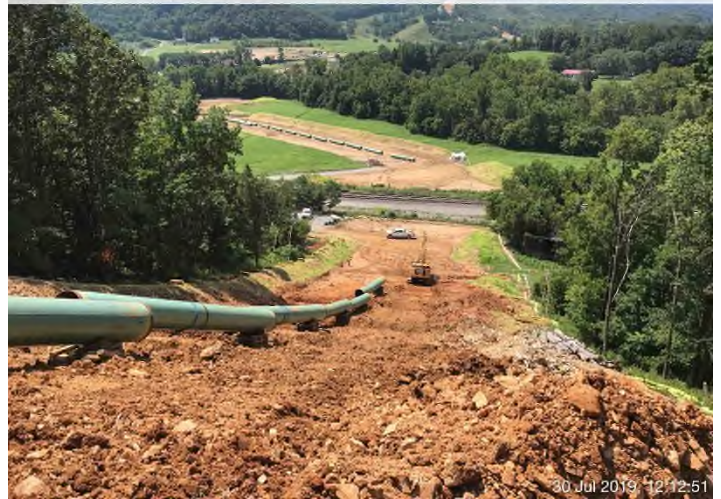
Fig. 4: **STA 12415+00** – Perimeter controls in place and functioning. Topsoil piles stabilized with straw and millet.
