FIELD INSPECTION

Project Name:	Mountain Valley Pipeline	Inspector:	Marshall Willis
Inspection Date:	Friday, July 26, 2019	Project Contact:	Brian Clauto
Spread I: Franklin County	STA 14230+00 – 14250+00 STA 14190+00 – 14200+00 STA 14410+00 – 14310+00	Weather (Wet/Dry/Rain):	Dry

FIELD INSPECTION PHOTO LOG

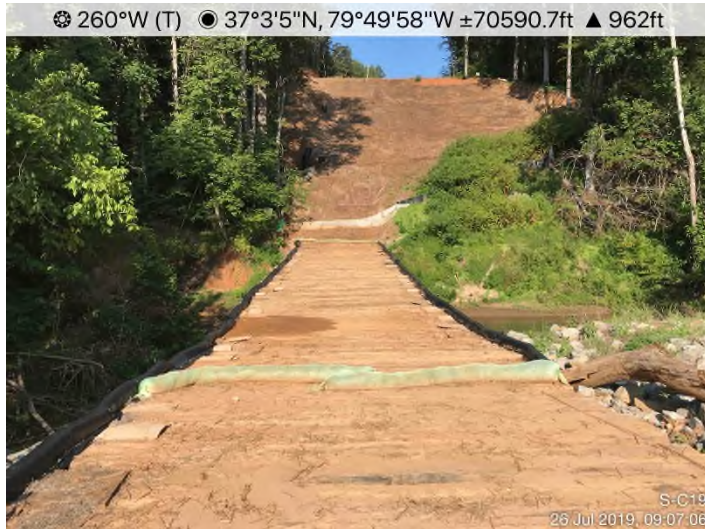
Fig. 1: **Stream S-C19** – Controls in place along Maggodee Creek.

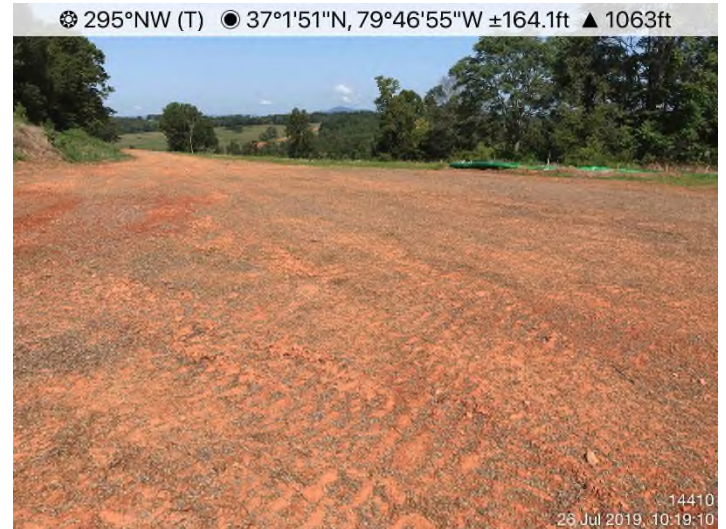
Fig. 2: **STA 14410+00** – ROW stabilized with Earth Guard and Millet.

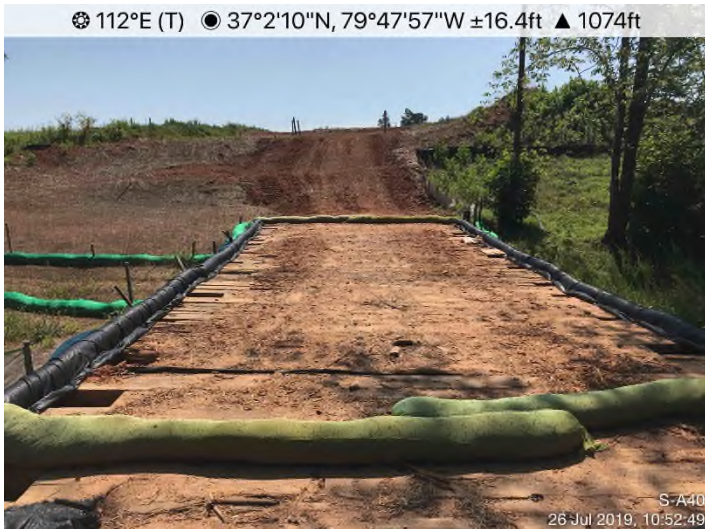
Fig. 3: **Stream S-A40** – Controls in place and functioning properly.

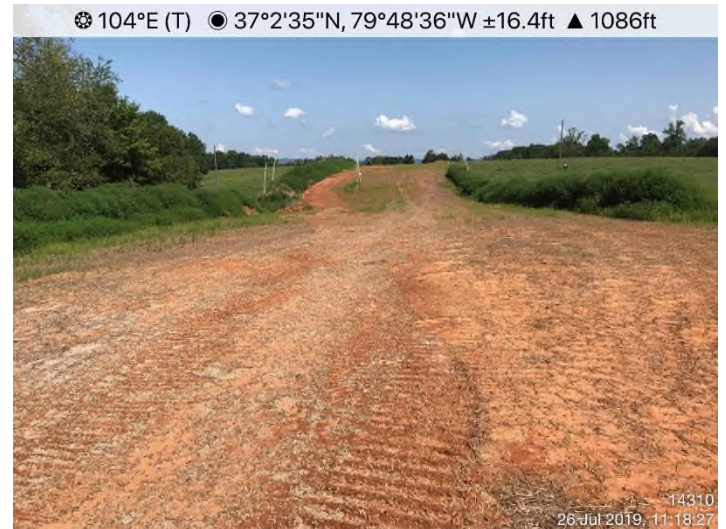
Fig. 4: **STA 14310+00** – ROW stabilized with Earth Guard and millet.
