## FIELD INSPECTION

| <b>Project Name:</b> | Mountain Valley Pipeline | <b>Inspector:</b> | Matthew Grant |
| <b>Inspection Date:</b> | Wednesday, July 24, 2019 | <b>Project Contact:</b> | Brian Clauto |

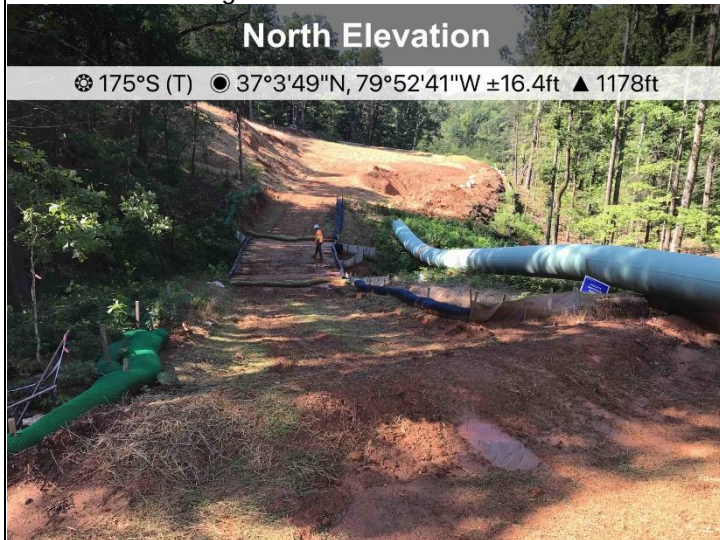
- Fig. 1 Designated stream crossing S-YZ5, ECD's in place and functioning.

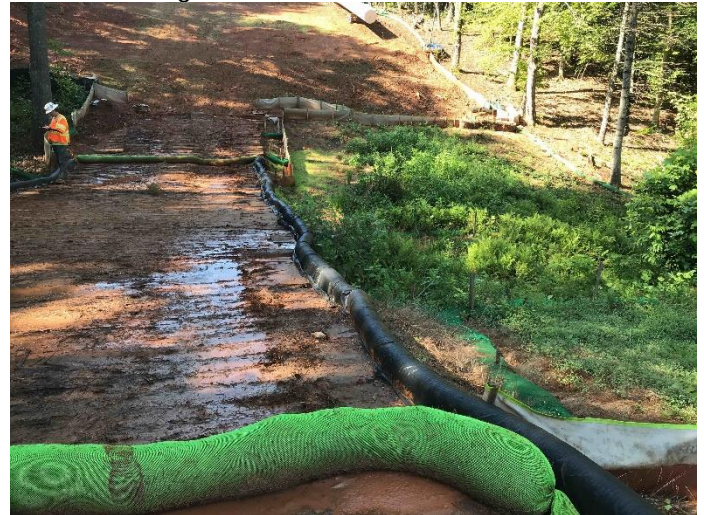
- Fig. 2 Designated stream crossing S-YZ4, ECD's in place and functioning.

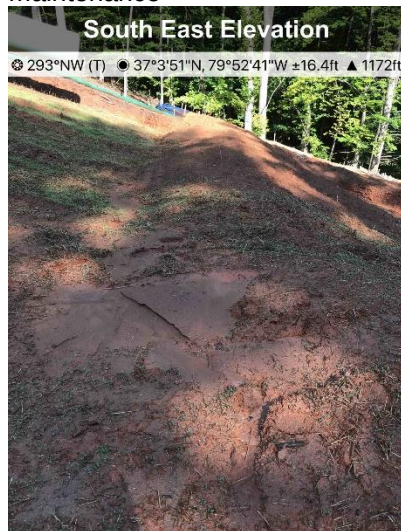
- Inspected designated stream included: S-YZ4, S-YZ5, S-IJ10
- Designated stream S-YZ4 and S-YZ5 have been cleaned of impacts.
- St14061-14043 requires additional stabilization of stockpiles and lower section of 2 tone on ROW noted on 7-18-19 inspection report.
- St14049+00 water bar flow path requires maintenance

- Fig. 3 St14049+00 water bar flow path requires maintenance

**Recommended Corrective Action:** Maintain controls per the approved plan and annual standard and specs.

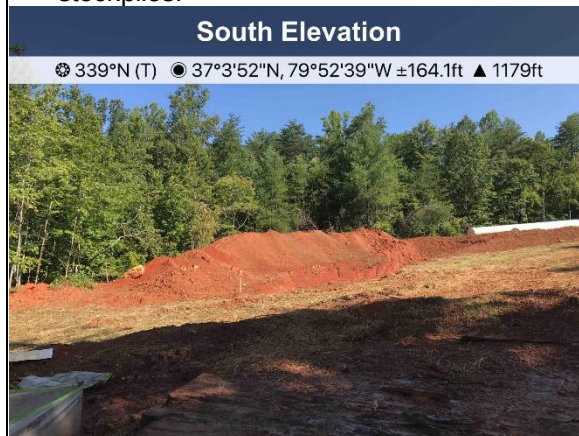
- Fig. 4 St14061-14043 requires additional stabilization of stockpiles.

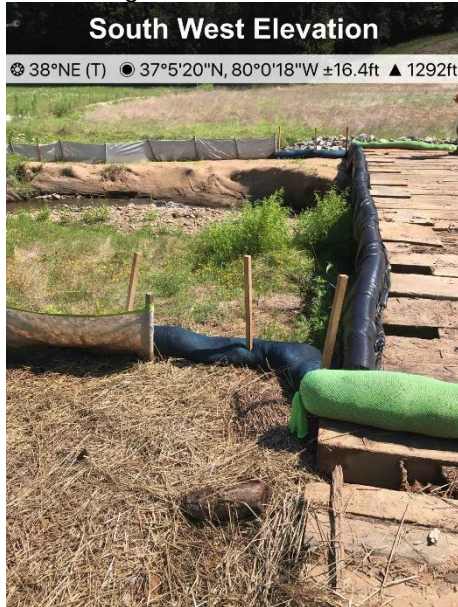
Fig. 5 Designated stream S-IJ10 ECD's and bridge in place and functioning.

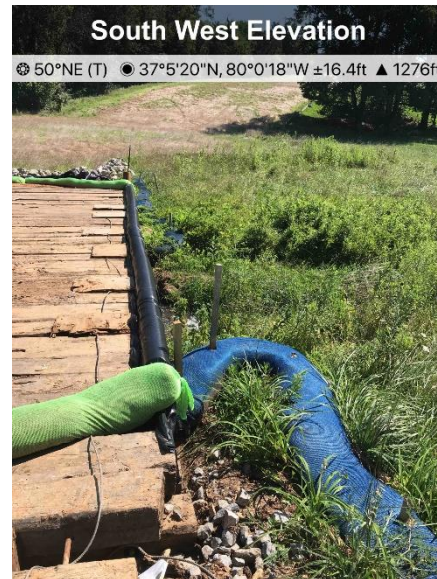
Fig. 6 Designated stream S-IJ10 ECD's and bridge in place and functioning
