## FIELD INSPECTION

| Project Name: | Mountain Valley Pipeline | Inspector: | Marshall Willis |
| Spread H:<br>Roanoke County | STA 12950+00 – 12973+43<br>MVP-RO-288 | Weather (Wet/Dry/Rain): | Dry |

## FIELD INSPECTION PHOTO LOG

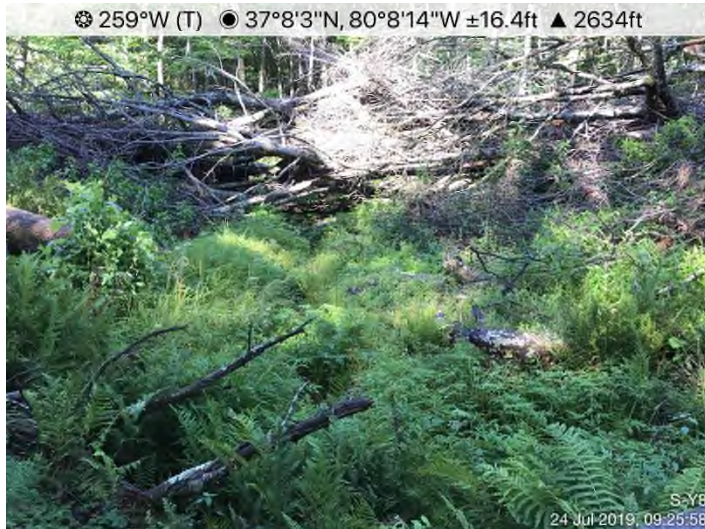
Fig. 1: **Stream S-Y8** – No ground disturbance. Trees flush cut and bridged over stream.

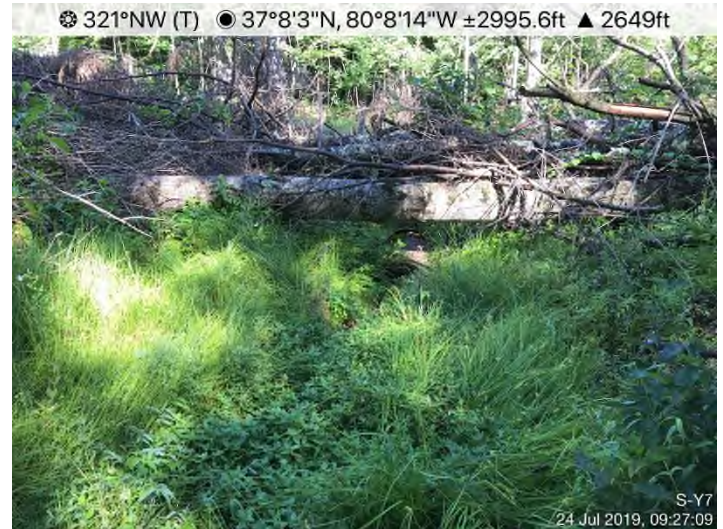
Fig. 2: **Stream S-Y7** – No ground disturbance. Trees flush cut and bridged over stream.

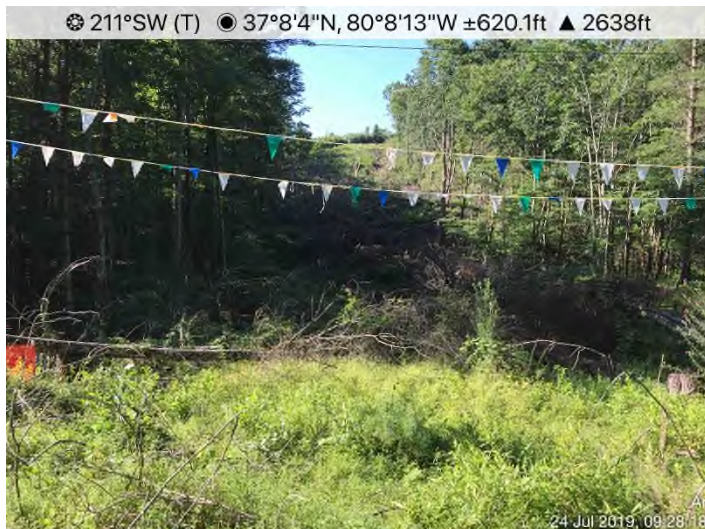
Fig. 3: **STA 12957+30** – No ground disturbance at MVP-RO-287 looking SW.

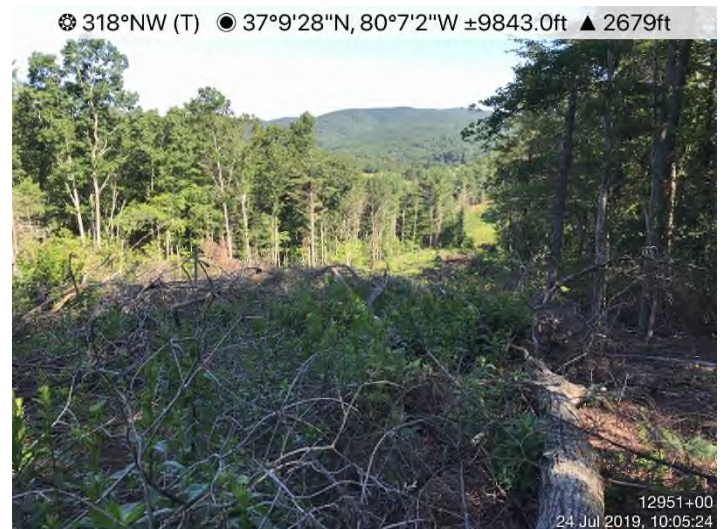
Fig. 4: **STA 12951+00** – No ground disturbance. Looking NW.
