## FIELD INSPECTION

| <b>Project Name:</b> | Mountain Valley Pipeline | <b>Inspector:</b> | Matthew Grant |
| <b>Inspection Date:</b> | Thursday, July 18, 2019 | <b>Project Contact:</b> | Brian Clauto |

## FIELD INSPECTION PHOTO LOG

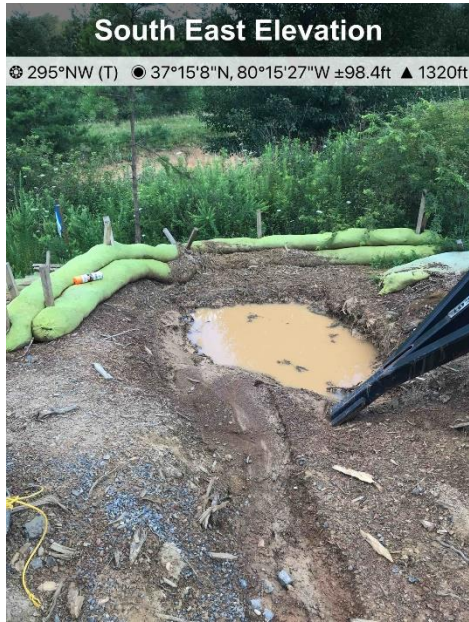
- Inspected designated streams included: S-001, S-C21, S-G26, S-G27, W-RR4, S-II4
- St12199 sump requires maintenance
- S-G26 & S-G27 bridge sidewalls require maintenance

- Fig. 1 St12199 sump requires maintenance

**Recommended Corrective Action:** Maintain controls per the approved plan and annual standard and specs.

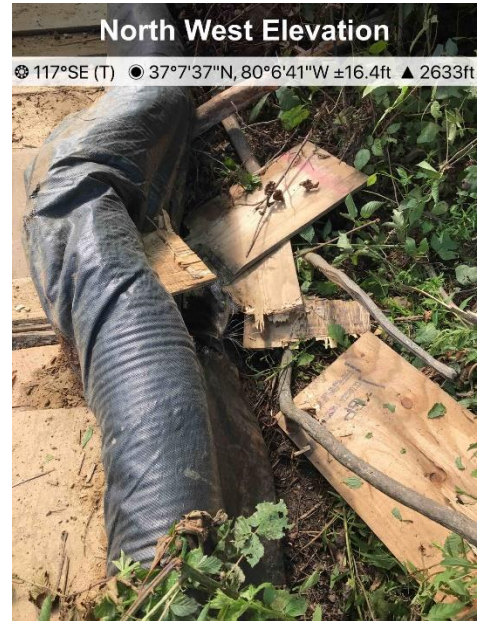
- Fig. 2 S-G26 & S-G27 bridge sidewalls require maintenance

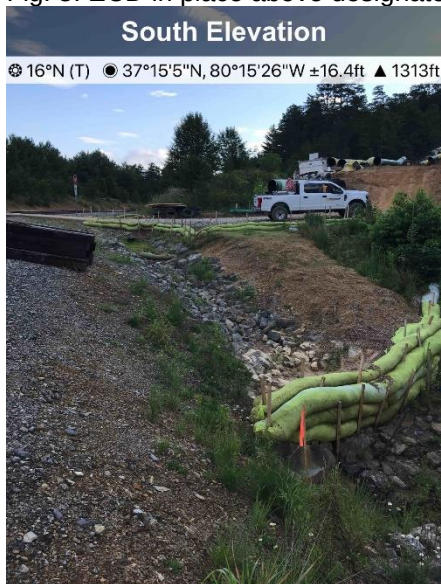
- Fig. 3. ECD in place above designated stream S-C21
