## FIELD INSPECTION

| <b>Project Name:</b> | Mountain Valley Pipeline | <b>Inspector:</b> | Matthew Grant |
| <b>Inspection Date:</b> | Wednesday, July 17, 2019 | <b>Project Contact:</b> | Brian Clauto |

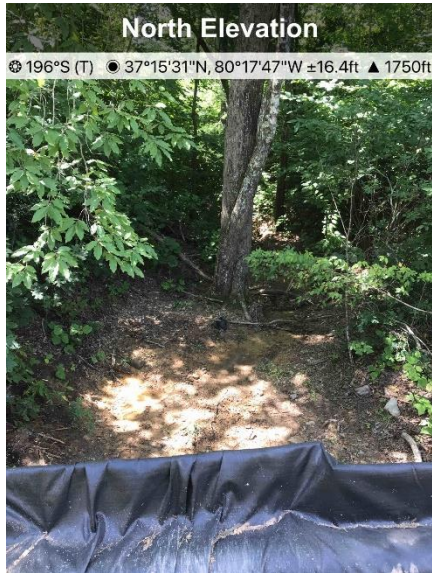
- Fig. 1 Designated stream MM-15 shows signs of sediment in stream

**Recommended Corrective Action:** Maintain controls per the approved plan and annual standard and specs, remove sediment per DEQ approval.

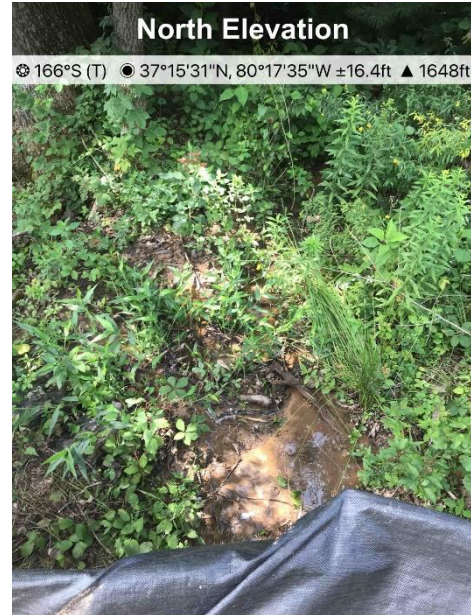
- Fig. 2 Designated stream MM-14 shows signs of sediment in stream

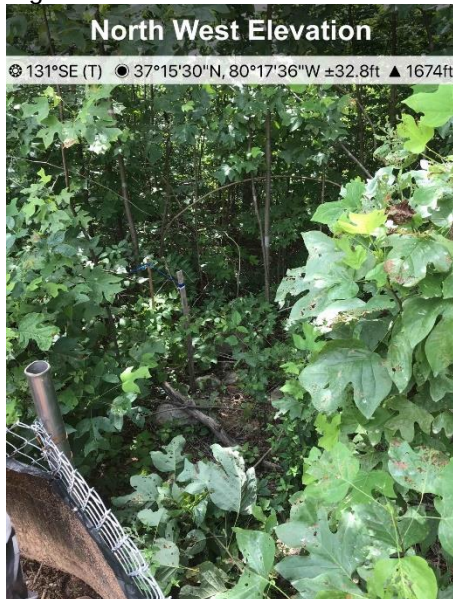
- Fig. 3. St12086 sediment is off the ROW

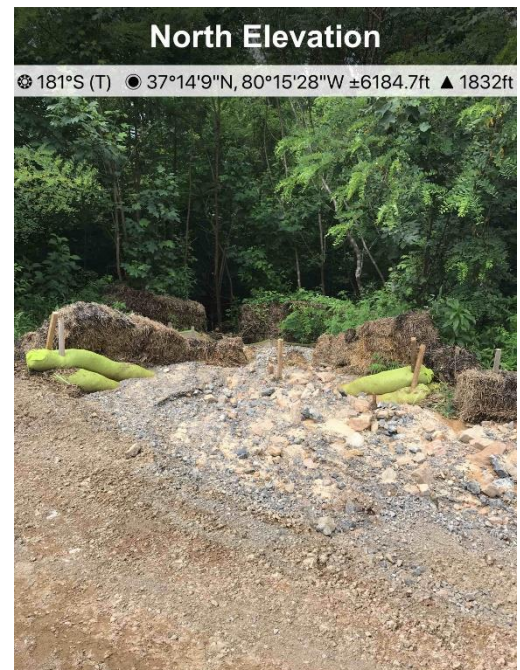
- Fig. 4. FR290 ECD requires repair

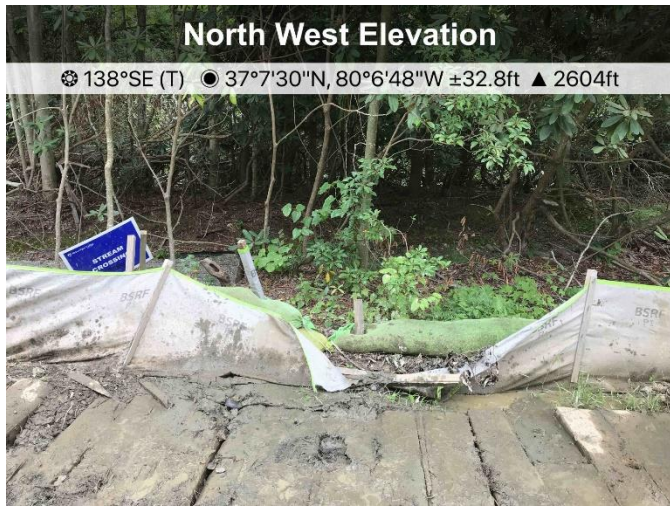
- Fig. 5 FR 290 P1 requires maintenance
