## FIELD INSPECTION

| <b>Project Name:</b> | Mountain Valley Pipeline | <b>Inspector:</b> | Marshall Willis |
| <b>Inspection Date:</b> | Monday, July 15, 2019 | <b>Project Contact:</b> | Brian Clauto |

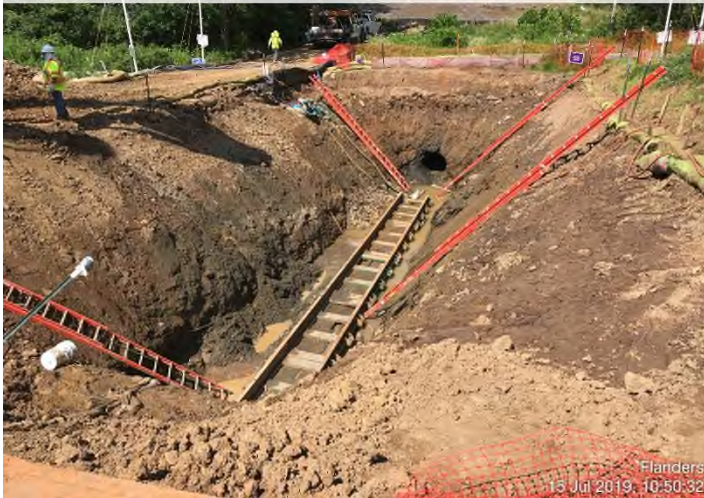
Fig. 1: **Stream S-II4** – GAS borepit for S-II4. Pumps have secondary containment. Trench dewatering to sediment bag inside dewatering structure.

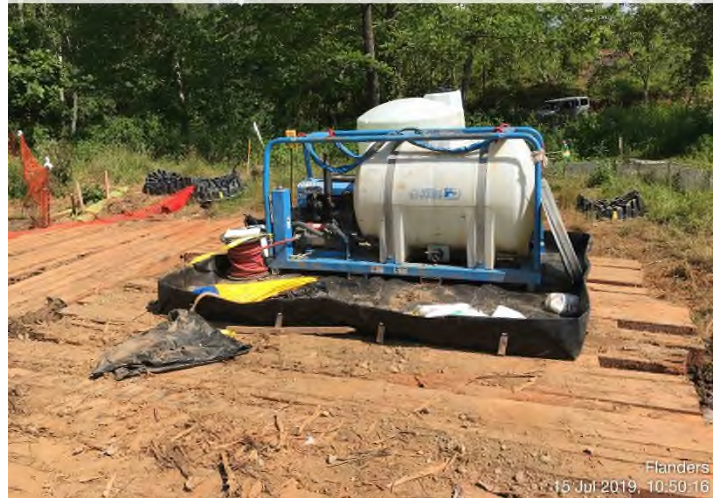
Fig. 2: **STA 13262+25** – Secondary containment structures intact and functioning as designed.

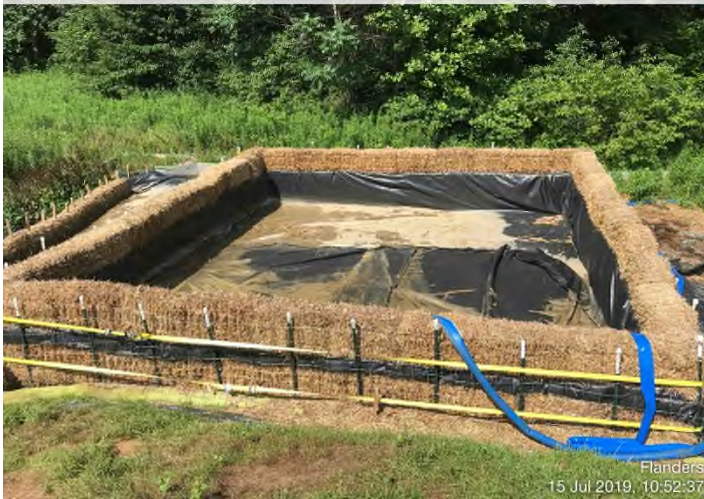
Fig. 3: **ATWS 1055** – Dewatering structure for GAS of conventional bore pit. Sediment bags are clean, filter structure intact and dewatering to stabilized area.

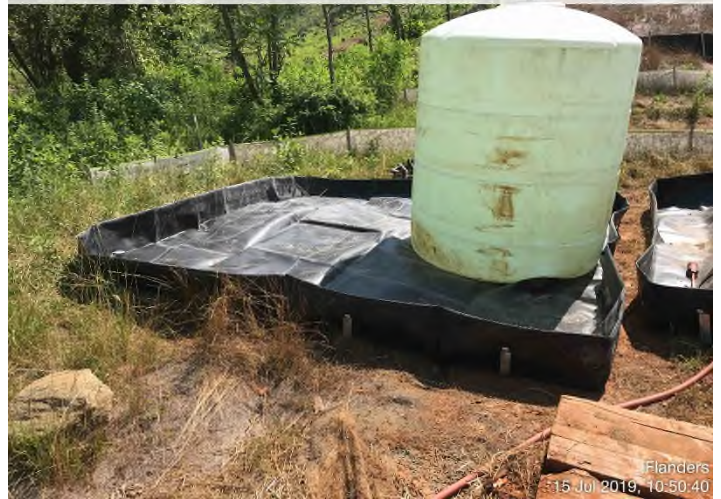
Fig. 4: **STA 13262+25** – Secondary containment structures intact and functioning as designed.

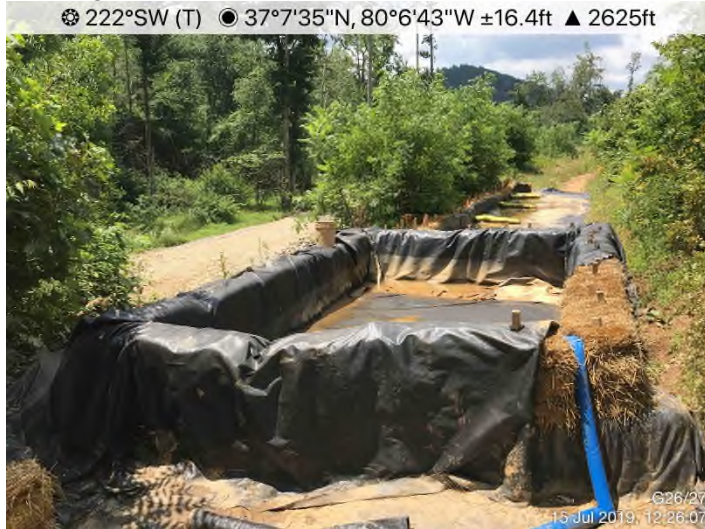
Fig. 5: **Stream S-G26** – Dewatering structure for CIS of conventional bore pit. Sediment bags functioning inside de-watering structure.

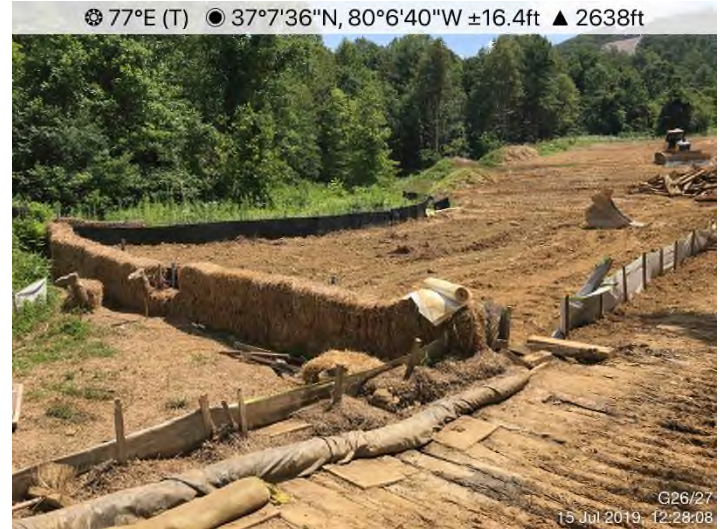
Fig. 6: **Stream S-G27** – Re-establish and stabilize 50' buffer needed for S-G27.

- STA 13063+10: (S-G27) Re-establish and stabilize 50' buffer zone.
- ATWS 344: Repair CFS end-treatment.
- ATWS 344: Repair CFS end-treatment and sump.
- STA 13064+82: Repair P1.
- STA 13063+64: Repair P1.

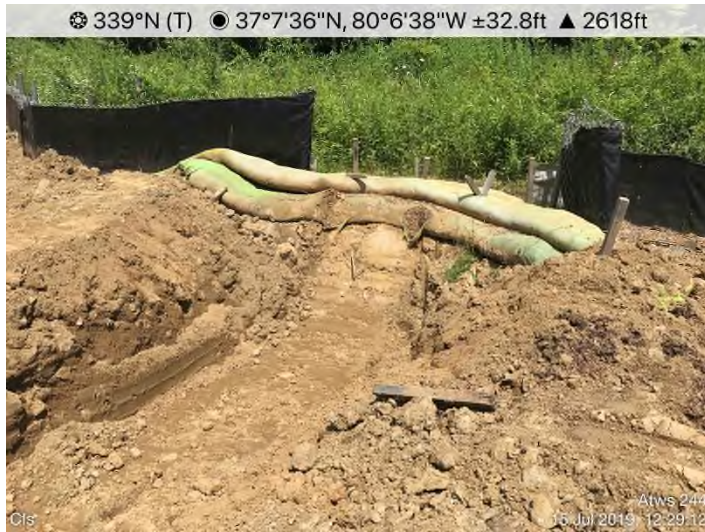
Fig. 7: **ATWS 344** – CFS repairs needed.

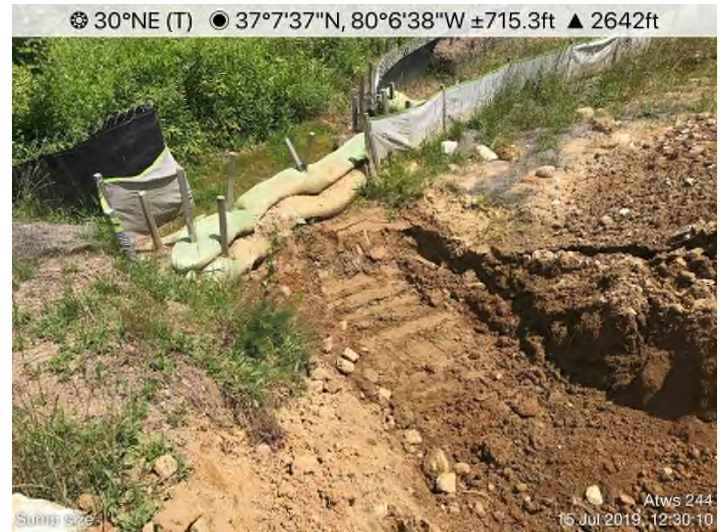
Fig. 8: **ATWS 344** – CFS repairs needed. Sump inadequate sizing.

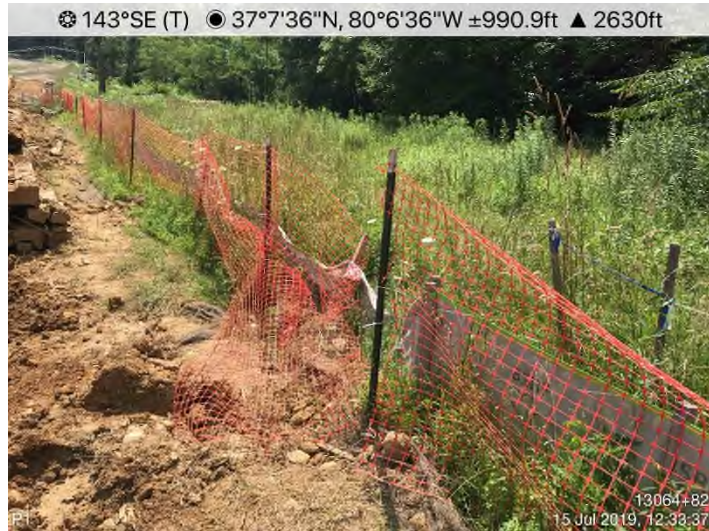
Fig. 9: **STA 13064+82** – P1 in repair needed.

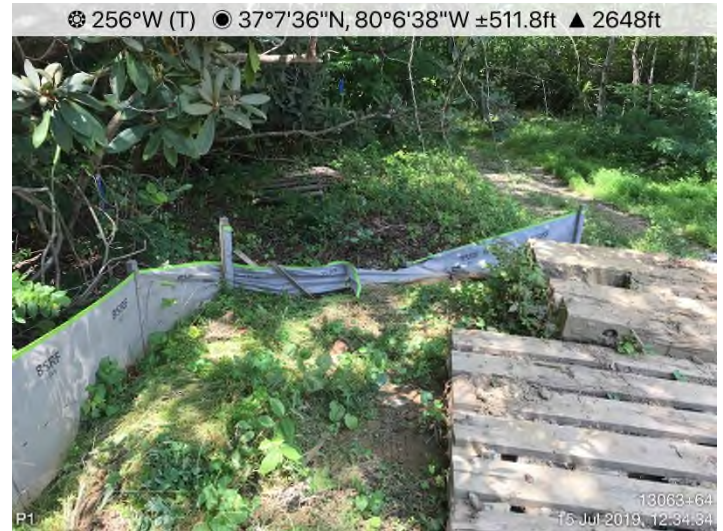
Fig. 10: **STA 13063+64** – P1 in repair needed.
