## FIELD INSPECTION

| Project Name: | Mountain Valley Pipeline | Inspector: | Marshall Willis |
| Inspection Date: | Thursday, July 11, 2019 | Project Contact: | Brian Clauto |

## FIELD INSPECTION PHOTO LOG

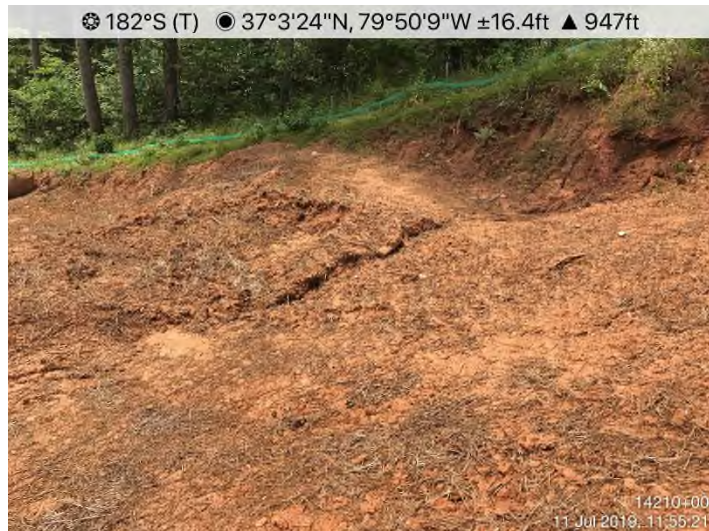
Fig. 1: **STA 14210+00 to 14213+75** – Inadequate stabilization. Repair rill erosion and stabilize.

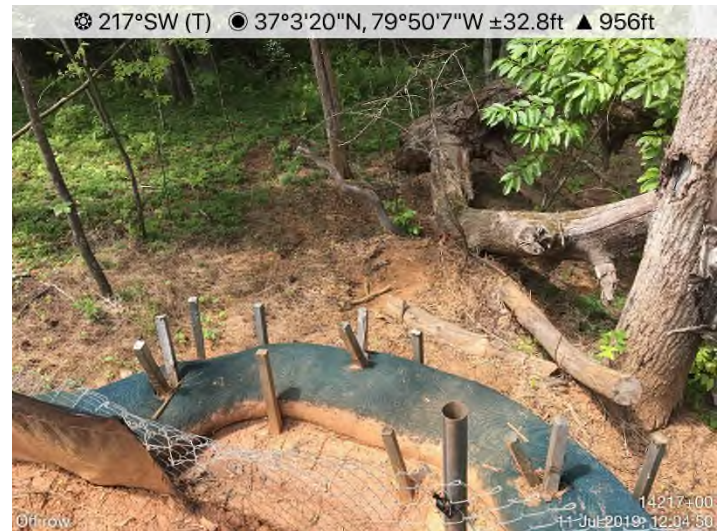
Fig. 2: **STA 14217+00** – Sediment off ROW.

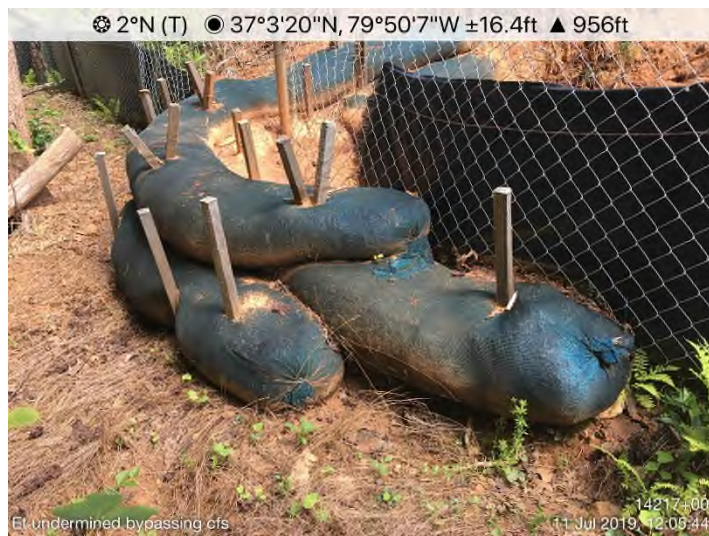
Fig. 3: **STA 14217+00** – End treatment undermined.

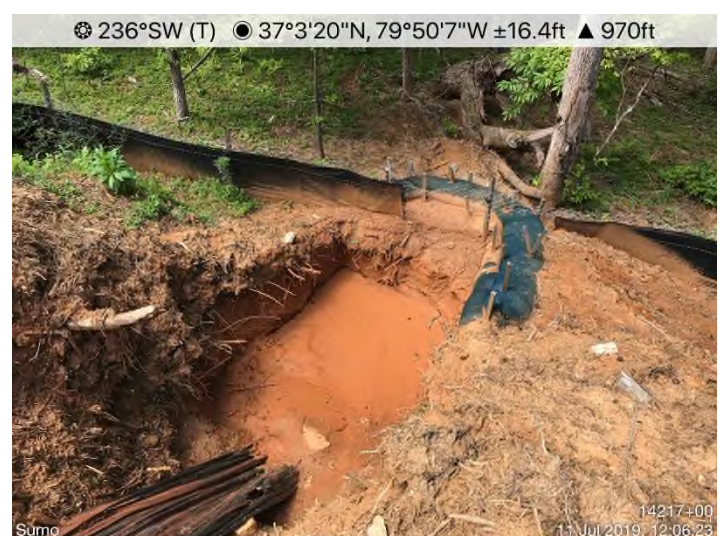
Fig. 4: **STA 14217+00** – Sump maintenance needed.

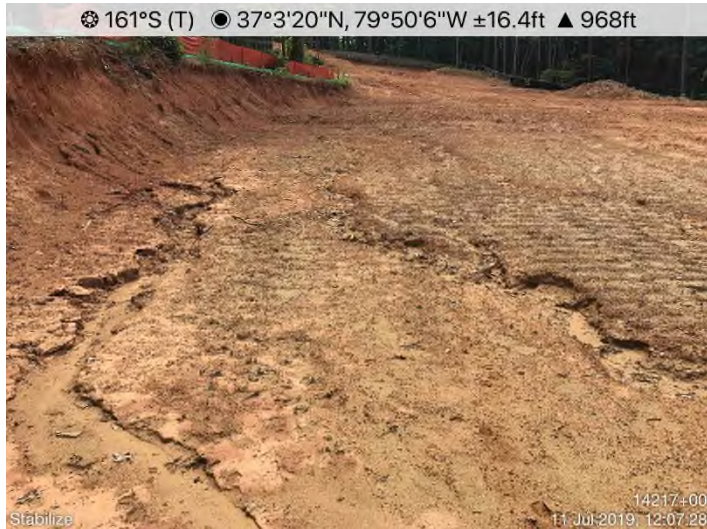
Fig. 5: **STA 14216+00 to 14223+41** – Inadequate stabilization. Repair rill erosion and stabilize.

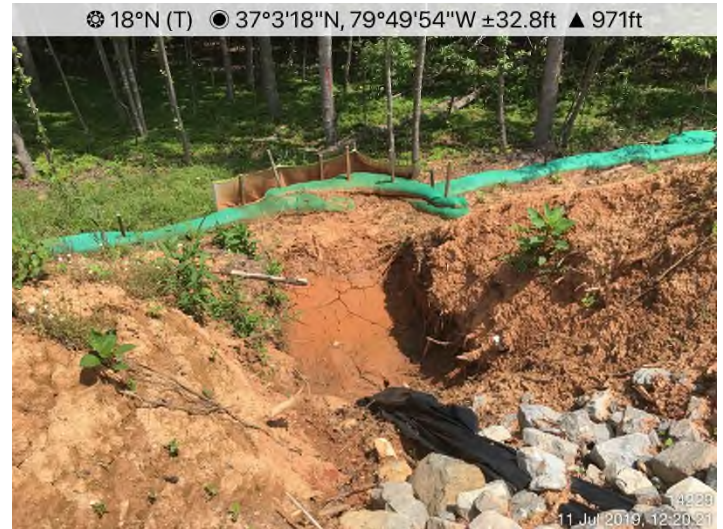
Fig. 6: **STA 14229+00** – Sump maintenance needed.

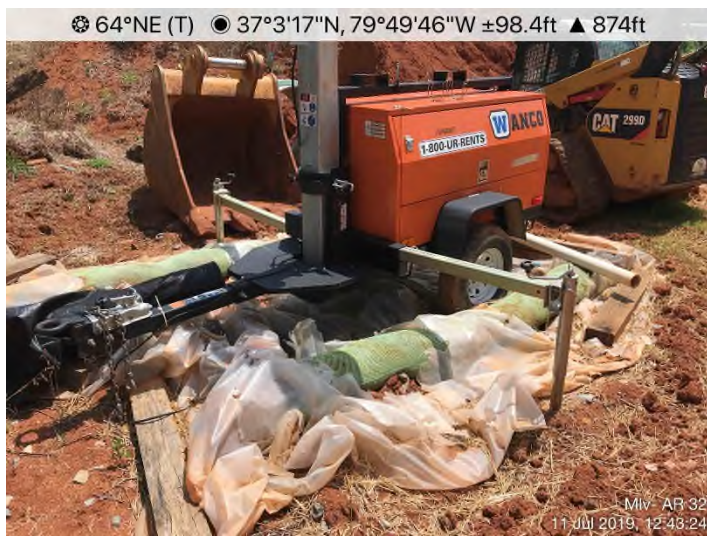
Fig. 7: **MVP-MLV-AR-23** – Repair secondary containment structure.
