## FIELD INSPECTION

| <b>Project Name:</b> | Mountain Valley Pipeline | <b>Inspector:</b> | Matthew Grant |
| <b>Inspection Date:</b> | Thursday, July 11, 2019 | <b>Project Contact:</b> | Brian Clauto |

## FIELD INSPECTION PHOTO LOG

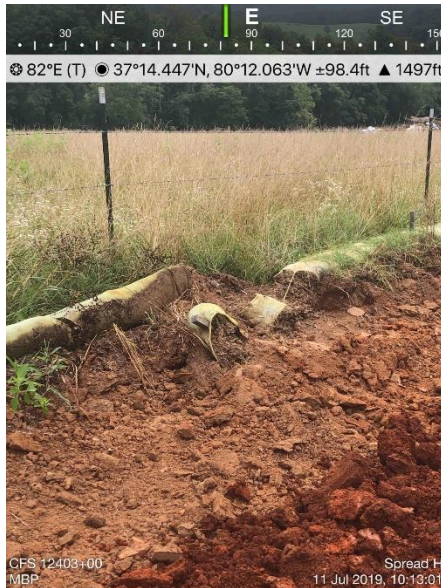
- Inspected designated stream included: S-OO16
- ECD's were in place and no impacts were observed at S-OO16 stream.
- 2 areas of CFS on MN 276.03 are torn and require repair.
- St12403 CFS torn and requires repair
- St12406 CFS torn and requires repair

Fig. 1 CFS torn at St 12403

**Recommended Corrective Action:** Maintain controls per the approved plan and annual standard and specs.

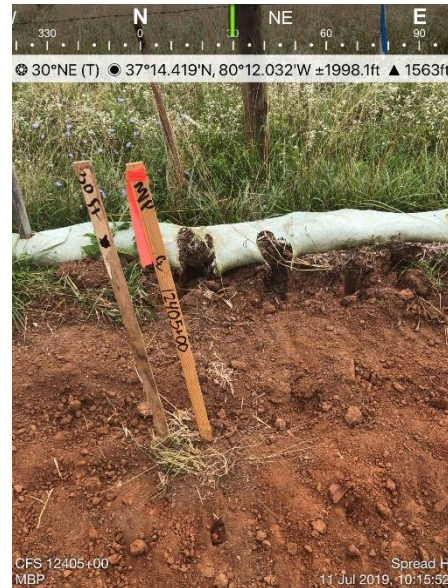
Fig. 2 CFS torn at St12405

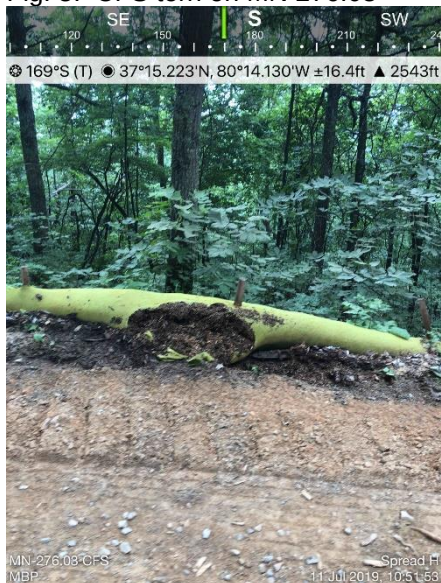
Fig. 3. CFS torn on MN 276.03

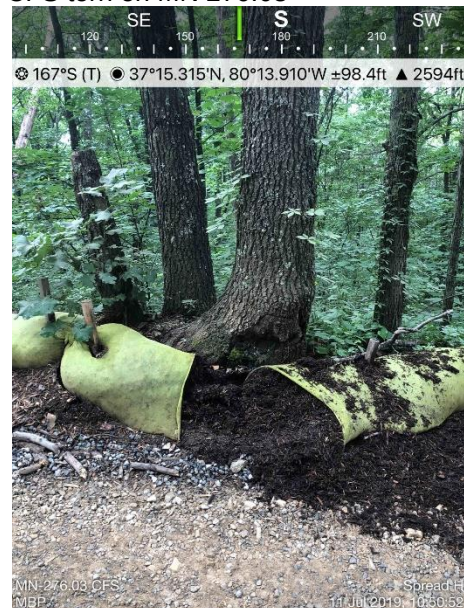
Fig. 4. CFS torn on MN 276.03
