## FIELD INSPECTION

| Project Name: | Mountain Valley Pipeline | Inspector: | Marshall Willis |
| Inspection Date: | Friday, June 28, 2019 | Project Contact: | Brian Clauto |
| Spread I:<br>Pittsylvania County | STA 15296+00 – 15370+62<br>STA 15647+03 – 15648+03 | Weather (Wet/Dry/Rain): | Dry |

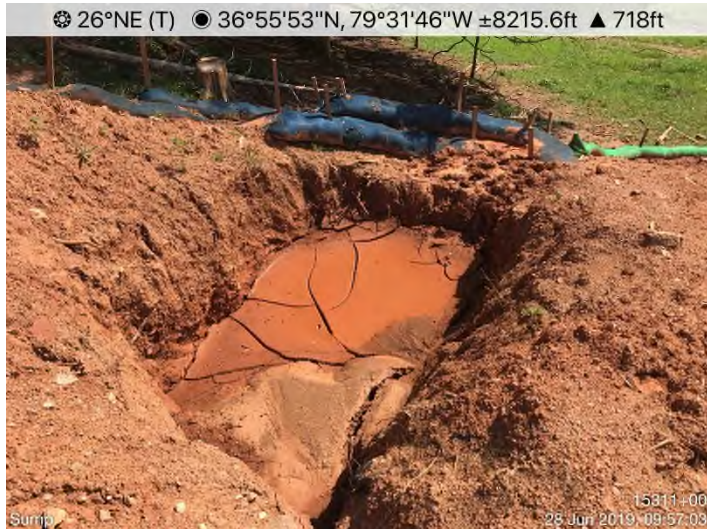
Fig. 1: **STA 15310+50 to 15311+50** – Sump/end treatment maintenance needed.

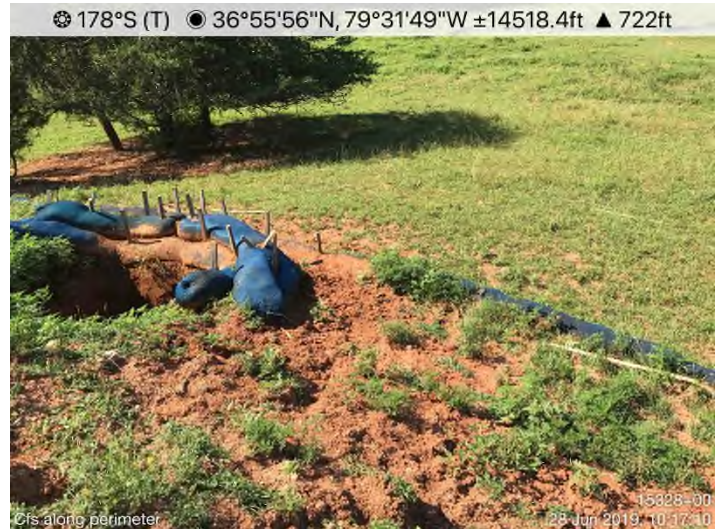
Fig. 2: **STA 15328+00** – Perimeter CFS maintenance needed.

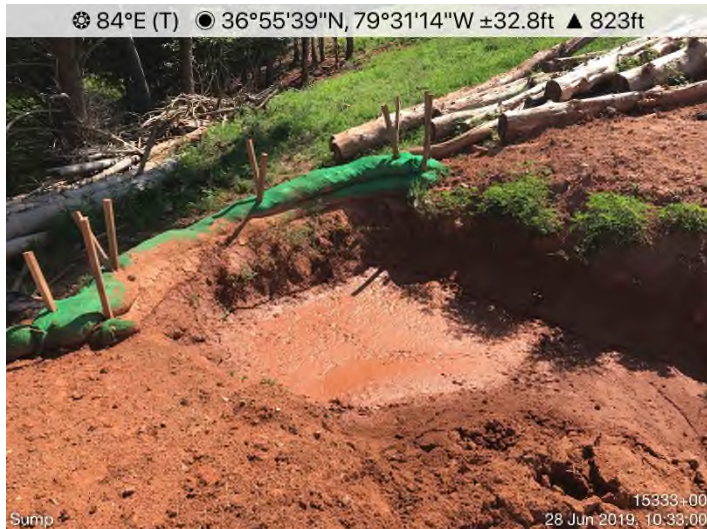
Fig. 3: **STA 15333+00** – Sump maintenance needed.

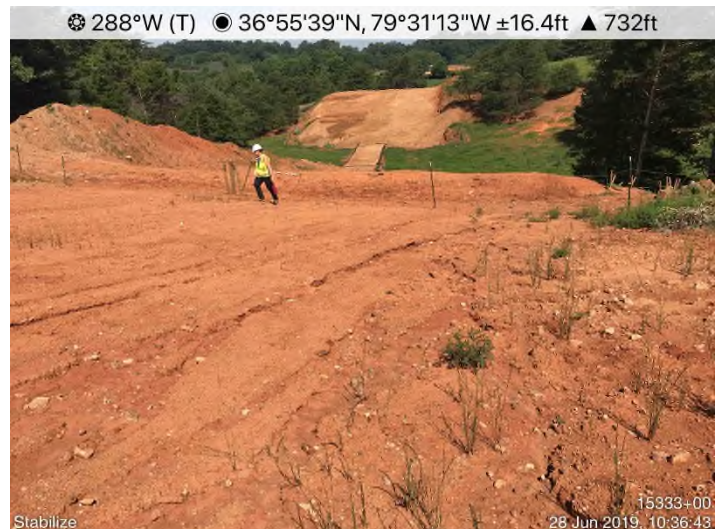
Fig. 4: **STA 15310+00 to 15370+00** – Re-stabilization needed.

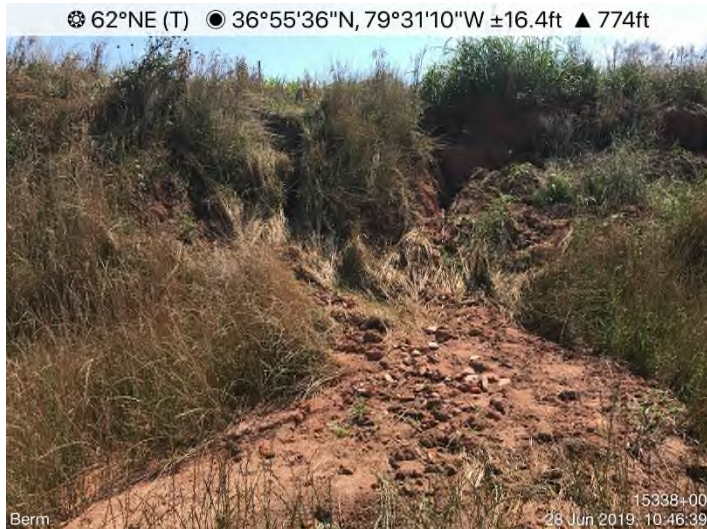
Fig. 5: **STA 15338+00** – Perimeter berm failure at CWD drop inlet.

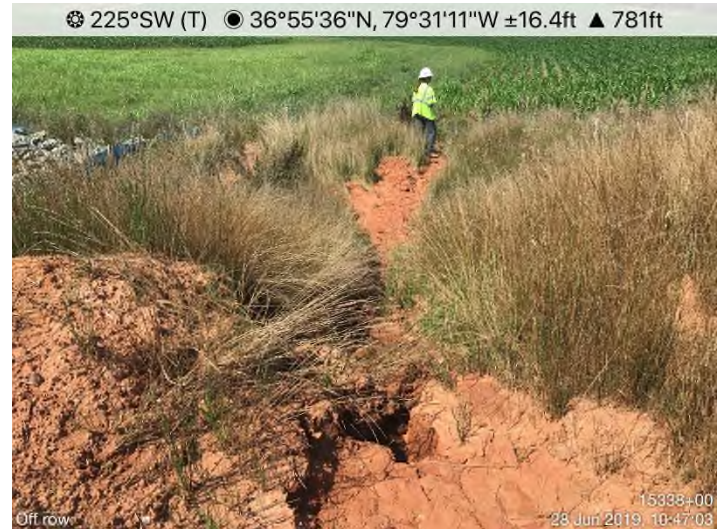
Fig. 6: **STA 15338+00** – Sediment off ROW.

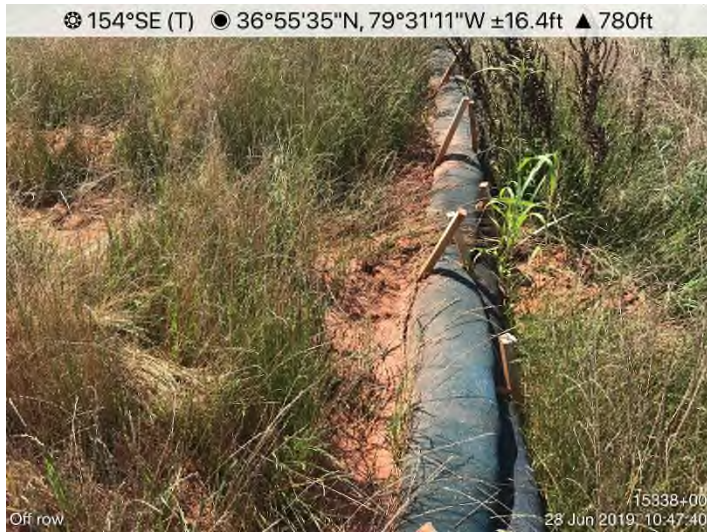
Fig. 7: **STA 15338+00** – CFS maintenance needed.

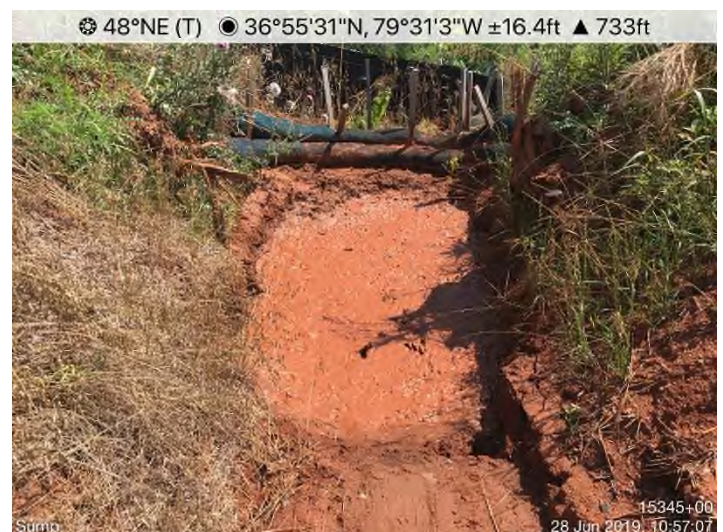
Fig. 8: **STA 15345+00** – Sump maintenance needed.

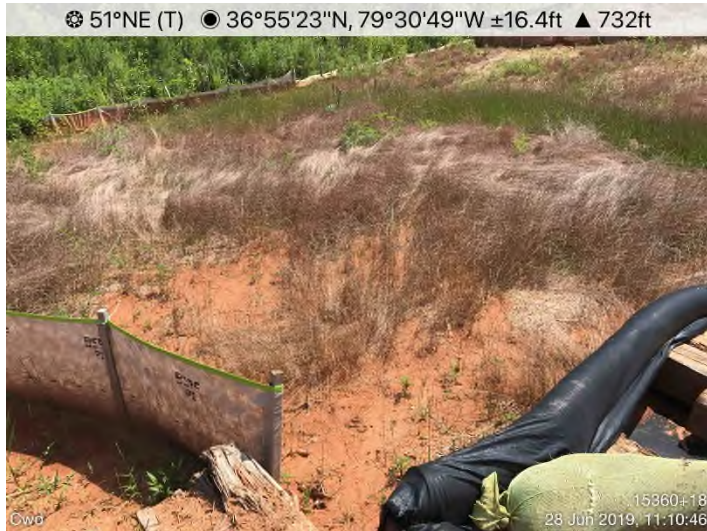
Fig. 9: **STA 15360+18** – Onsite sediment discharging into CWD swale.
