## FIELD INSPECTION

| <b>Project Name:</b> | Mountain Valley Pipeline | <b>Inspector:</b> | Marshall Willis |
| <b>Inspection Date:</b> | Thursday, June 27, 2019 | <b>Project Contact:</b> | Brian Clauto |
| <b>Spread H:<br/>Montgomery County<br/>Franklin County</b> | STA 12298+05 – 12370+00<br>STA 13060+00 – 13084+00<br>MVP-FR-290<br>MVP-MN-276.03 | <b>Weather (Wet/Dry/Rain):</b> | Dry |

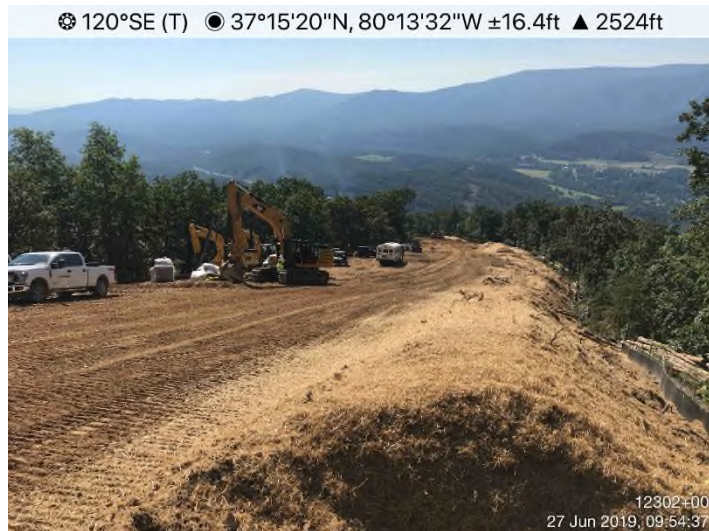
Fig. 1: **STA 12302+00** – Controls in place.

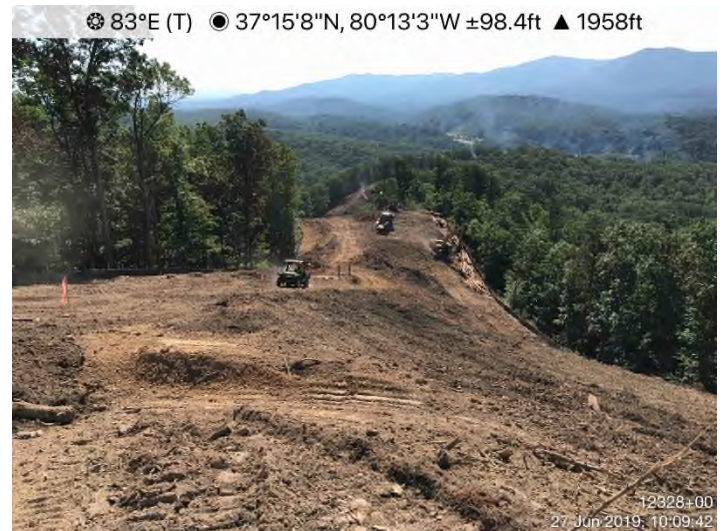
Fig. 2: **STA 12328+00** – Controls in place.

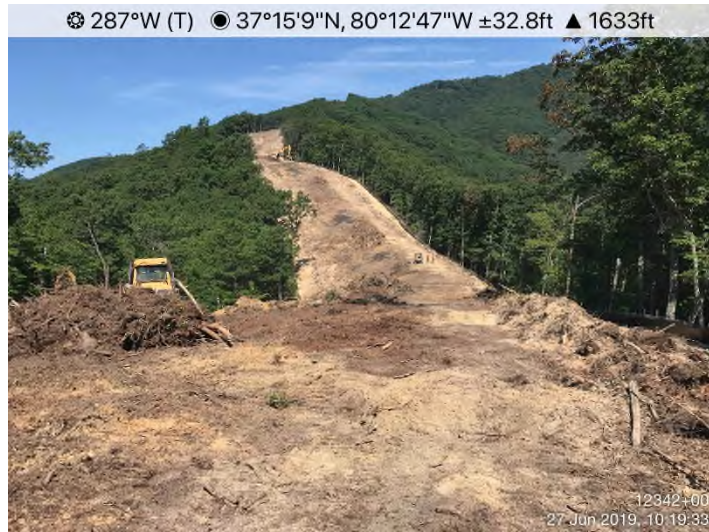
Fig. 3: **STA 12342+00** – Controls in place.

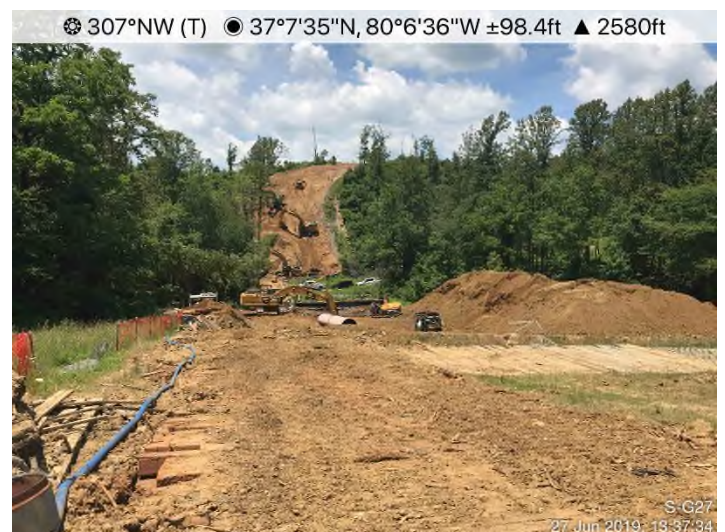
Fig. 4: **STA 13084+00** – Controls in place.
