## FIELD INSPECTION

| <b>Project Name:</b> | Mountain Valley Pipeline | <b>Inspector:</b> | Marshall Willis |
| <b>Inspection Date:</b> | Thursday, June 20, 2019 | <b>Project Contact:</b> | Brian Clauto |

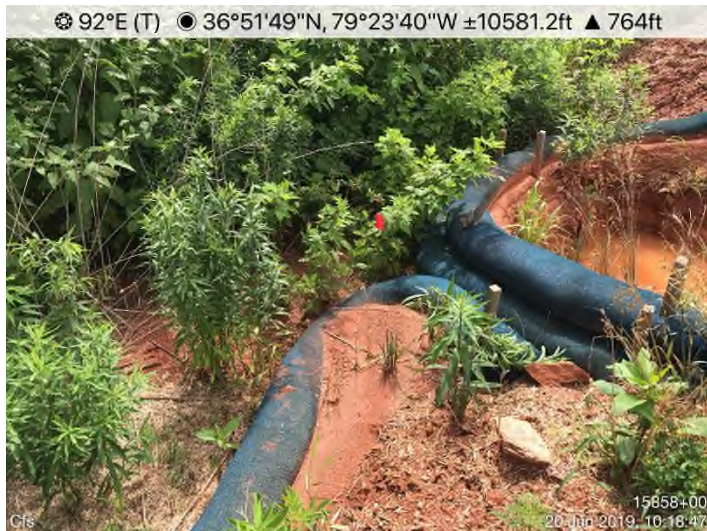
Fig. 1: **STA 15858+00** – CFS maintenance needed.

**Recommended Corrective Action:** Maintain and install all controls per the approved plan and specs.

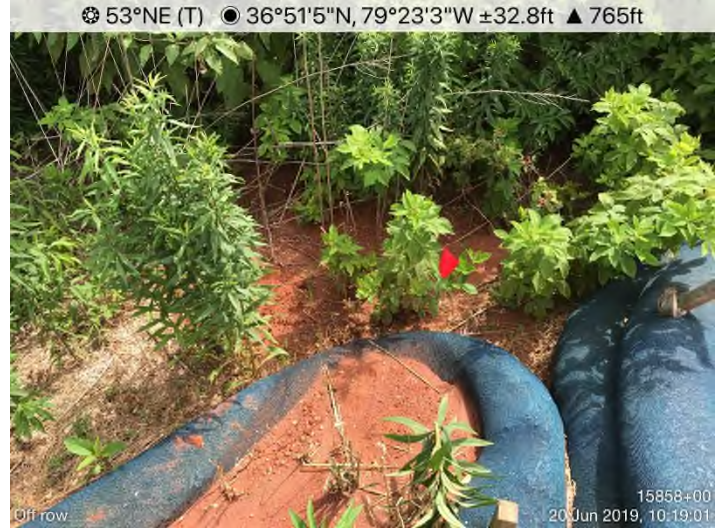
Fig. 2: **STA 15858+00** – Sediment off ROW.

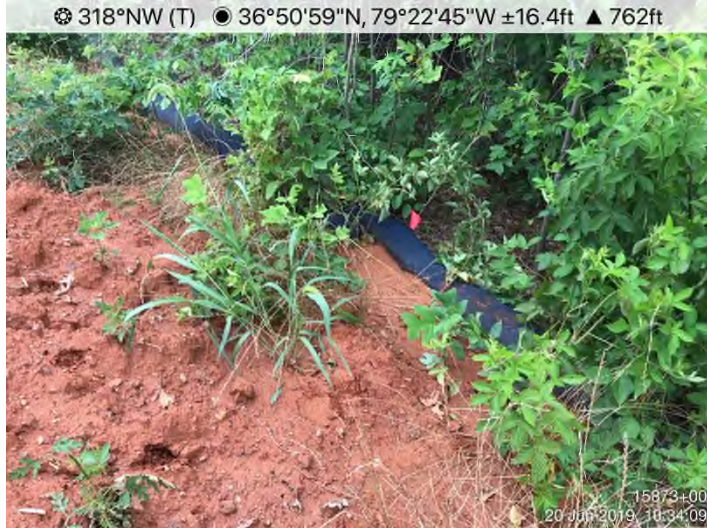
Fig. 3: **STA 15873+00** – CFS maintenance needed.

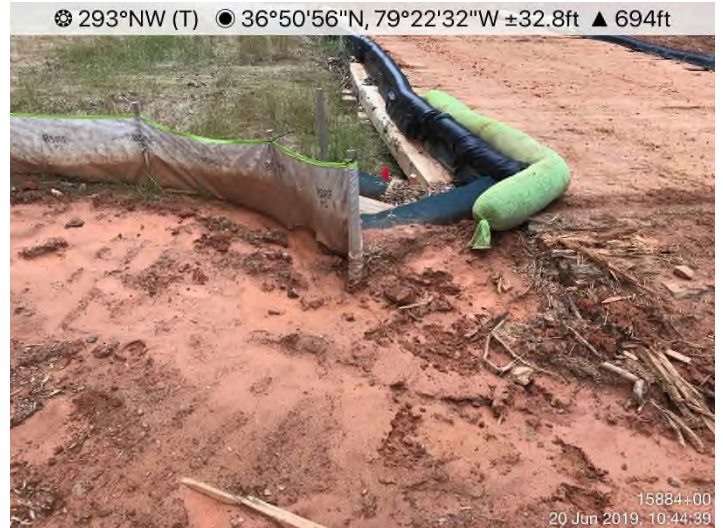
Fig. 4: **STA 15884+00** – CFS maintenance needed.

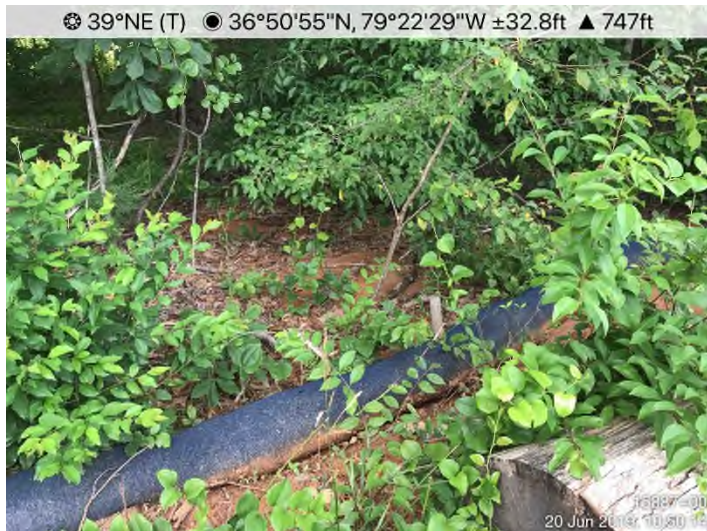
Fig. 5: **STA 15887+00** – Sediment off ROW.

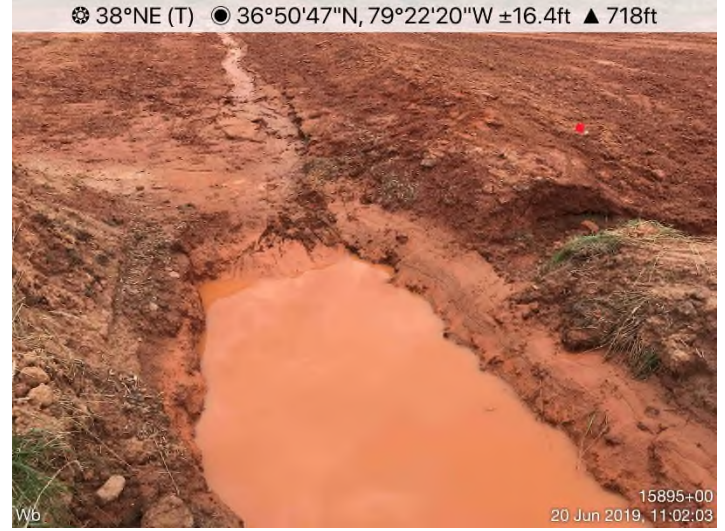
Fig. 6: **STA 15895+00** – Waterbar maintenance needed.

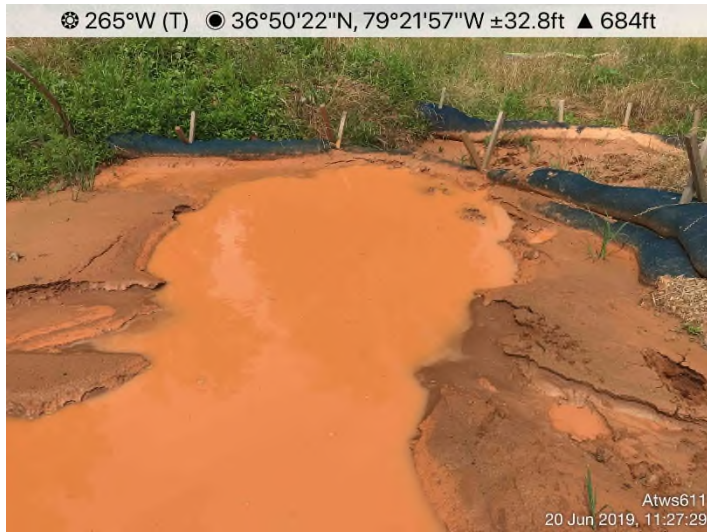
Fig. 7: **ATWS 611** – CFS maintenance needed.

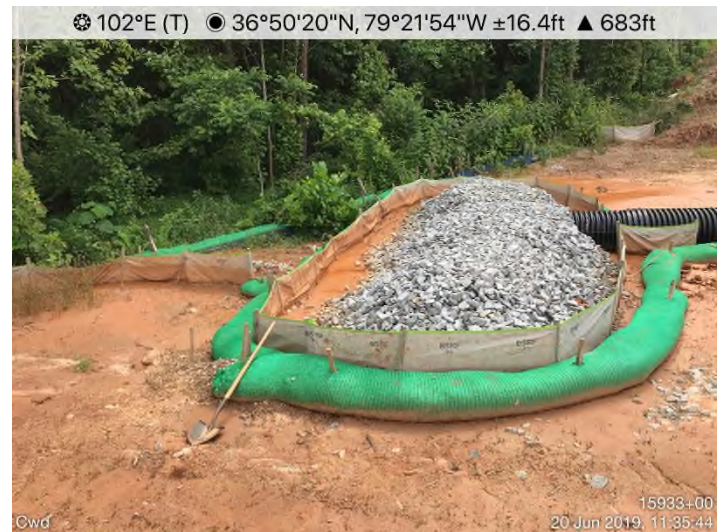
Fig. 8: **STA 15933+00** – Sediment accumulation inside CWD outlet. Inadequate protection from onsite discharge.

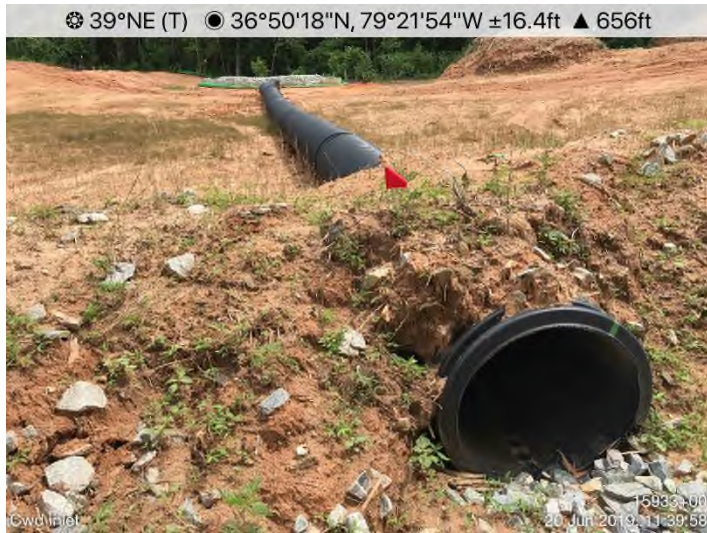
Fig. 9: **STA 15933+00** – CWD inlet not functioning.

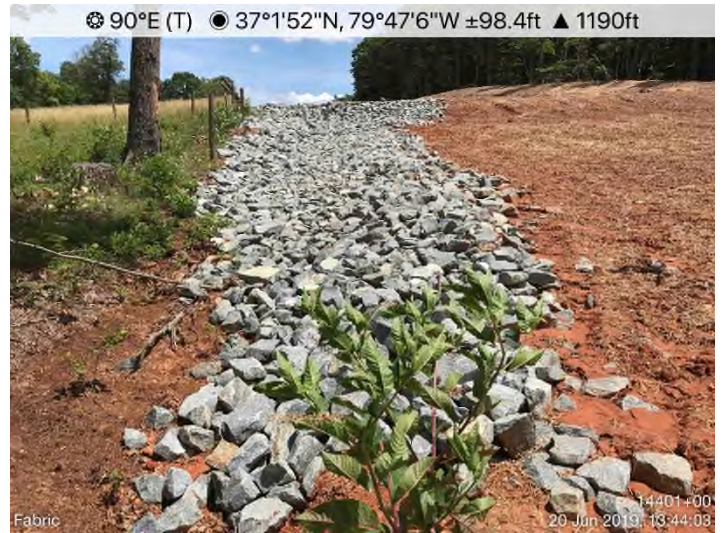
Fig. 10: **STA 14401+00** – Riprap channel does not have fabric underlayment.
