## FIELD INSPECTION

| <b>Project Name:</b> | Mountain Valley Pipeline | <b>Inspector:</b> | Matthew Grant |
| <b>Inspection Date:</b> | Thursday, June 20, 2019 | <b>Project Contact:</b> | Brian Clauto |

## FIELD INSPECTION PHOTO LOG

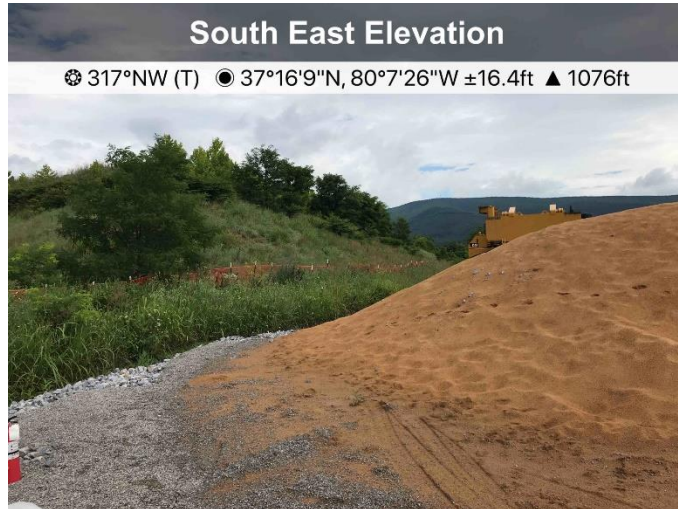
- Inspected designated streams and wetlands included: W-C5, W-C6, S-C29, S-MM31, W-C11, W-C12, S-C36, S-C33, S-NN12.
- Stockpile in laydown yard 049 lacks protection

- Fig. 1 Stockpile in laydown yard 049 lacks protection.

**Recommended Corrective Action:** Maintain all controls per the approved plan and specs and install all controls per the plan.

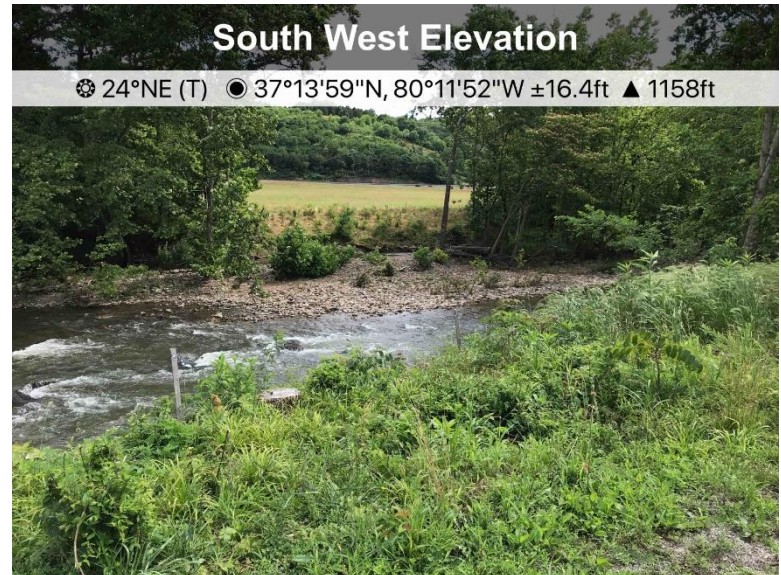
- Fig. 2 No impacts were observed at designated stream S-NN12

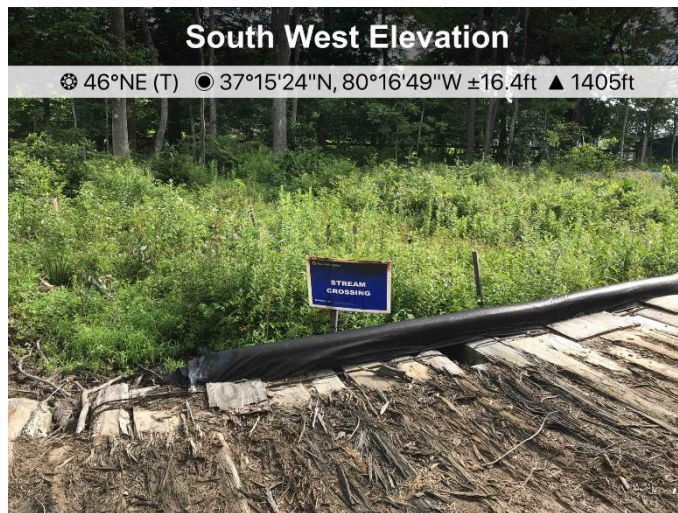
- Fig. 3. No impacts were observed at designated Stream S-MM31

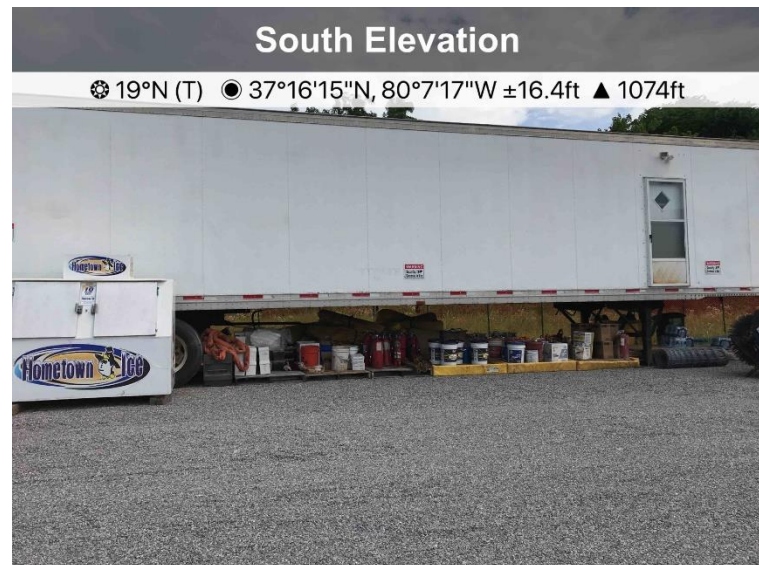
- Fig. 4. Controls in place for chemical storage in laydown yard 049
