## FIELD INSPECTION

| <b>Project Name:</b> | Mountain Valley Pipeline | <b>Inspector:</b> | Matthew Grant |
| <b>Inspection Date:</b> | Wednesday, June 19, 2019 | <b>Project Contact:</b> | Brian Clauto |

## FIELD INSPECTION PHOTO LOG

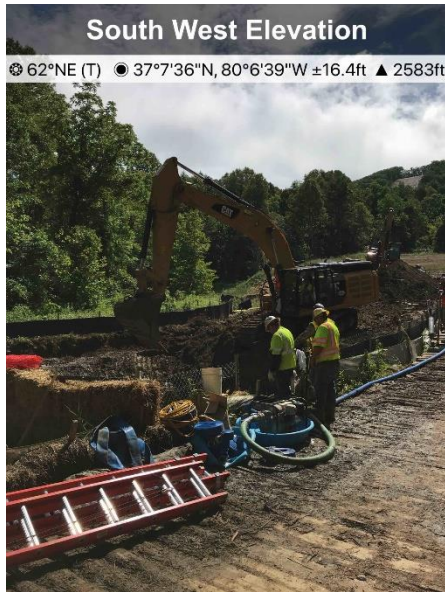
- Fig. 1 ECD controls are in place at the bore pit for designated streams S-G26 & S-G27

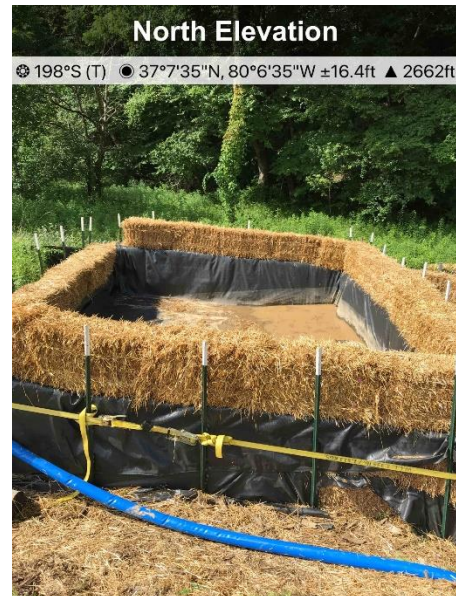
- Fig. 2 ECD dewatering structure in place for bore pit area for designated streams S-G26 & S-G27

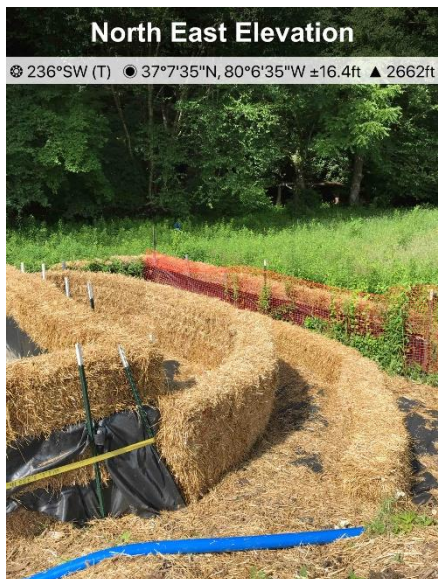
- Fig. 3. ECD dewatering structure in place for bore pit area for designated streams S-G26 & S-G27

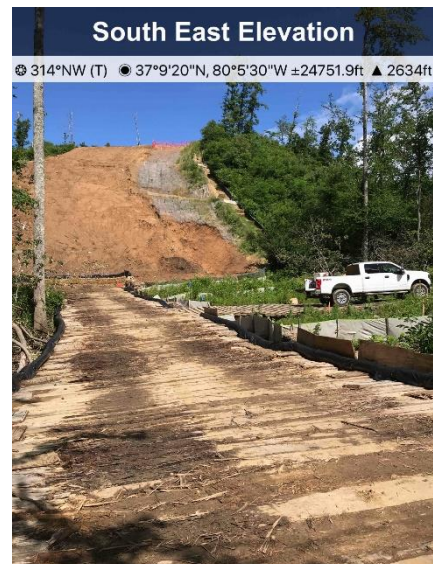
- Fig. 4. ECD controls are in place at designated streams S-G26 & S-G27 and bore pits.
