## FIELD INSPECTION

| <b>Project Name:</b> | Mountain Valley Pipeline | <b>Inspector:</b> | Marshall Willis |
| <b>Inspection Date:</b> | Wednesday, July 10, 2019 | <b>Project Contact:</b> | Brian Clauto |
| <b>Spread H:<br/>Franklin County</b> | STA 13258+74 – 13262+66<br>MVP-FR-293.01<br>ATWS 1055 | <b>Weather (Wet/Dry/Rain):</b> | Dry |

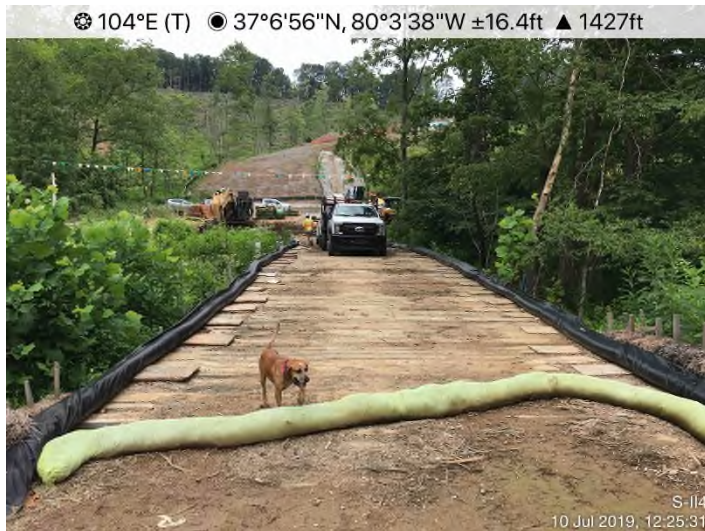
Fig. 1: **Stream S-II4** – Clean bridge with sideboards in place and in good condition.

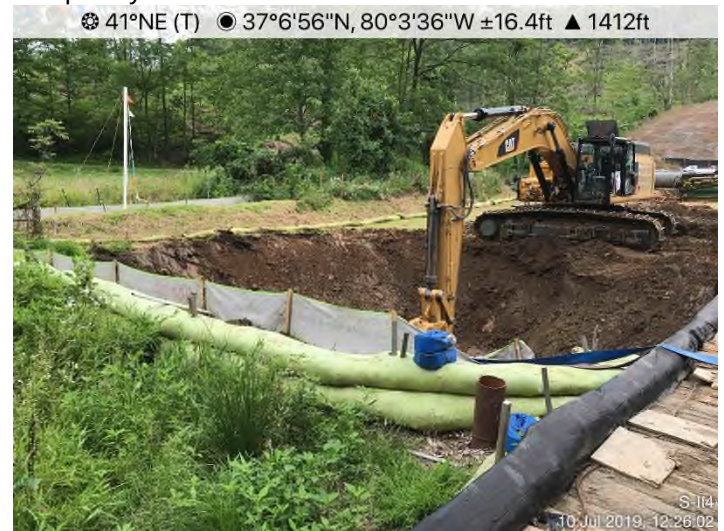
Fig. 2: **Stream S-II4** – GAS bore pit in progress. CFS and P1 in place and functioning properly. Perimeter berms adequately stabilized.

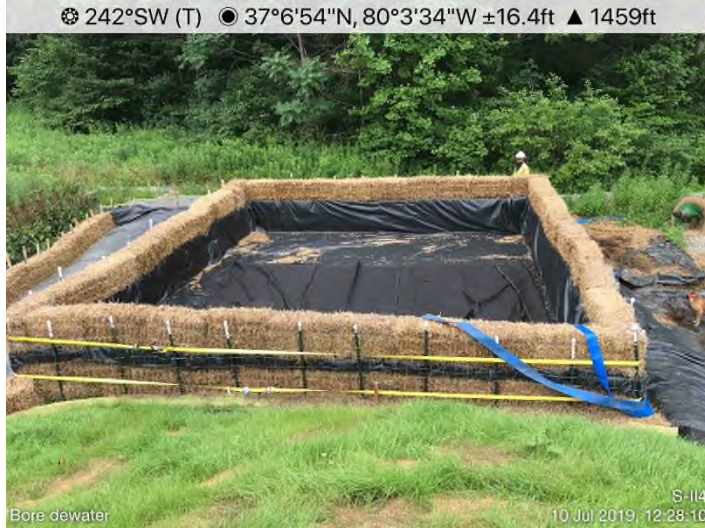
Fig. 3: **ATWS 1055** – Dewatering structure for GAS of conventional bore pit. Sediment bags are clean, filter structure intact and dewatering to stabilized area.

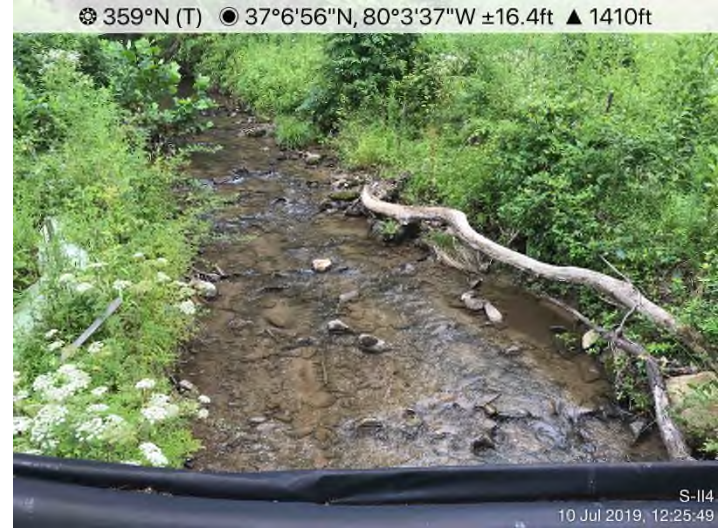
Fig. 4: **Stream S-II4** – Upstream view of stream S-II4 from construction bridge. Bridge sideboards in place and in good condition.
