## FIELD INSPECTION

| <b>Project Name:</b> | Mountain Valley Pipeline | <b>Inspector:</b> | Marshall Willis |
| <b>Inspection Date:</b> | Tuesday, June 18, 2019 | <b>Project Contact:</b> | Brian Clauto |

## FIELD INSPECTION PHOTO LOG

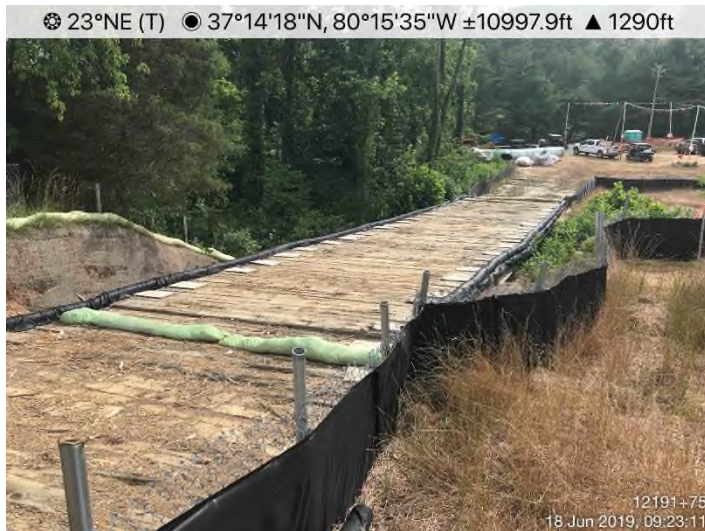
Fig. 1: **Stream S-C21** – Controls in place.

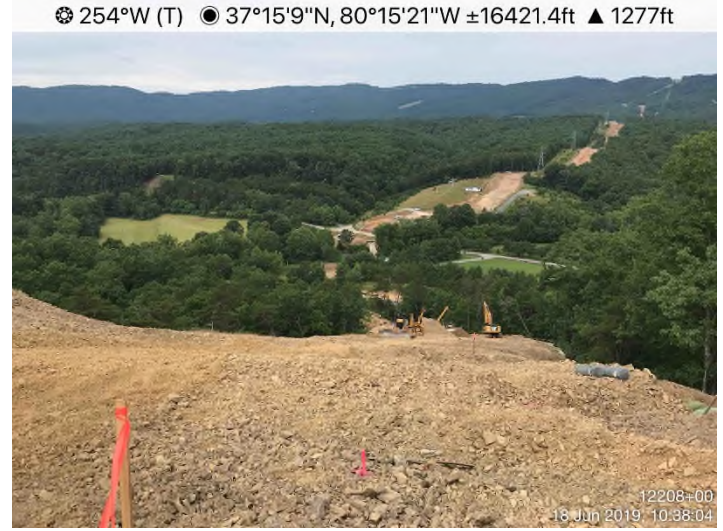
Fig. 2: **STA 12208+00** – Controls in place. Active trenching, stringing and welding.

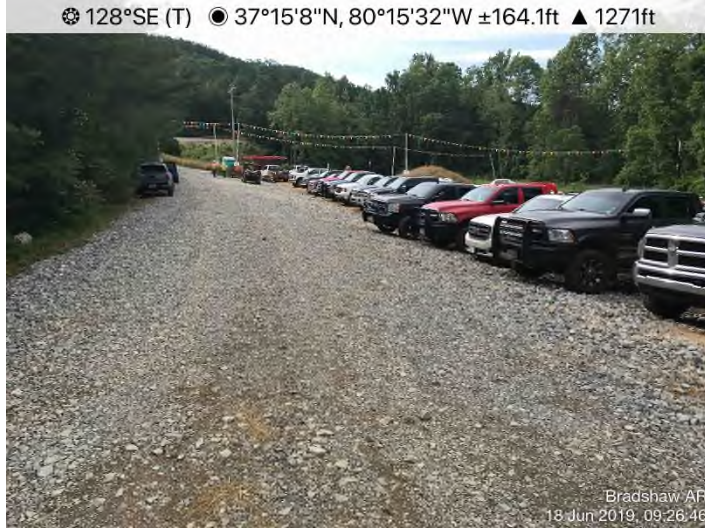
Fig. 3: **MVP-MN-275** – Controls in place.

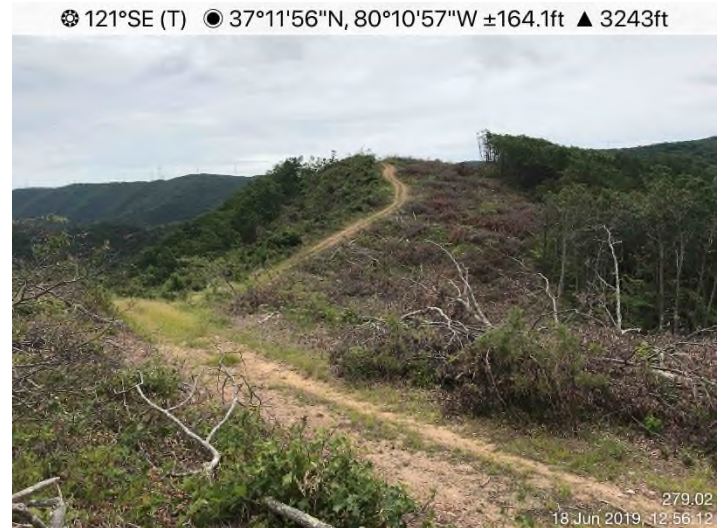
Fig. 4: **MVP-RO-279.02** – No ground disturbance observed.
