## FIELD INSPECTION

| Project Name: | Mountain Valley Pipeline | Inspector: | Marshall Willis |
| Inspection Date: | Wednesday, June 12, 2019 | Project Contact: | Brian Clauto |
| Spread I:<br>Franklin County | STA 14062+17 – 14171+36<br>STA 13415+51 – 13437+75 | Weather (Wet/Dry/Rain): | Wet |

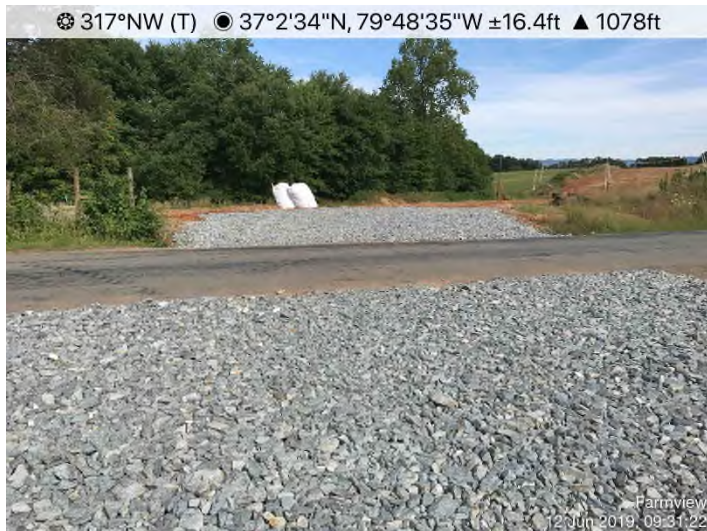
Fig. 1: **STA 13415+51** – Controls in place.

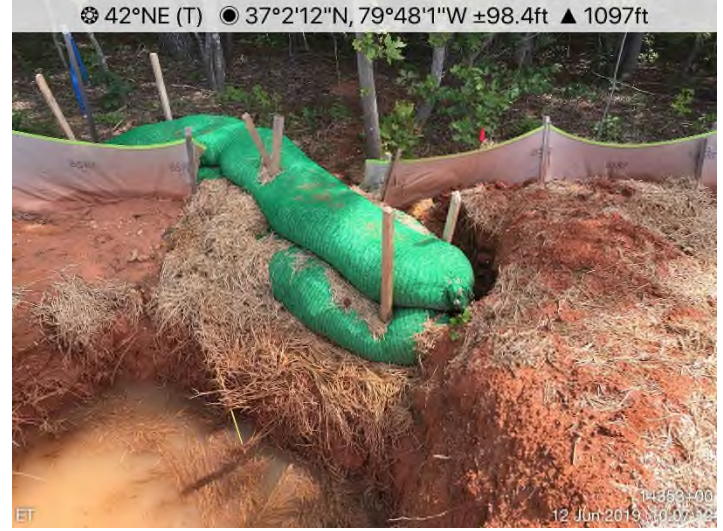
Fig. 2: **STA 14351+00** – Discharge bypassing end treatment.

**Recommended Corrective Action:** Maintain and install all controls per the approved plan and specs.

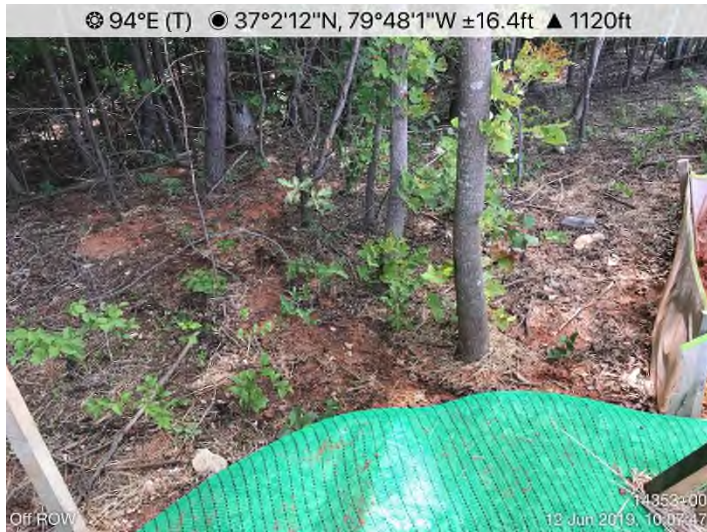
Fig. 3: **STA 14351+00** – Sediment off ROW.

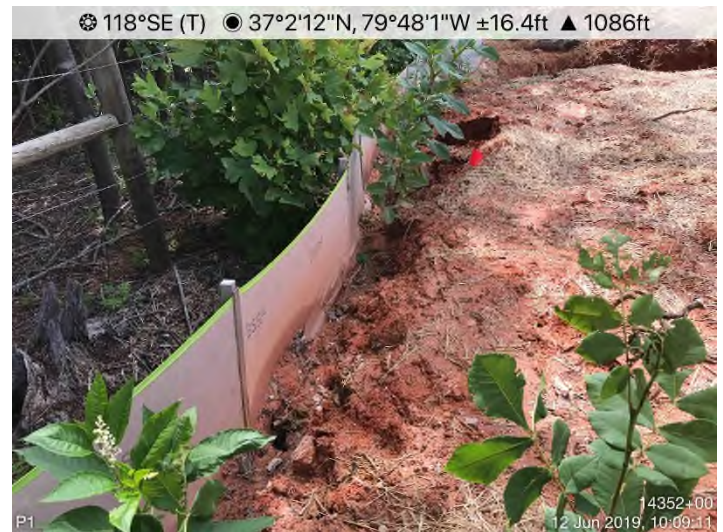
Fig. 4: **STA 14351+00 to 14352+00** – P1 undermined.

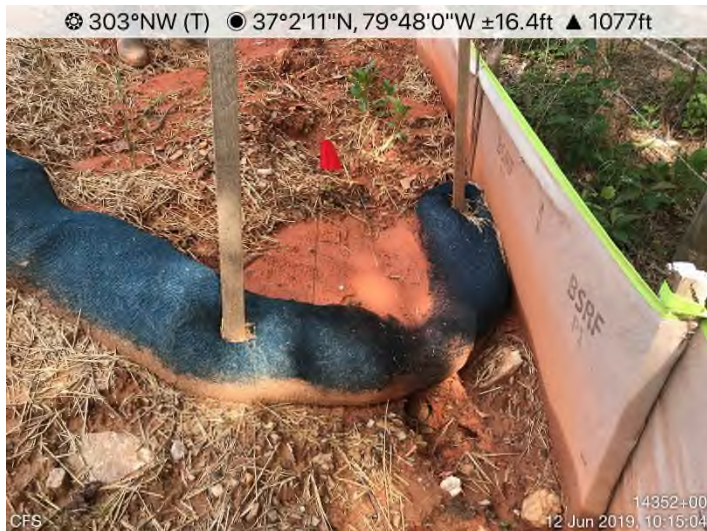
Fig. 5: **STA 14352+00** – CFS requires maintenance.

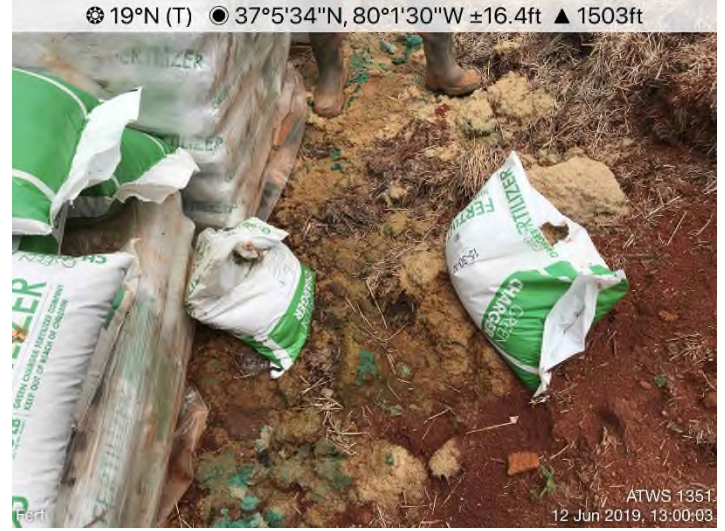
Fig. 6: **ATWS 1351** – Opened fertilizer improperly stored.

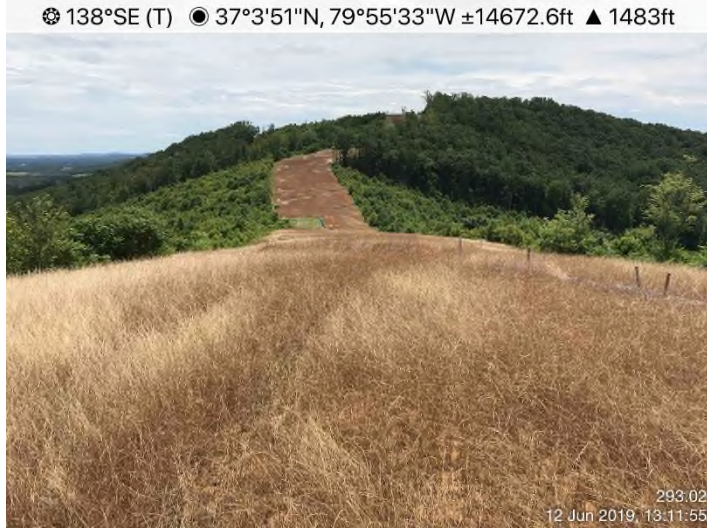
Fig. 7: **STA 13436+00** – Controls in place. Area stabilized.

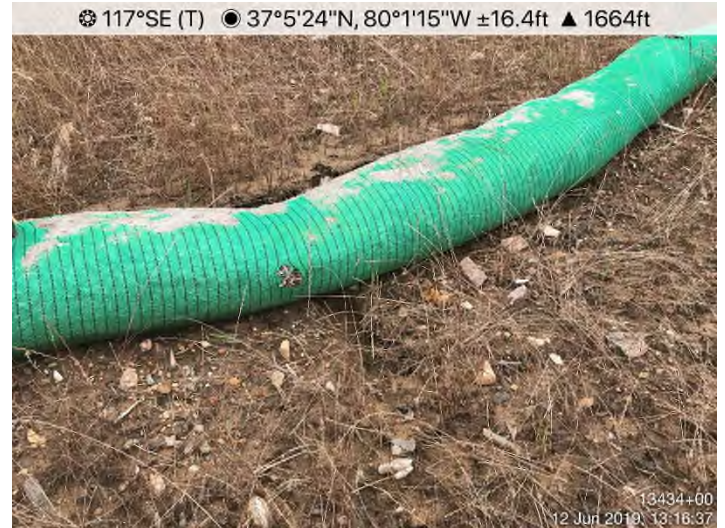
Fig. 8: **STA 13434+00** – CFS undermined.
