## FIELD INSPECTION

| <b>Project Name:</b> | Mountain Valley Pipeline | <b>Inspector:</b> | Matthew Grant |
| <b>Inspection Date:</b> | Wednesday, June 12, 2019 | <b>Project Contact:</b> | Brian Clauto |
| <b>Spread: Pittsylvania County AR32 MP269-269</b> | Spread I | <b>Weather (Wet/Dry/Rain):</b> | Dry |

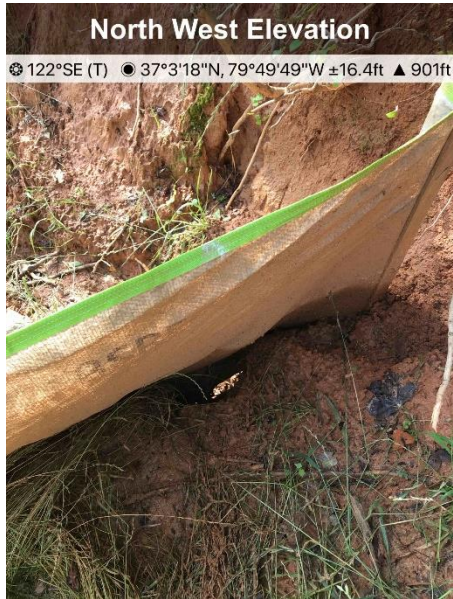
- Fig. 1 St1423+00 undermined P1 fence

**Recommended Corrective Action:** Maintain all controls per the approved plan and specs and remove escaped sediment and bridge debris.

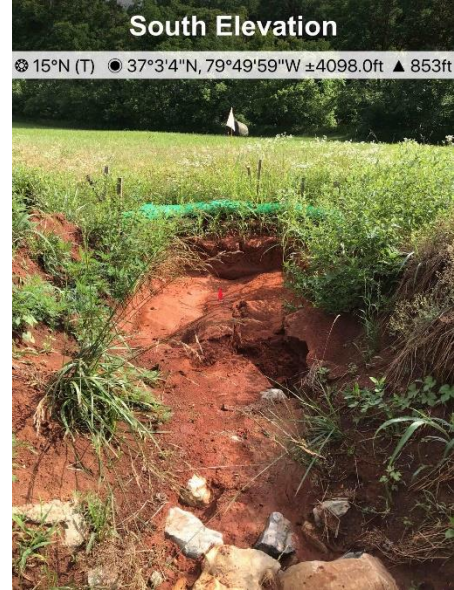
- Fig. 2 St14219-14244+34 three sumps require maintenance

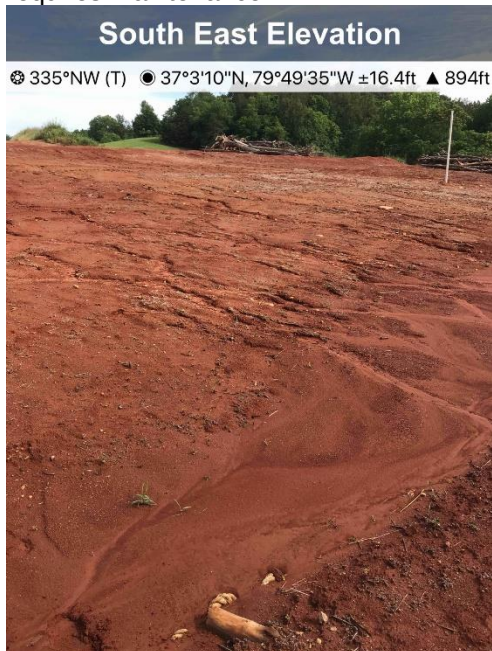
- Fig. 3 St14248+12 evidence of rill erosion and flow path requires maintenance

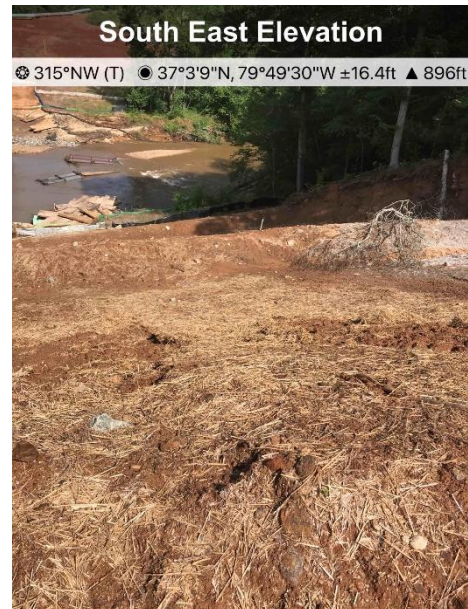
- Fig. 4 St14251+97 slip on slope

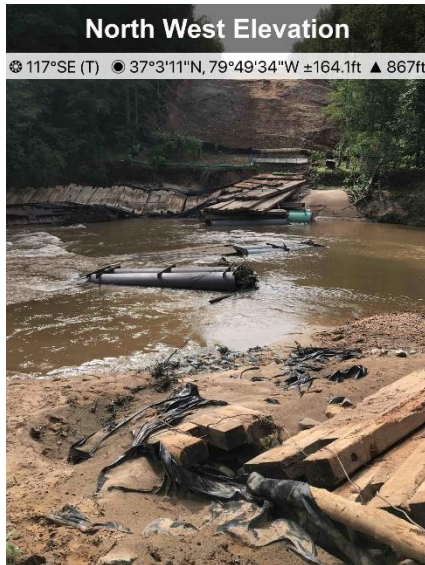
- Fig. 5 S-F11 bridge has been destroyed and debris is off the ROW

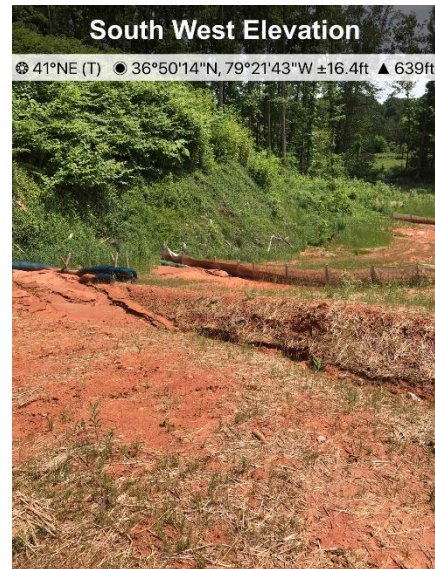
- Fig. 6 St15919+20 CFS and P1 requires maintenance

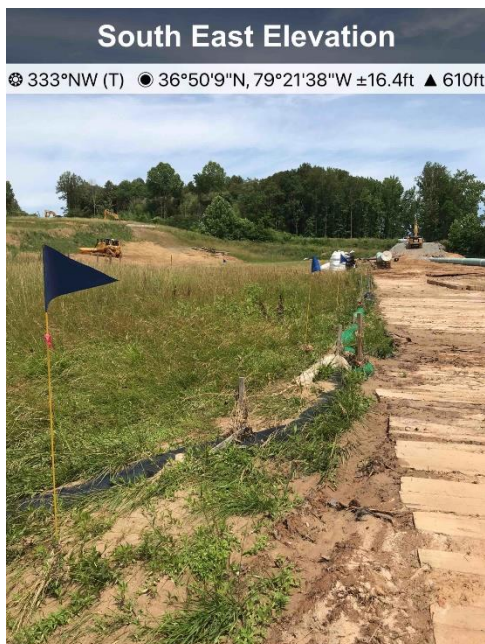
- Fig. 7 St15964+51-15947+75 escaped sediment in wetlands

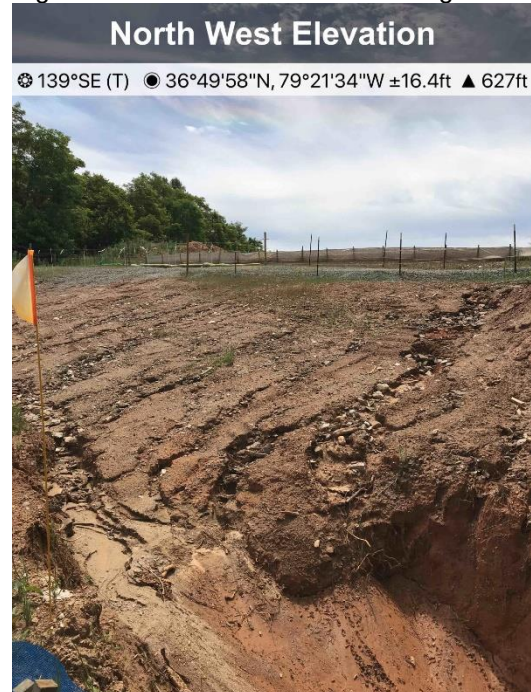
- Fig. 8 St15964+00 rill erosion leading to sump
