## FIELD INSPECTION

| Project Name: | Mountain Valley Pipeline | Inspector: | Marshall Willis |
| Spread H:<br>Montgomery County | STA 12071+80 – 12190+85 | Weather (Wet/Dry/Rain): | Wet |

## FIELD INSPECTION PHOTO LOG

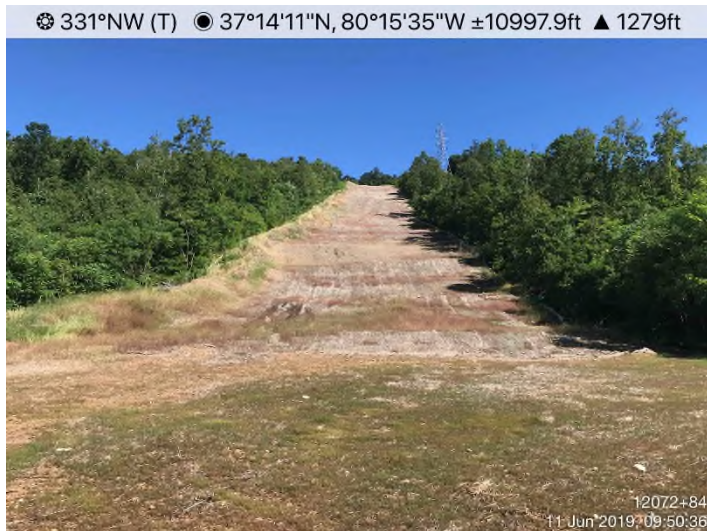
Fig. 1: **STA 12072+84** – Controls in place. Area stabilized.

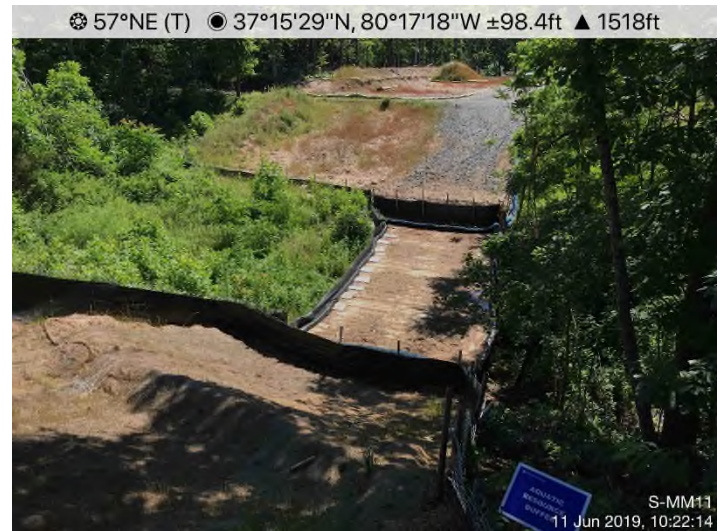
Fig. 2: **Stream S-MM11**– Controls in place. Area stabilized.

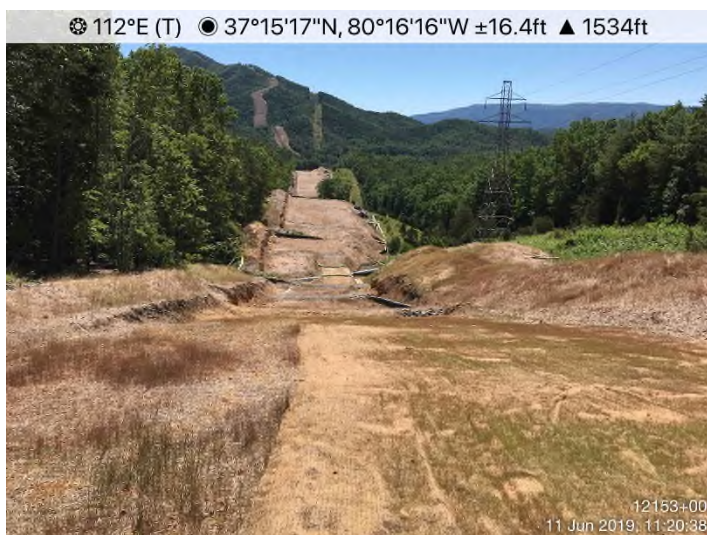
Fig. 3: **STA 12153+00** – Controls in place. Area stabilized.

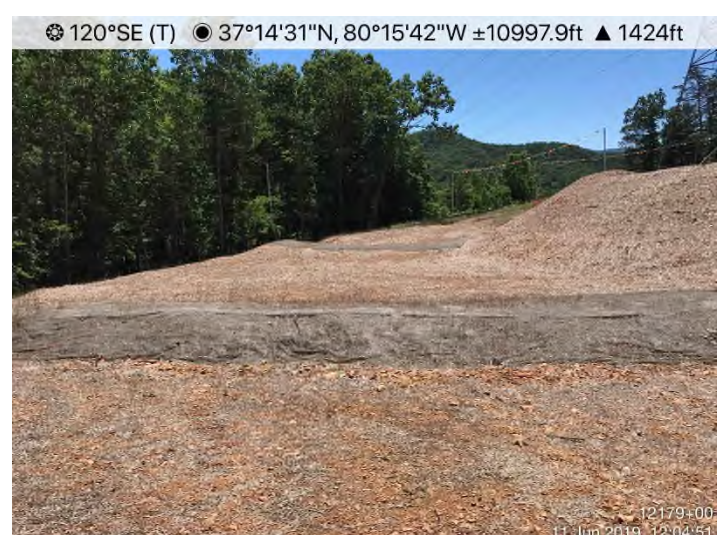
Fig. 4: **STA 12179+00** – Controls in place. Area stabilized.
