## FIELD INSPECTION

| <b>Project Name:</b> | Mountain Valley Pipeline | <b>Inspector:</b> | Marshall Willis |
| <b>Inspection Date:</b> | Tuesday, June 4, 2019 | <b>Project Contact:</b> | Brian Clauto |

## FIELD INSPECTION PHOTO LOG

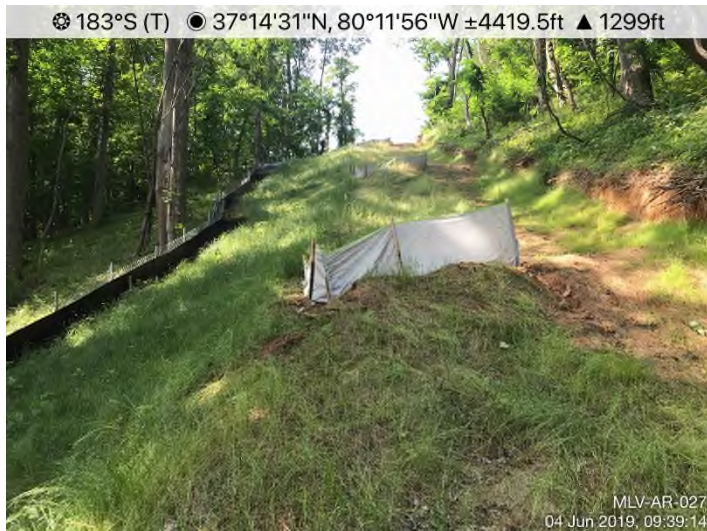
Fig. 1: **MLV-AR-027** – Controls in place.

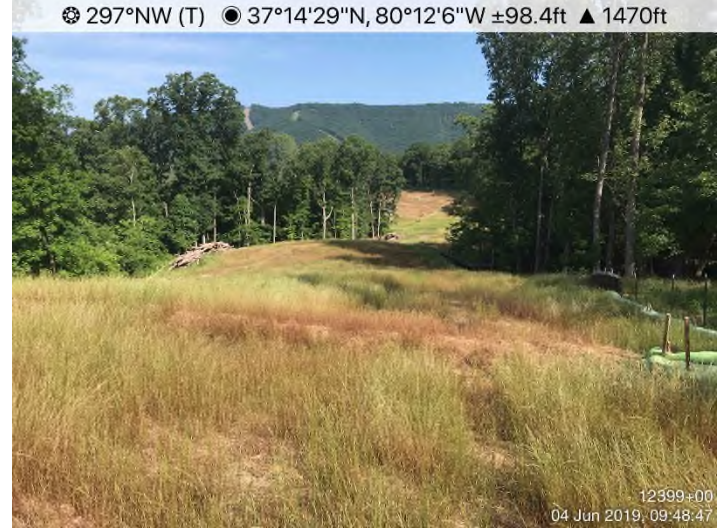
Fig. 2: **STA 12399+00** – Controls in place. Area Stabilized.

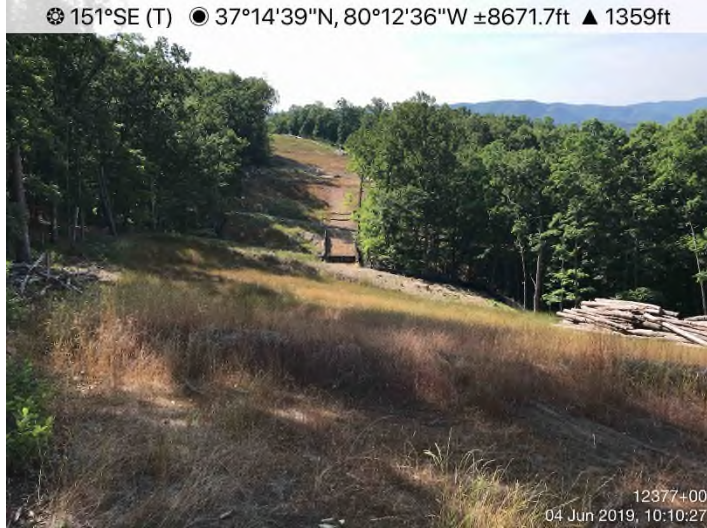
Fig. 3: **STA 12377+00** – Controls in place. Area Atabilized.

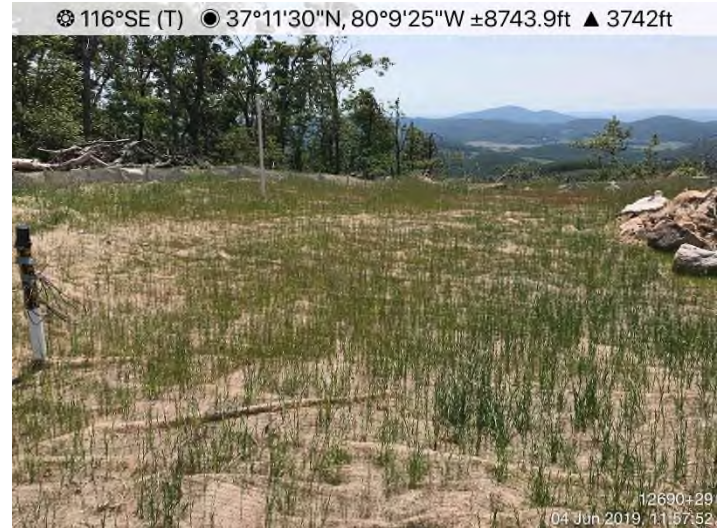
Fig. 4: **STA 12690+29** – Controls in place. Area stabilized with fabric.
