## FIELD INSPECTION

| <b>Project Name:</b> | Mountain Valley Pipeline | <b>Inspector:</b> | Marshall Willis |
| <b>Inspection Date:</b> | Wednesday, May 29, 2019 | <b>Project Contact:</b> | Brian Clauto |

## FIELD INSPECTION PHOTO LOG

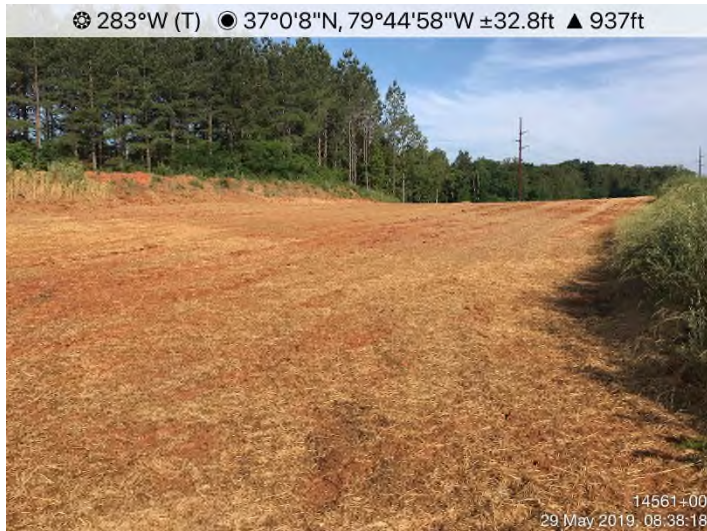
Fig. 1: **STA 14561+00** – Controls in place. Area stabilized with Earth Guard and straw.

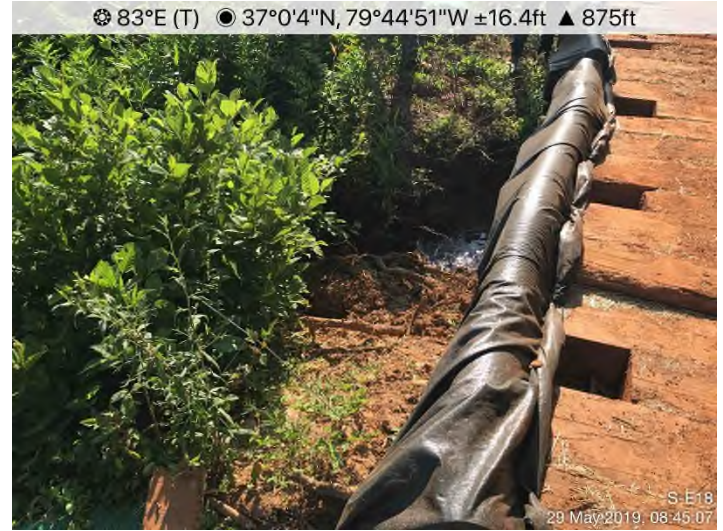
STA 14568+10: Stabilize stream bank of S-E18.  
STA 15125+84: Repair P1.

Fig. 2: **STA 14508+10** – Stabilize bank of S-E18.

**Recommended Corrective Action:** Maintain and install all controls per the approved plan and specs.

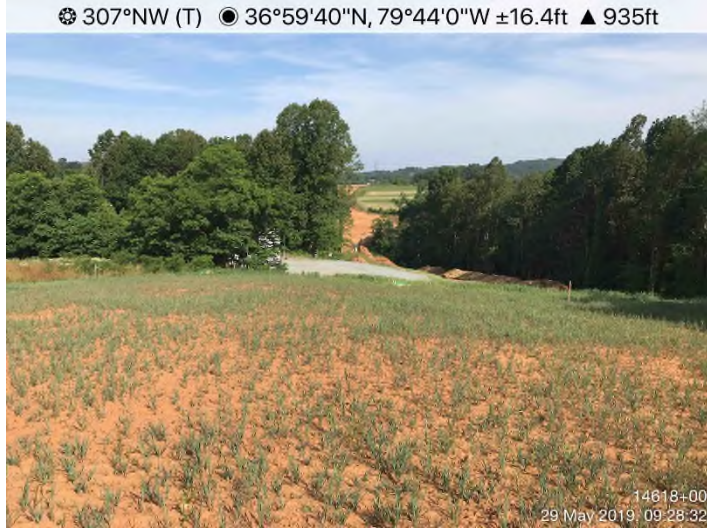
Fig. 3: **STA 14618+00** – Controls in place. Area establishing permanent vegetative cover.

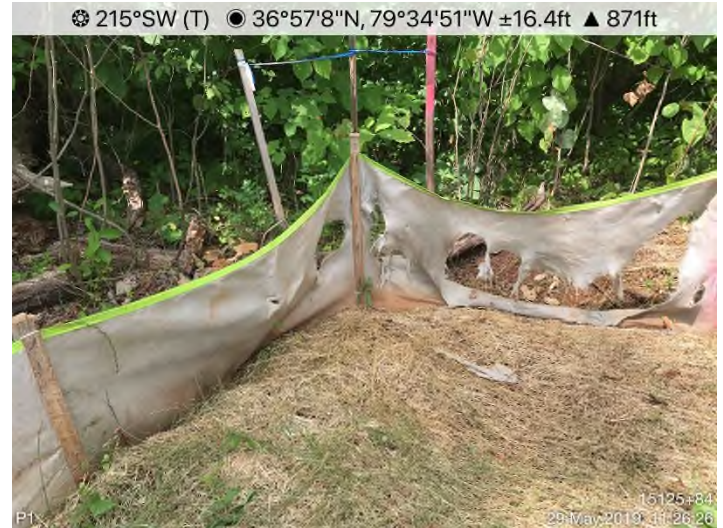
Fig. 4: **STA 15125+84** – P1 maintenance needed.
