## FIELD INSPECTION

| <b>Project Name:</b> | Mountain Valley Pipeline | <b>Inspector:</b> | Matthew Grant |
| <b>Spread:</b> Montgomery County MP 230-231<br>St12235-12193<br>AR-276.03 | Spread H | <b>Weather (Wet/Dry/Rain):</b> | Dry |

## FIELD INSPECTION PHOTO LOG

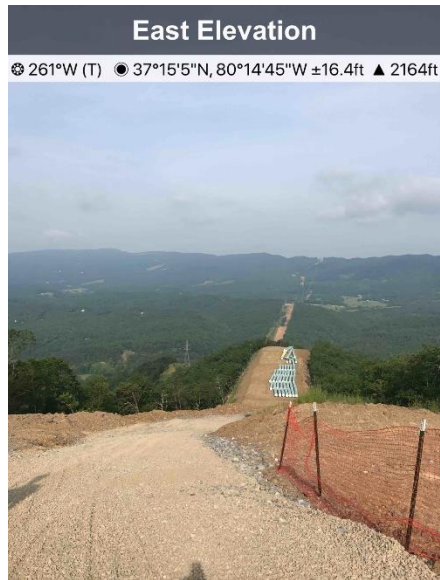
- Fig. 1 At St12235+00 controls in place

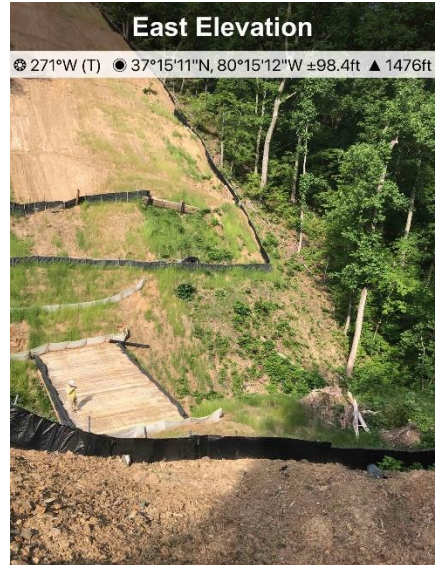
- Fig. 2 At St 12211+00 controls in place

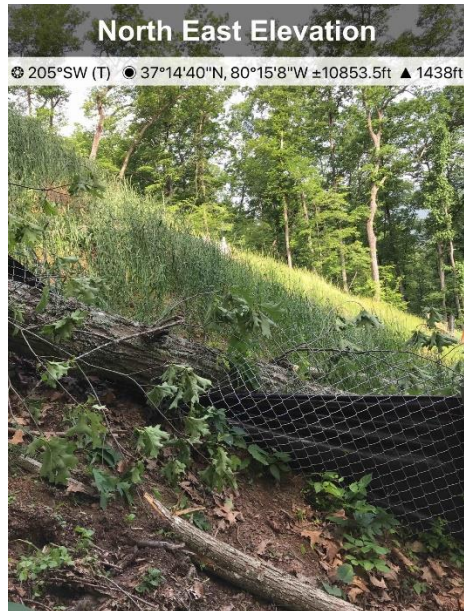
- Inspected designated streams included: S-C21
- ECD's were in place near the stream, no impacts were observed at the time of the inspection.
- St#12210+00 SSF requires maintenance

- Fig. 3. St12210+00 SSF requires tree removal / maintenance

**Recommended Corrective Action:** Maintain all controls per the approved plan and specs.

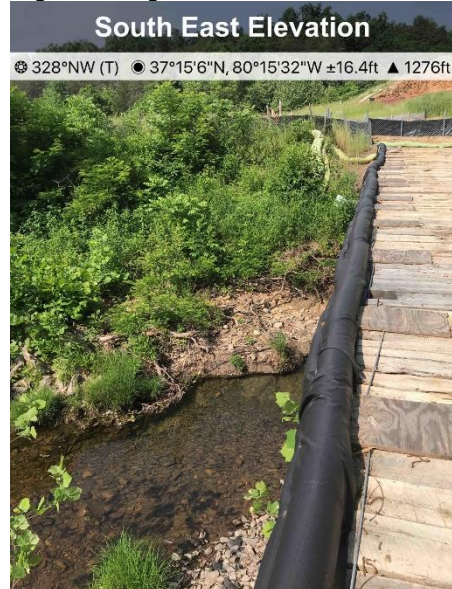
- Fig. 4. Designated stream S-C21
