FIELD INSPECTION

Project Name:	Mountain Valley Pipeline	Inspector:	Marshall Willis
Inspection Date:	Wednesday, May 22, 2019	Project Contact:	Brian Clauto
Spread H: Franklin County	STA 13197+35 – 13318+21	Weather (Wet/Dry/Rain):	Dry

FIELD INSPECTION PHOTO LOG

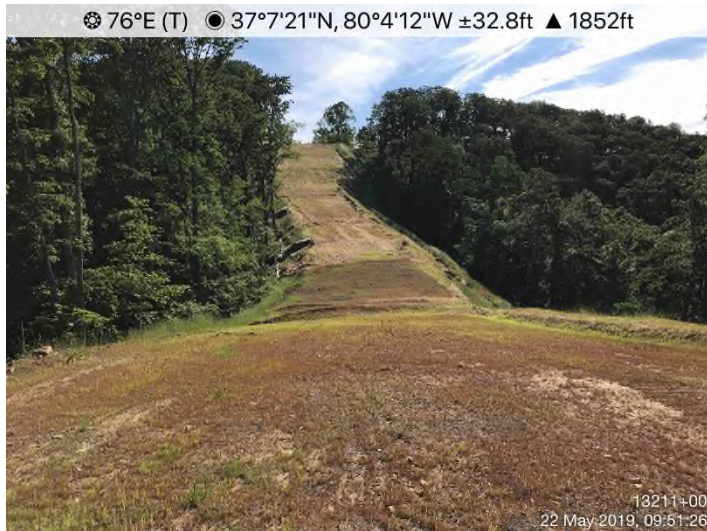
Fig. 1: **STA 13211+00** – Controls in place. Area stabilized with erosion fabric/Earth Guard.

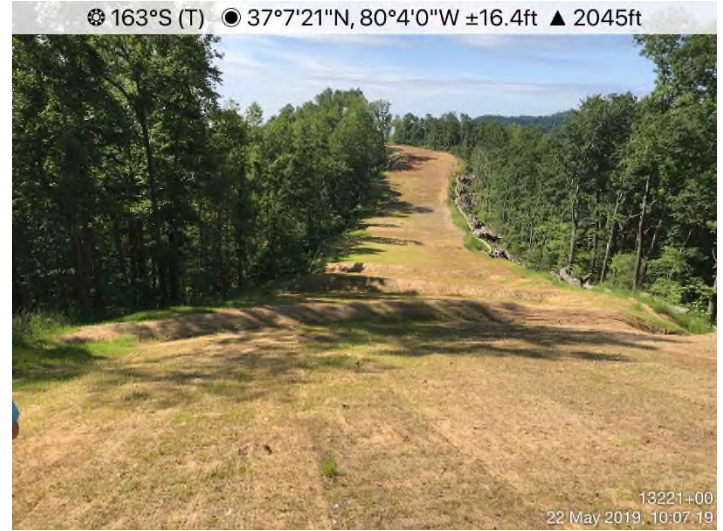
Fig. 2: **STA 13221+00** – Controls in place. Area stabilized with erosion fabric/Earth Guard.

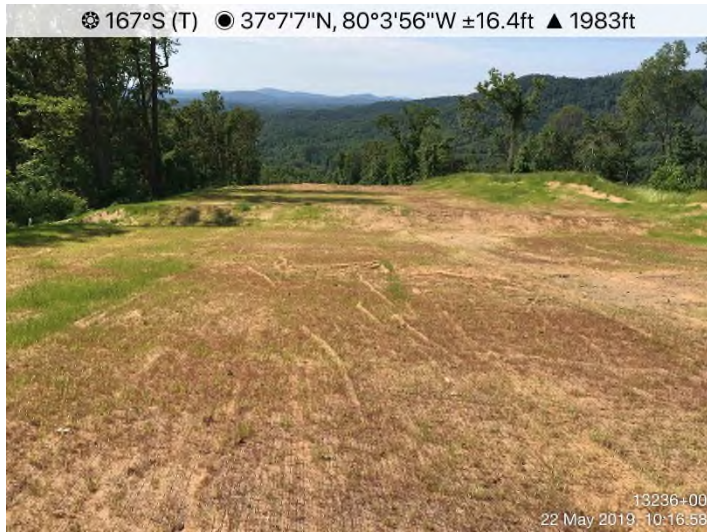
Fig. 3: **STA 13236+00** – Controls in place. Area stabilized with erosion fabric/Earth Guard.

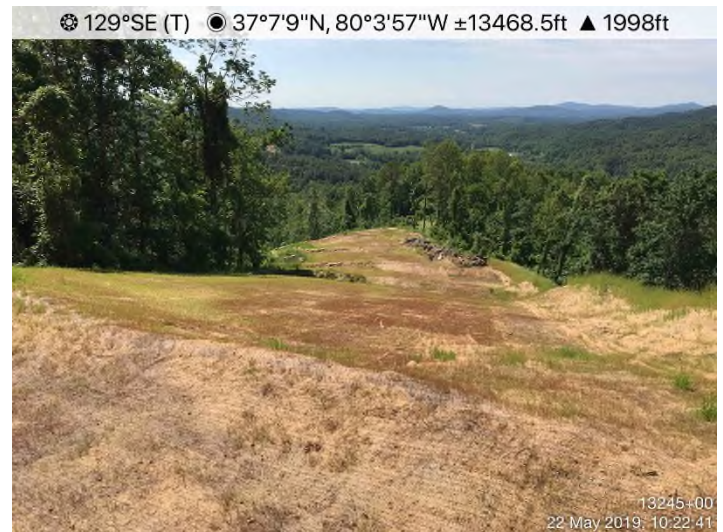
Fig. 4: **STA 13245+00** – Controls in place. Area stabilized with erosion fabric/Earth Guard.

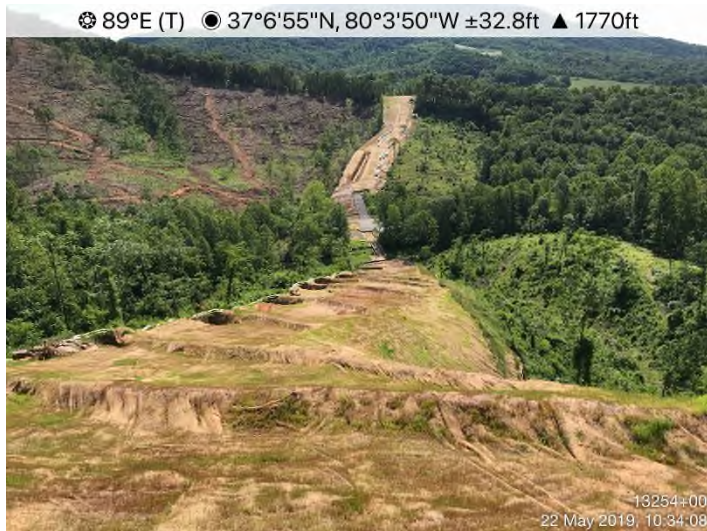
Fig. 5: **STA 13254+00** – Controls in place. Area stabilized with erosion fabric/Earth Guard.

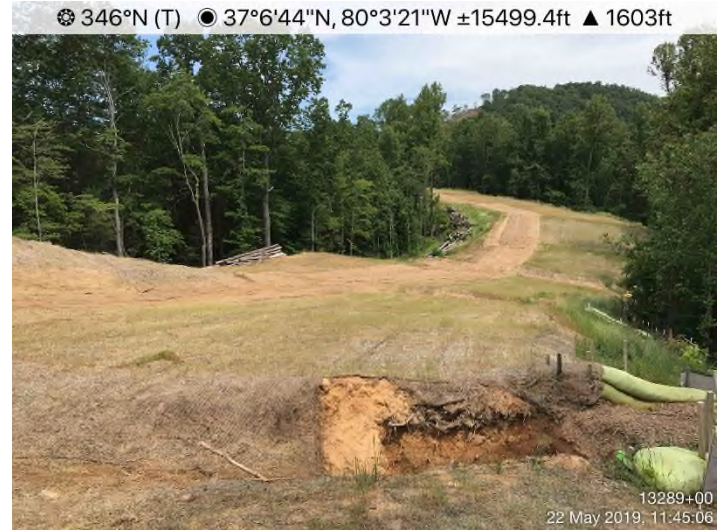
Fig. 6: **STA 13289+00** – Controls in place. Area stabilized with erosion fabric/Earth Guard.

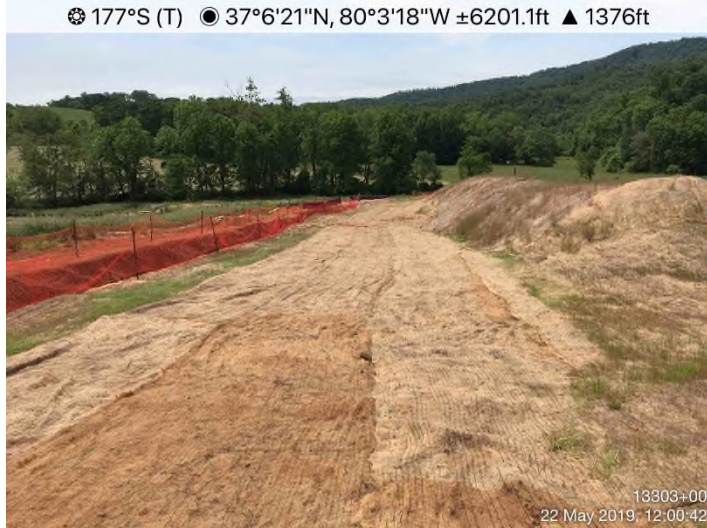
Fig. 7: **STA 13303+00** – Controls in place. Area stabilized with erosion fabric/Earth Guard.

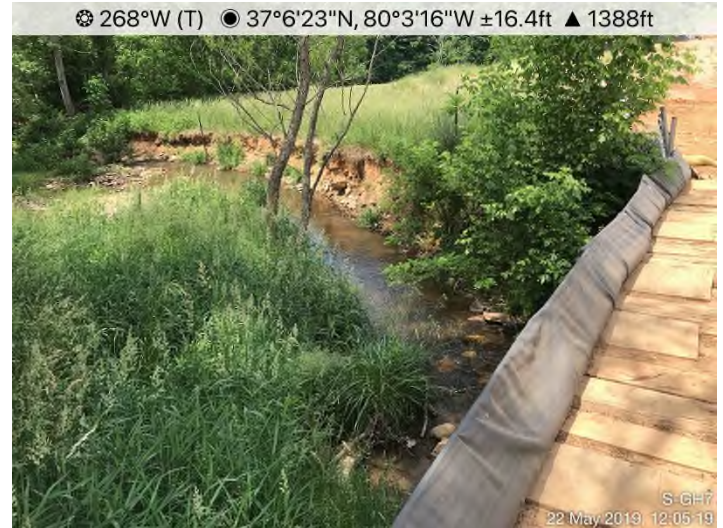
Fig. 8: **Stream S-GH7** – Controls in place.
