## FIELD INSPECTION

| Project Name: | Mountain Valley Pipeline | Inspector: | Marshall Willis |
| Inspection Date: | Tuesday, May 14, 2019 | Project Contact: | Brian Clauto |
| Spread I:<br>Pittsylvania County | STA 15584+23 – 15647+03 | Weather (Wet/Dry/Rain): | Wet |

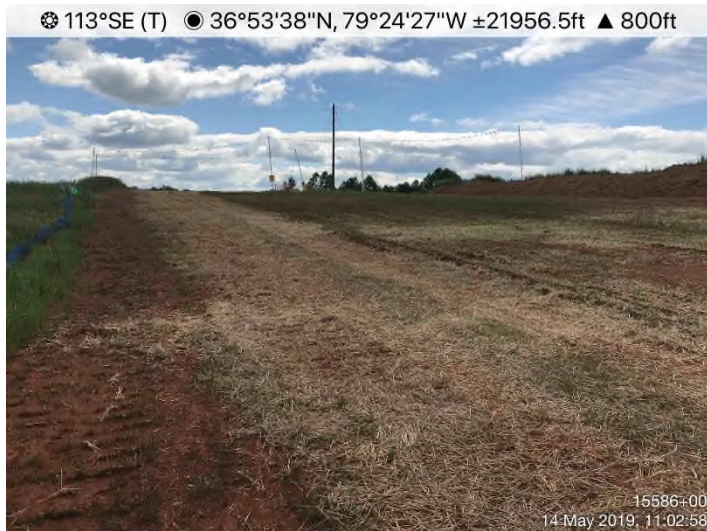
Fig. 1: **STA 15586+00** – Controls in place. Area adequately stabilized with straw and Earth Guard.

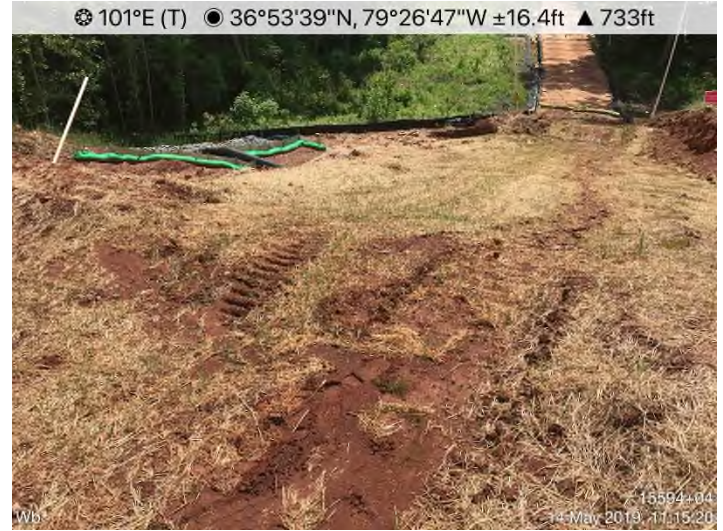
Fig. 2: **STA 15594+04** – Waterbar maintenance required.

**Recommended Corrective Action:** Maintain and install all controls per the approved plan and specs.

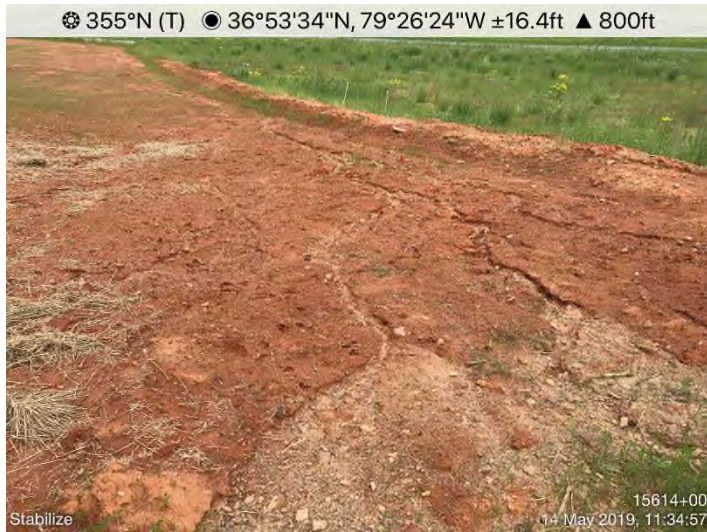
Fig. 3: **STA 15614+00** – Inadequate stabilization.

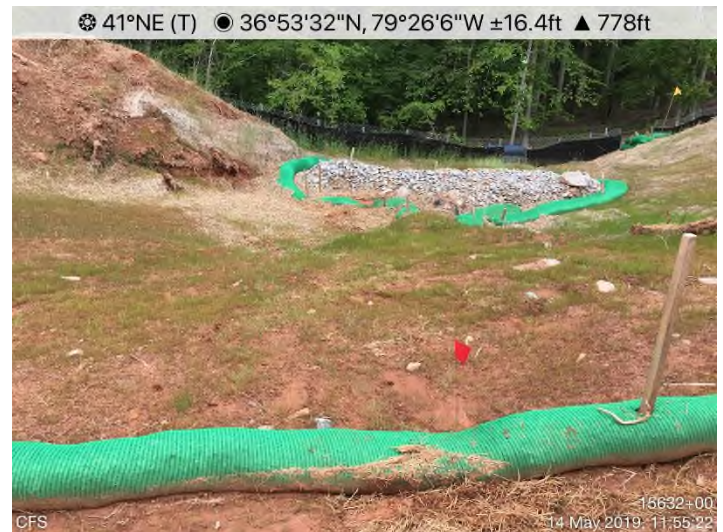
Fig. 4: **STA 15623+00** – CFS undermined.

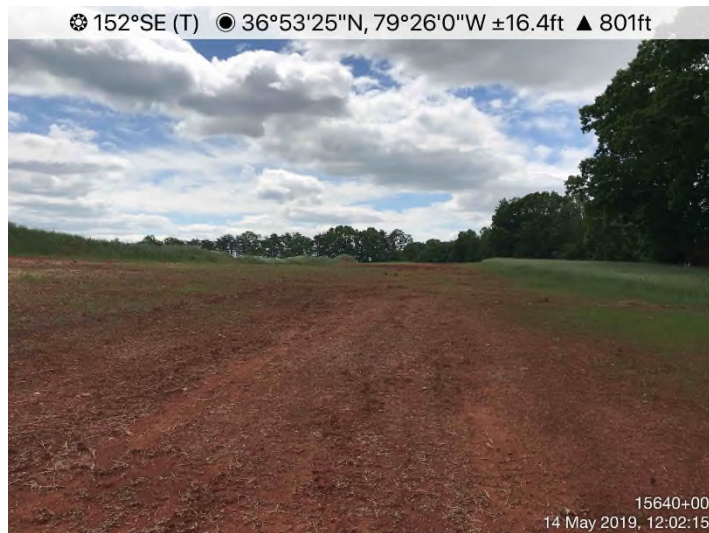
Fig. 5: **STA 15640+00** – Controls in place. Area adequately stabilized with straw and Earth Guard.

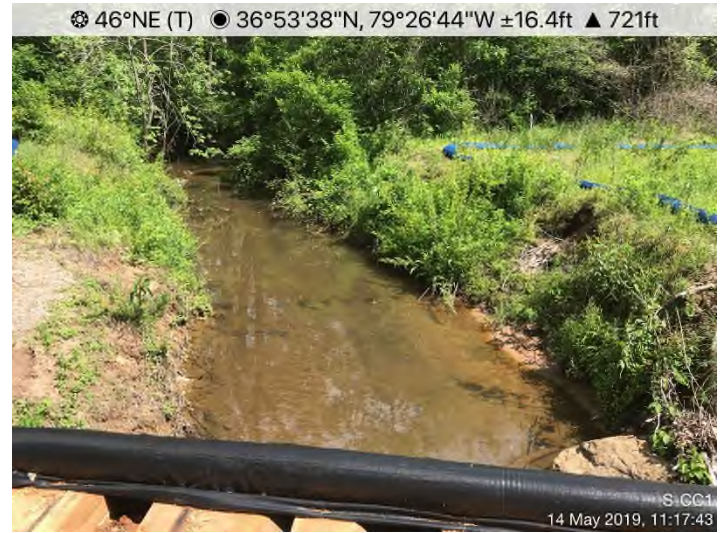
Fig. 6: **Stream S-CC1** – Controls in place.

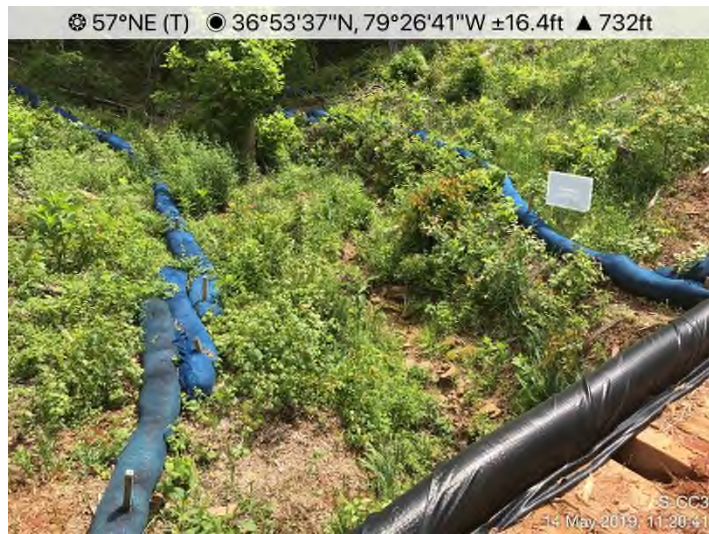
Fig. 7: **Stream S-CC3** – Controls in place.

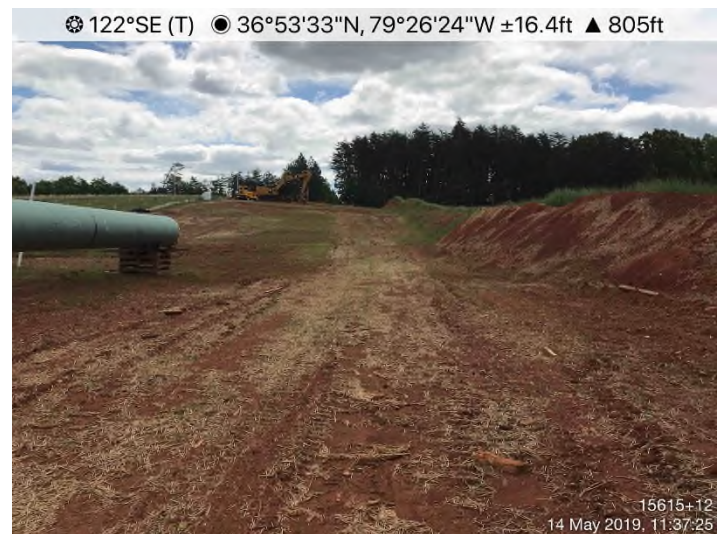
Fig. 8: **STA 15615+12** – Controls in place. Area adequately stabilized with straw and Earth Guard.
