## FIELD INSPECTION

| Project Name: | Mountain Valley Pipeline | Inspector: | Marshall Willis |
| Inspection Date: | Thursday, May 9, 2019 | Project Contact: | Brian Clauto |
| Spread I:<br>Pittsylvania County | STA 15498+70 – 15584+00 | Weather (Wet/Dry/Rain): | Dry |

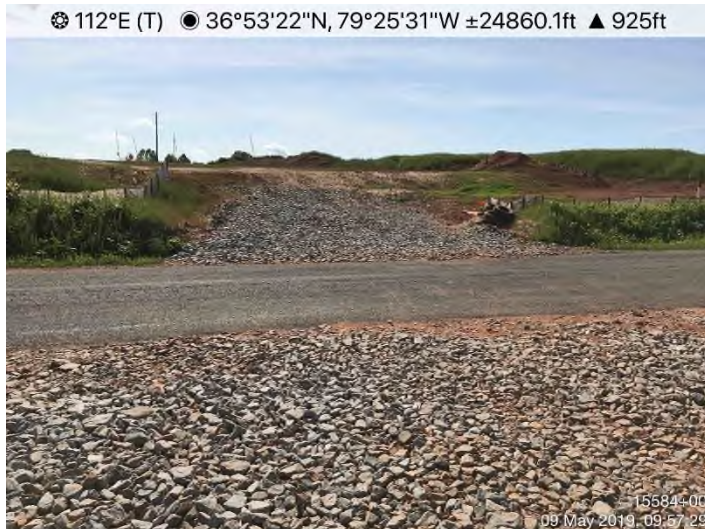
Fig. 1: **STA 15584+00** – Controls in place.

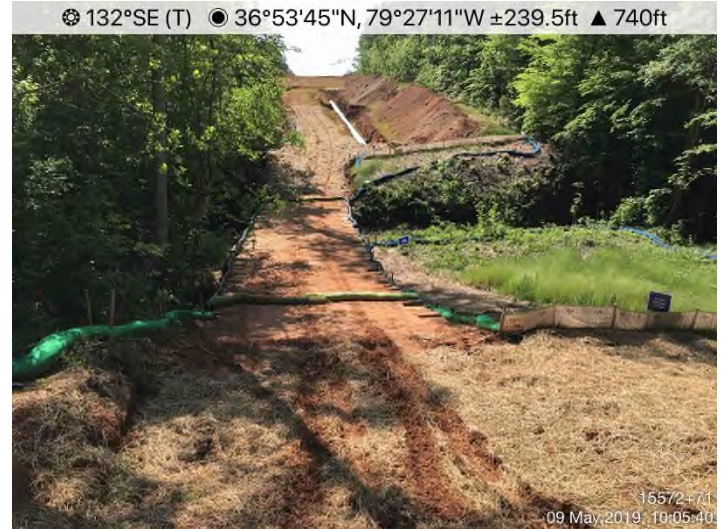
Fig. 2: **STA 15572+71** – Controls in place. Area stabilized with Earth Guard and straw.

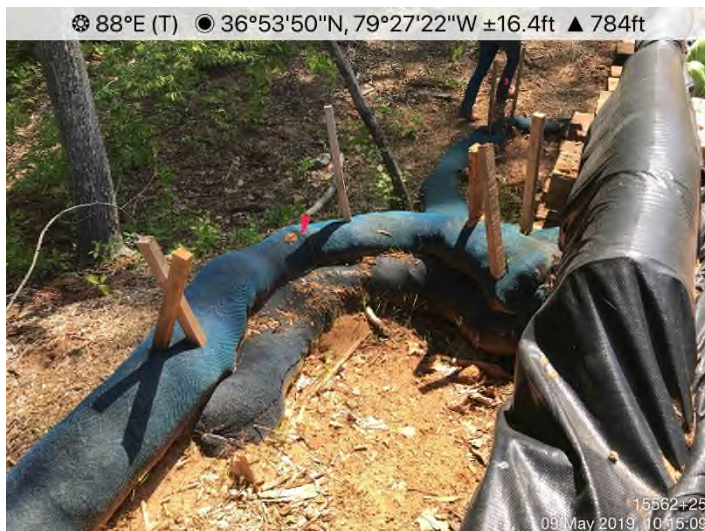
Fig. 3: **STA 15562+25** – CFS in need of maintenance.

**Recommended Corrective Action:** Maintain and install all controls per the approved plan and specs.

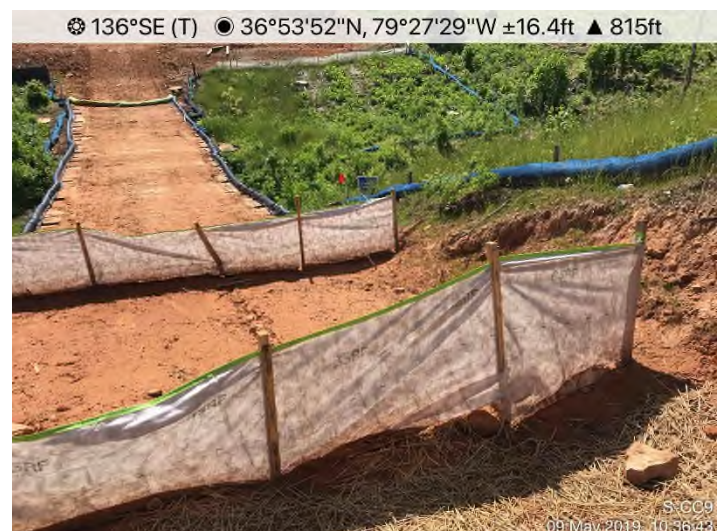
Fig. 4: **STA 15556+23** – P1 not properly entrenched.

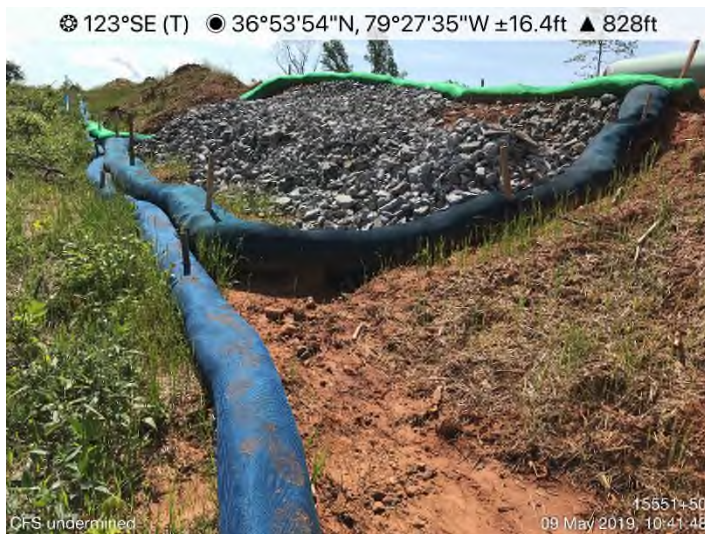
Fig. 5: **STA 15551+50** – CFS undermined.

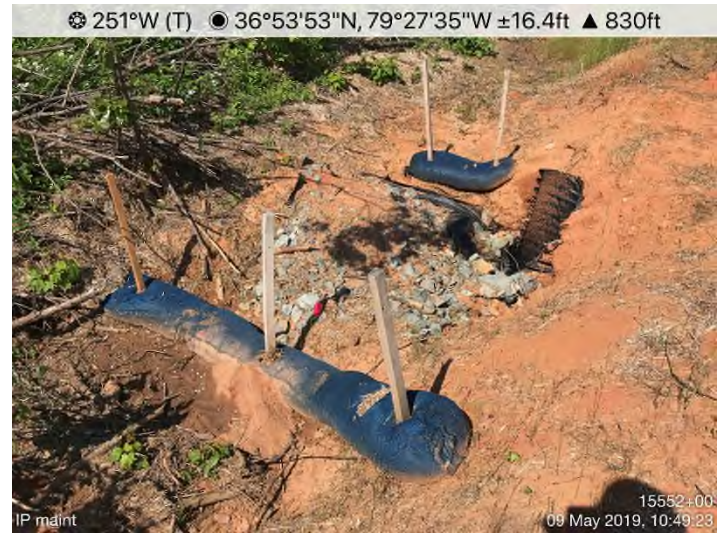
Fig. 6: **STA 15552+50** – IP/CFS maintenance needed.

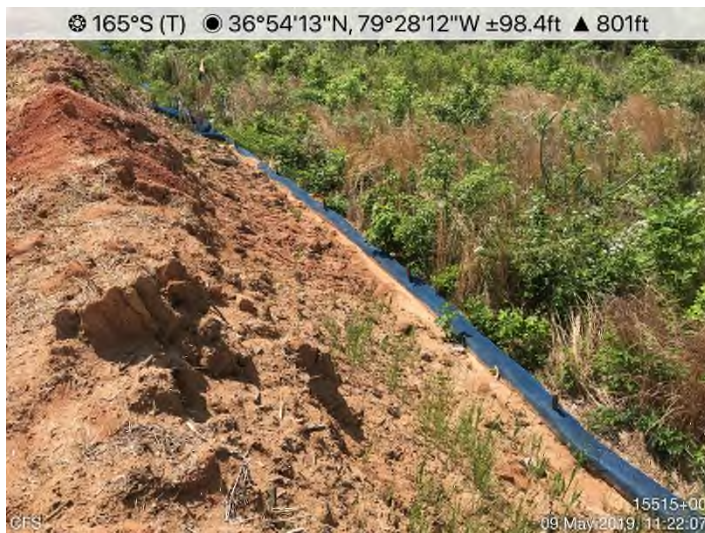
Fig. 7: **STA 15514+00 - 15515+00** – CFS maintenance needed.

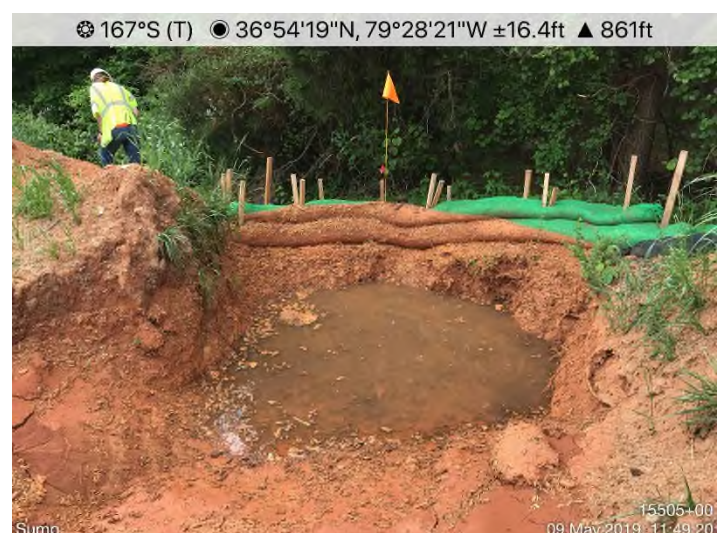
Fig. 8: **STA 15505+00** – Sump maintenance needed.
